TVA Disposal Facility Assessment Phase 1 Plant Summary Colbert Fossil Plant (COF)

Facilities Reviewed:	Ash Pond 4 Disposal Area 5 Dry Stack Disposal Area 5 Drainage Basin Closed Disposal Area 1

TVA Disposal Facility Assessment
Phase 1 Coal Combustion Product Disposal
Facility Summary
Colbert Fossil Plant (COF)
Ash Pond 4 (AP-4)

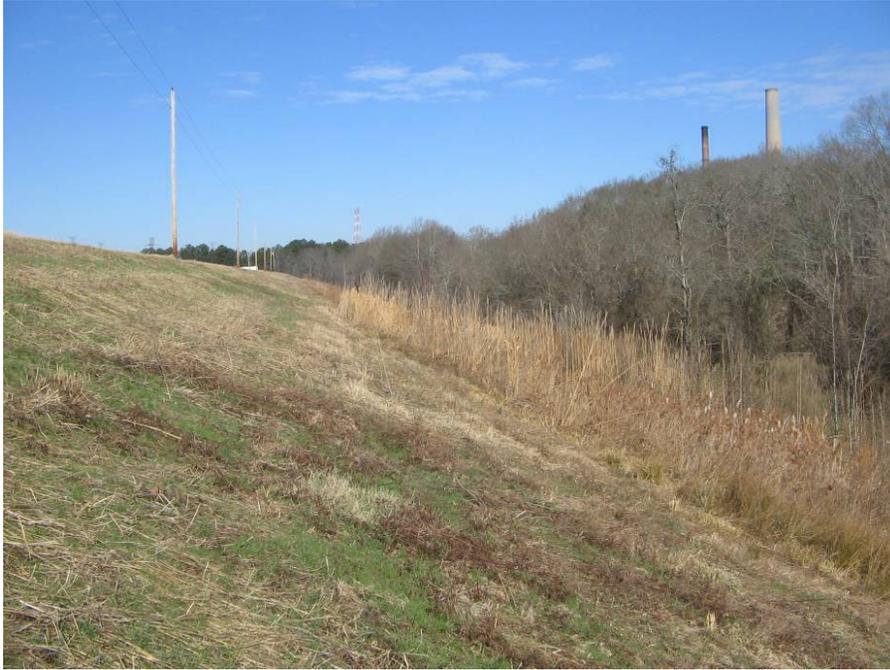
- The seepage along east dike at mid-slope is a concern. It has been reportedly ongoing since about 1984, when the dikes were initially raised. The seepage has been continuously monitored by TVA with little or no change being reportedly noticed through the years. In 2007, TVA retained a geotechnical consultant to investigate the seepage. The investigation identified a seepage zone between the two phases of dike construction where a thin zone of bottom ash and organic material was found. The report recommended to continue monitoring the seepage, and to install a collection system below the seeps. A collection system has not been installed.

Drawing Mark AP-4-1 Typical photo representing mid-slope seepage locations along the east and southeast dike.

- Monitor seepage areas on east dike for change until engineering evaluation can be completed and remedial actions developed.
- Continue annual joint repairs of RCP risers. This spillway system may ultimately be modified or replaced, pending Stantec-TVA assessment of replacement system. Monitor until that time.

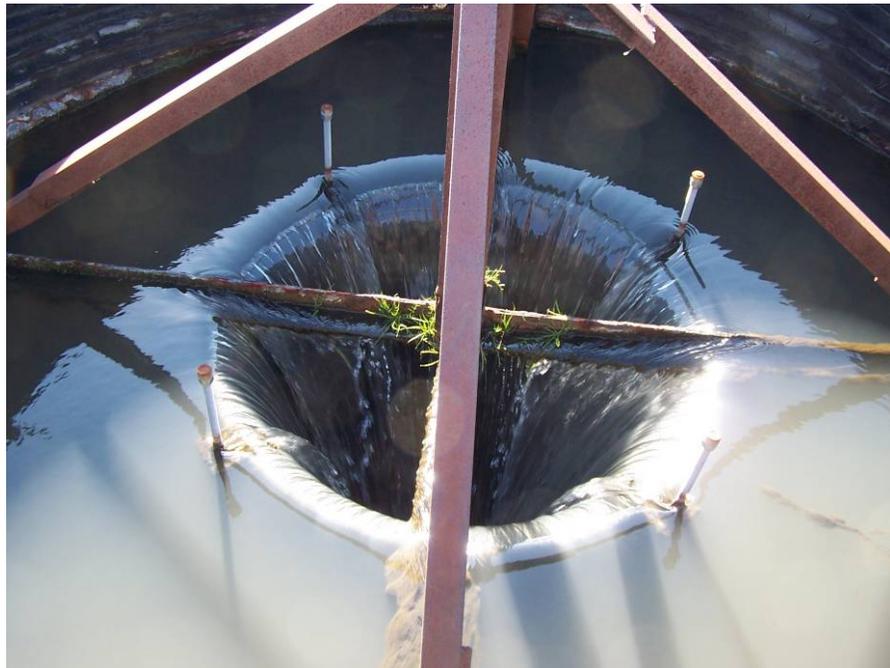
- RCP push-together riser structure spillways are a concern. The joints of the riser pipes at Ash Pond 4 reportedly receive annual repair using oakum joint sealant, suggesting that there is a historic joint leakage issue.

Drawing Mark AP-4-2 Stacked RCP riser outlet structures.

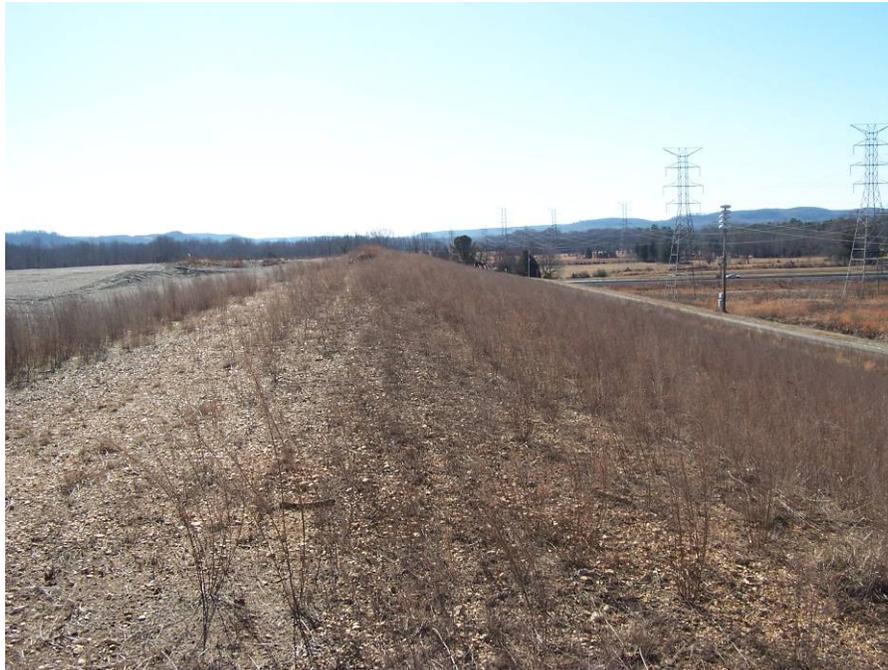
- Raising the dikes by using upstream construction over sluiced ash is a potential slope stability concern.
- Excavating and stacking dried bottom ash in the west portion of the pond is a concern. Constructing embankments over hydraulically placed ash requires engineering analysis and geotechnical explorations. The rate and manner of placement is critical to the integrity and stability. Also, placement of embankment within the ash pond pool area reduces storm and process water storage capacity.

Drawing Mark AP-4-3 Stacking operation at west side of ash pond, located at left in photo.

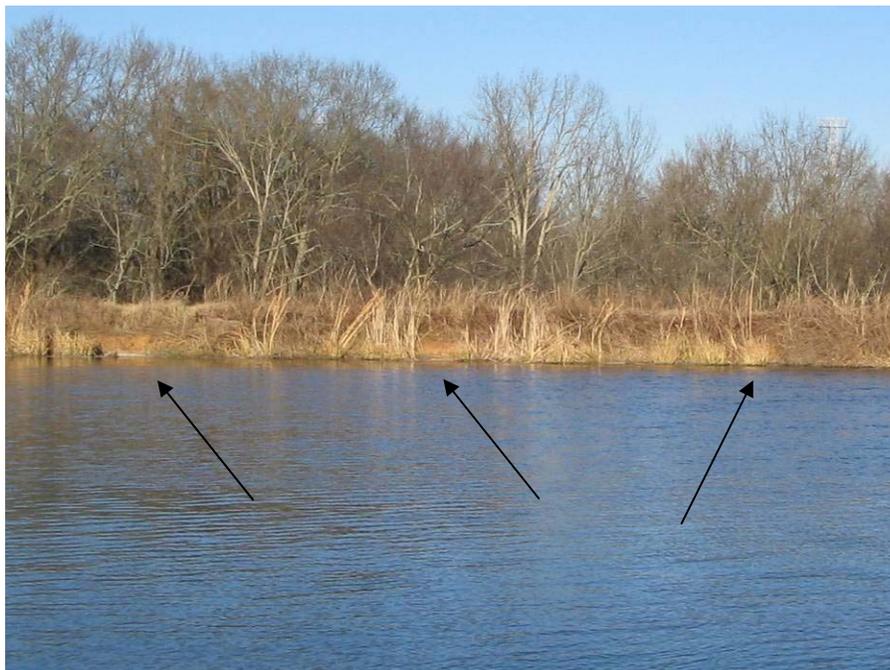
Drawing Mark AP-4-4 Typical photo of inner slope wave erosion.

- Repair erosion on interior slopes, and line with rip-rap to help reduce future erosion.
- Cut tall brush and cattails at seepage areas to permit better observations.

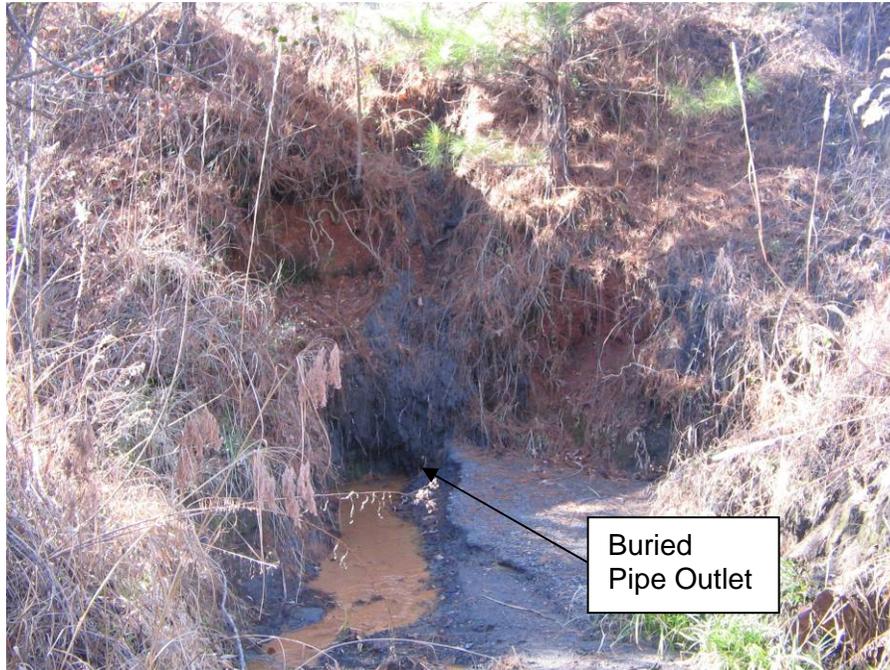
- Wave action erosion was noted at several locations along interior slopes just above pool level.
- Both inlet and outlet ends of the drainage pipe beneath the access road northwest of the pond outlet was observed to be buried/covered with sedimentation. Some flow from this pipe through the sedimentation and into the discharge channel was observed.

Drawing Mark AP-4-5 Buried drainage pipe located at access road.

- Continue mowing of exterior slopes.
- Continue annual inspection program and execute recommendations.
- Clean sedimentation from drainage pipe that lies beneath access road leading up to Ash Pond 4. The inlet and outlet ends of this pipe are completely buried, but some water still trickles through into the discharge channel. This pipe is not associated with the ash pond, but should be cleaned and inlet/outlet ends re-opened and maintained for positive site drainage.

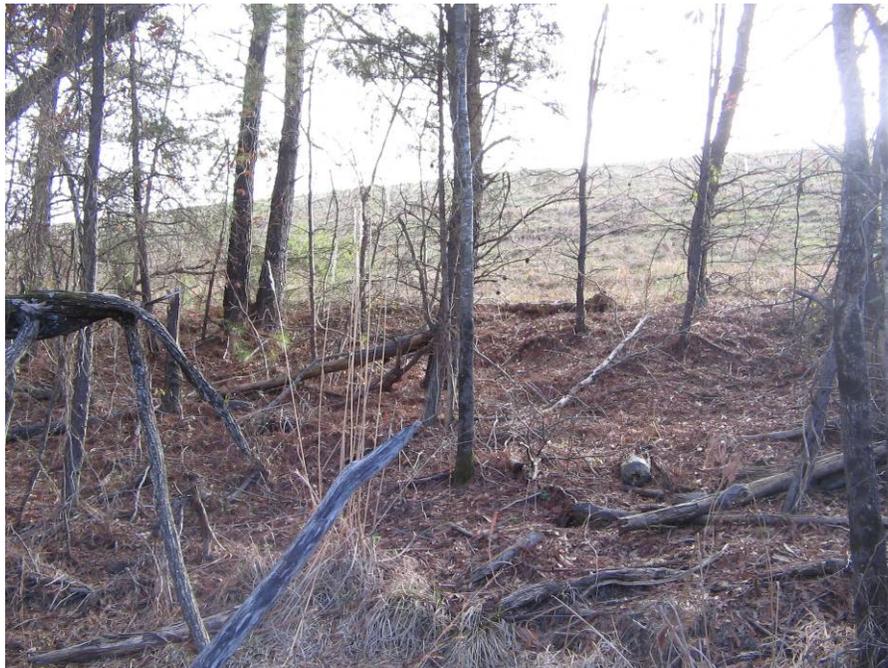
- Trees located on north dike, and at a few other isolated locations are a concern. Recommendations for tree removal have been provided in past annual reports, but have not yet been performed.

Drawing Mark AP-4-6 Trees located at toe of North dike.

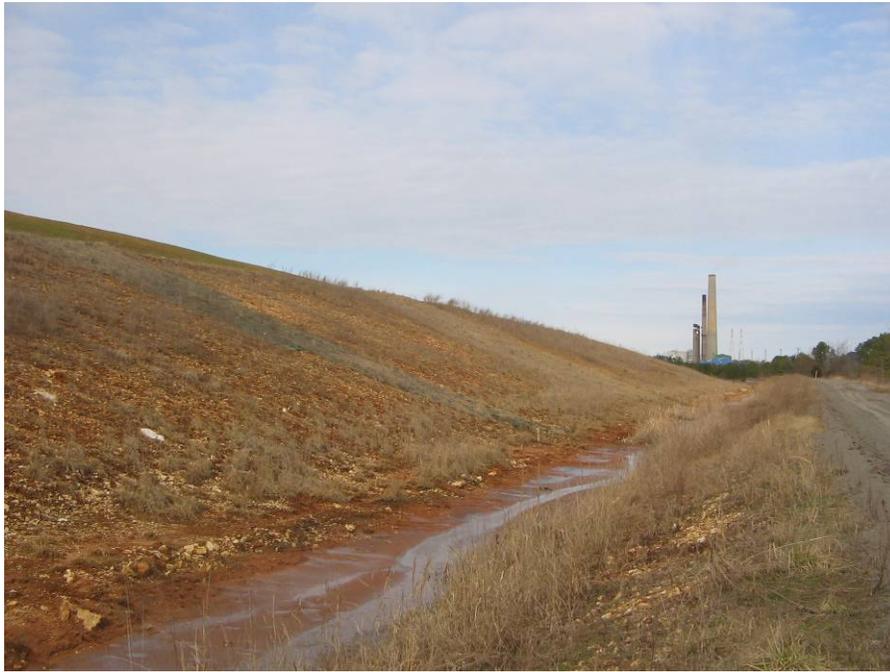
Drawing Mark DS-5-1 View showing perimeter ditch and dry stack slope, siltation in ditch, sparse vegetation on stack.

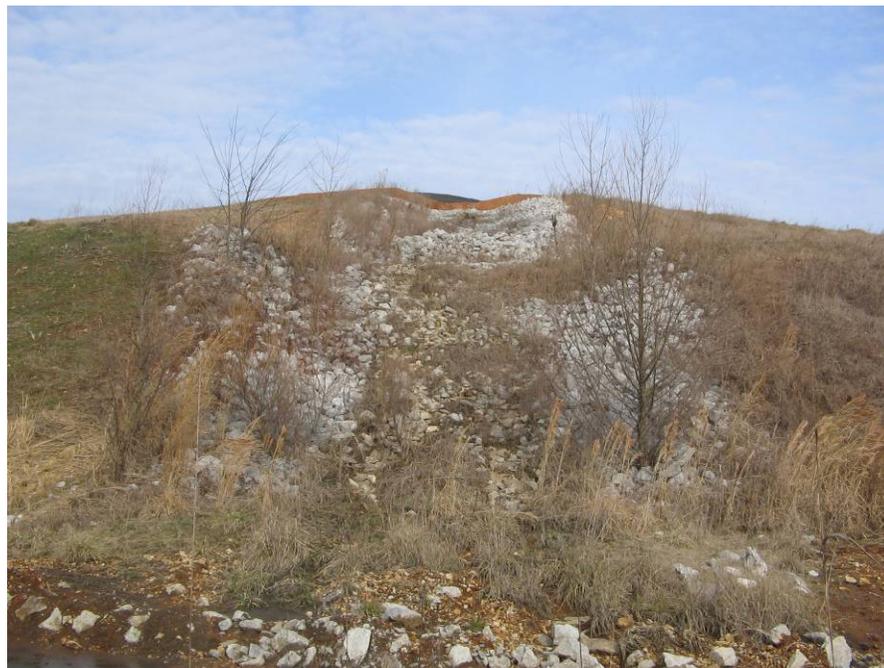
Drawing Mark DS-5-2 View of typical downdrain on the dry stack.

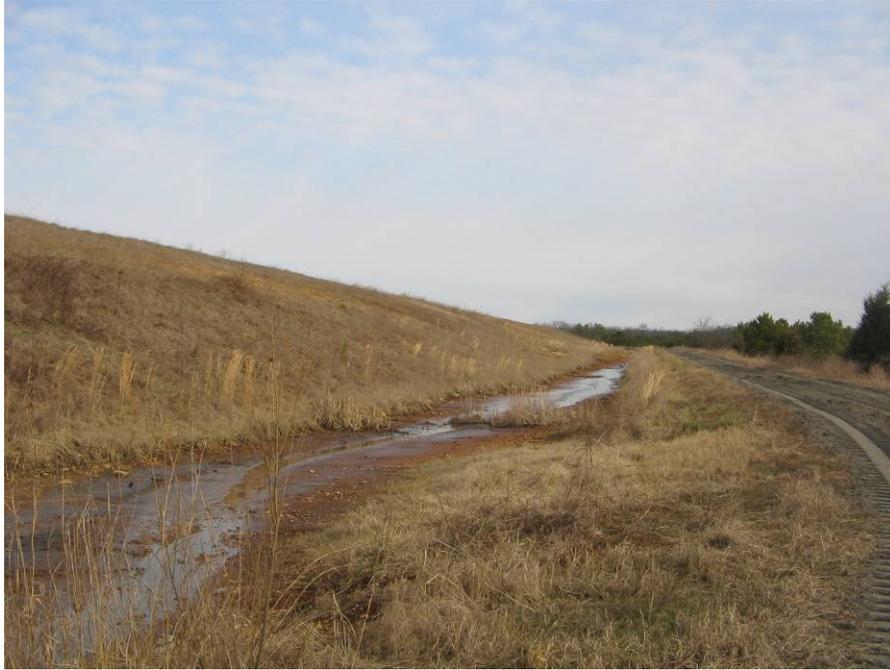
Drawing Mark DS-5-3

View showing perimeter ditch and dry stack slope, siltation in ditch, sparse vegetation on stack.

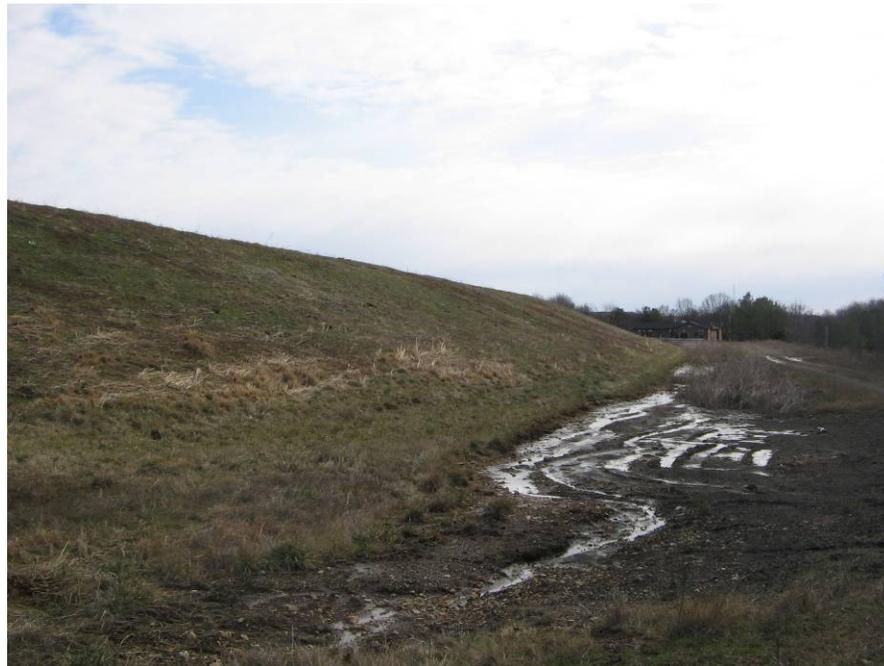
Drawing Mark DS-5-4

View showing perimeter ditch and dry stack slope, siltation in ditch, vegetation on stack.

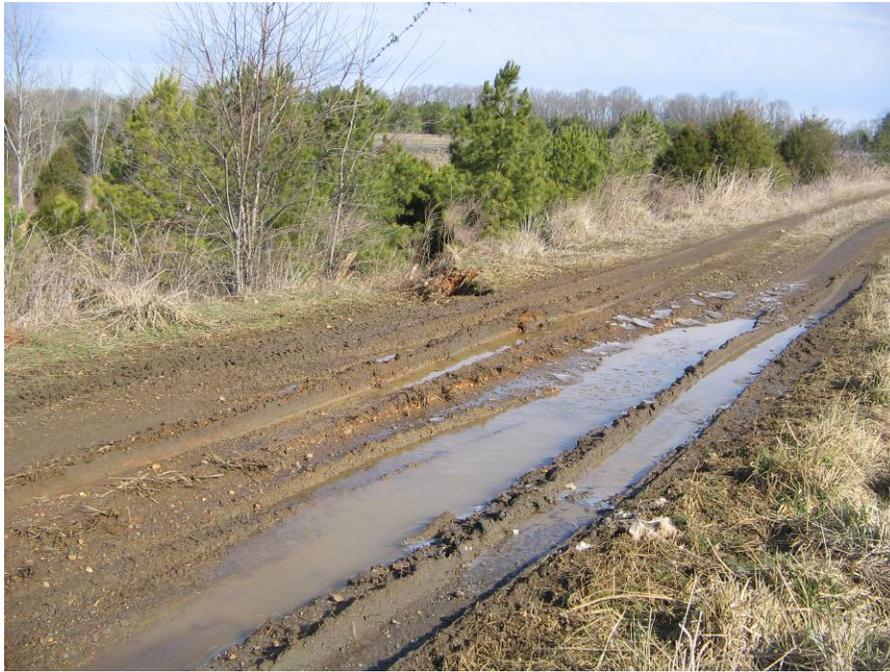
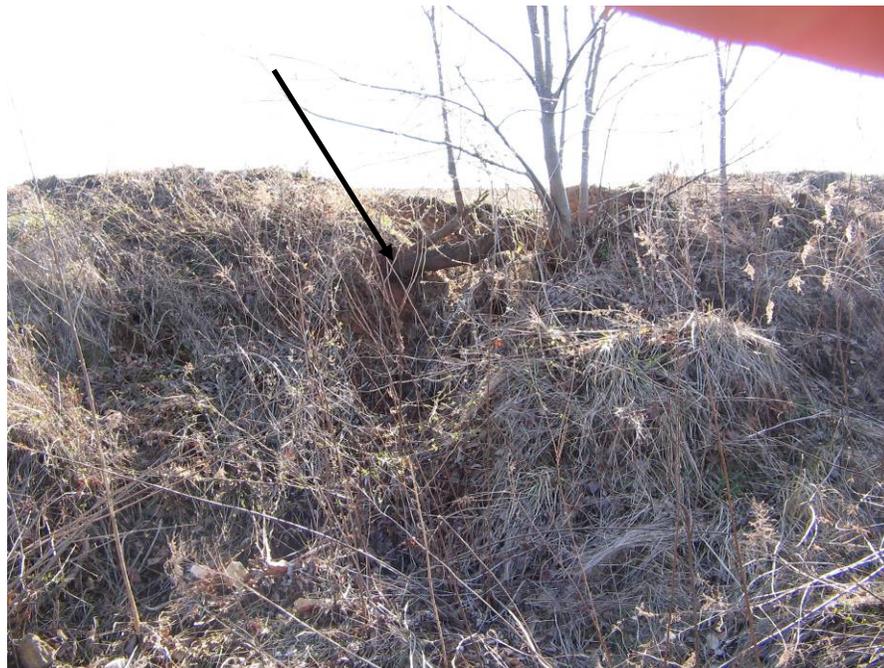
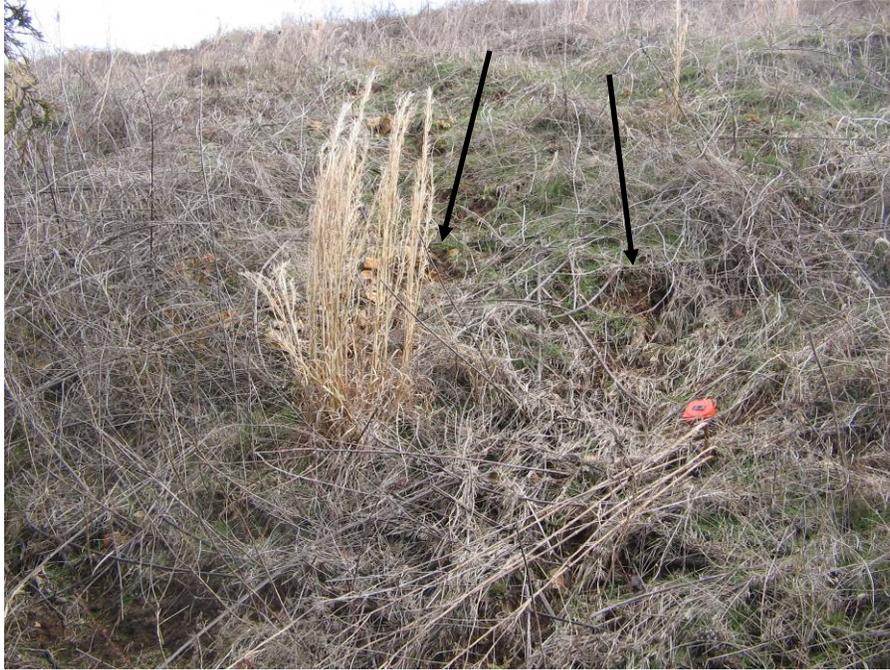
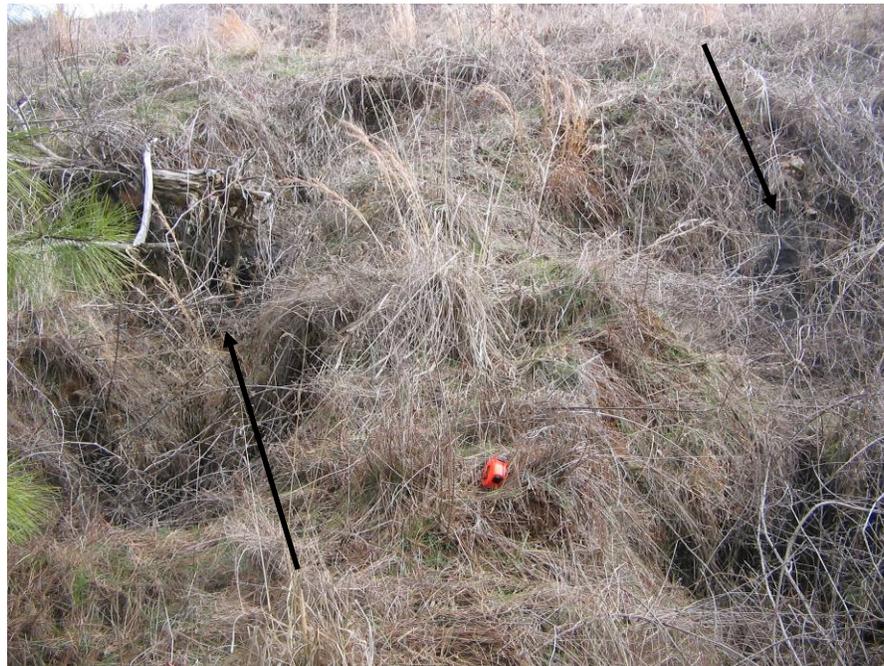
Drawing Mark DS-5-7 Erosion on exterior slope of dike, ruts on access road

Drawing Mark DS-5-7 Erosion on exterior slope of dike.

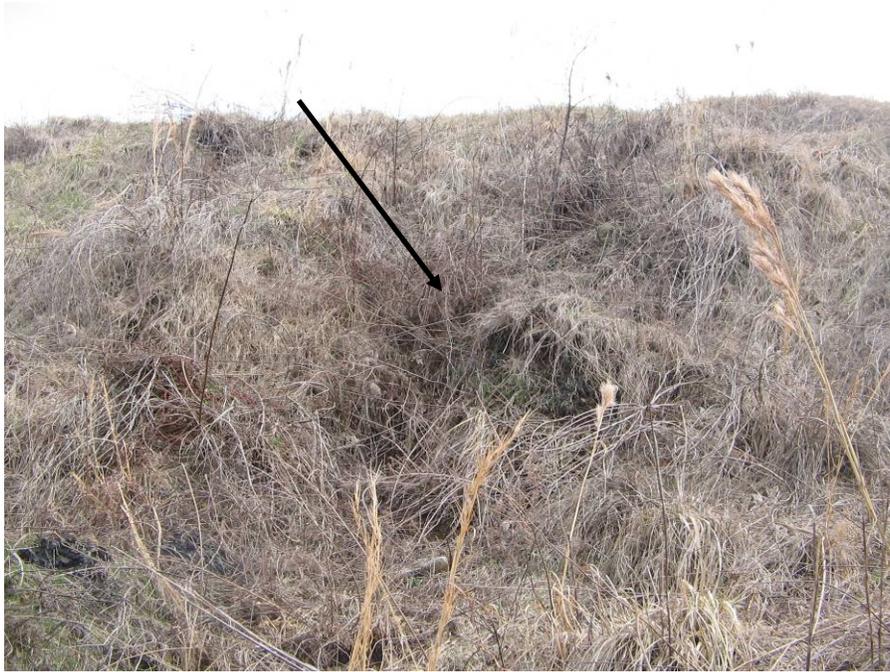
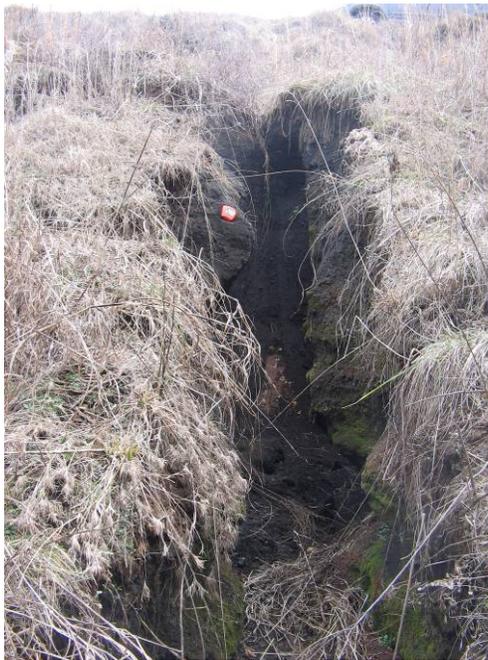
floods and water probably flows across the access road and down the slopes of the perimeter dike, which has lead to the severe rill/gully erosion noted under item 6.1.

Drawing Mark DS-5-8 Significant rill/gully erosion on northwest face of perimeter dike.

- Repair locations of significant rill and gully erosion at the northwest face of the perimeter dike. The areas should be excavated, foundation benches cut into the slopes, and new fill placed to reform the slope. After grading, clay cover should be placed, the area seeded, and then protected with an erosion control blanket. Monitor for future erosion/sparse vegetation and repair as needed.

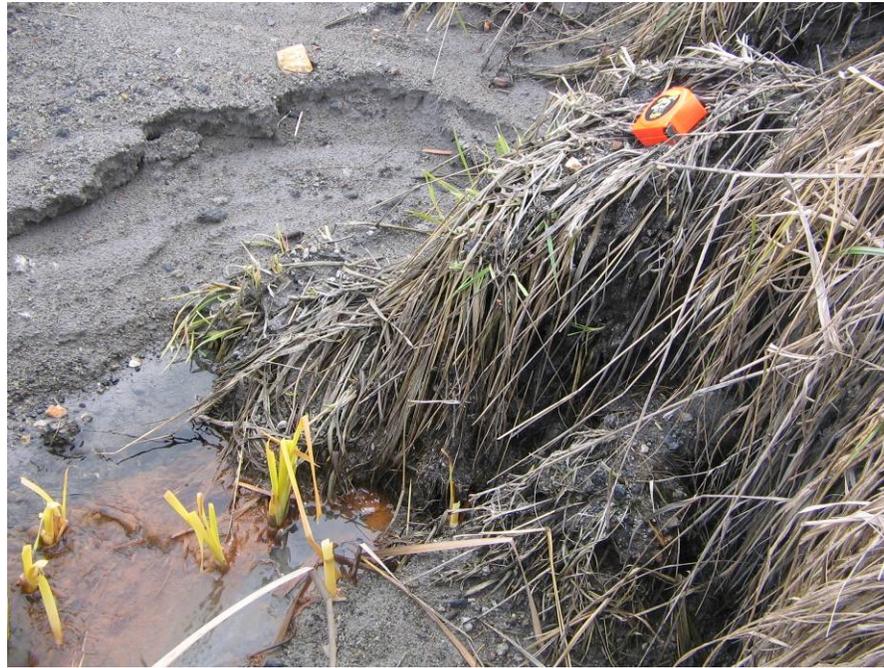
- Storm water flow through the perimeter ditch drainage pipe that lies beneath the haul road on the northwest side of the stack is impeded (inlet end is partly impeded by siltation and outlet end is buried and not visible). This has lead to poor drainage and ponded water within the portion of the perimeter drainage ditch upstream of the pipe crossing. Stantec also observed significant rill and gully erosion along the exterior perimeter dike slopes below this ditch interval. It is believed that during rain events, the perimeter ditch floods and water flows across the adjacent access road and down the slope, which has lead to the erosion.

Drawing Mark DS-5-10 Outlet of perimeter ditch drainage pipe beneath haul road, buried.

- It is recommended that siltation be cleaned from the perimeter ditch drainage pipe that crosses beneath the haul road at the northwest area to improve perimeter ditch drainage. Both inlet and outlet ends need cleaning. Extend inlet and outlet ends past haul road as needed. The grades along the entire length of the perimeter ditch should also be checked and the ditch re-graded as necessary for positive drainage. Sedimentation and long grass/cattail growth should also be removed. Last, it is recommended that the perimeter ditch be lined with rip-rap to help reduce future erosion.

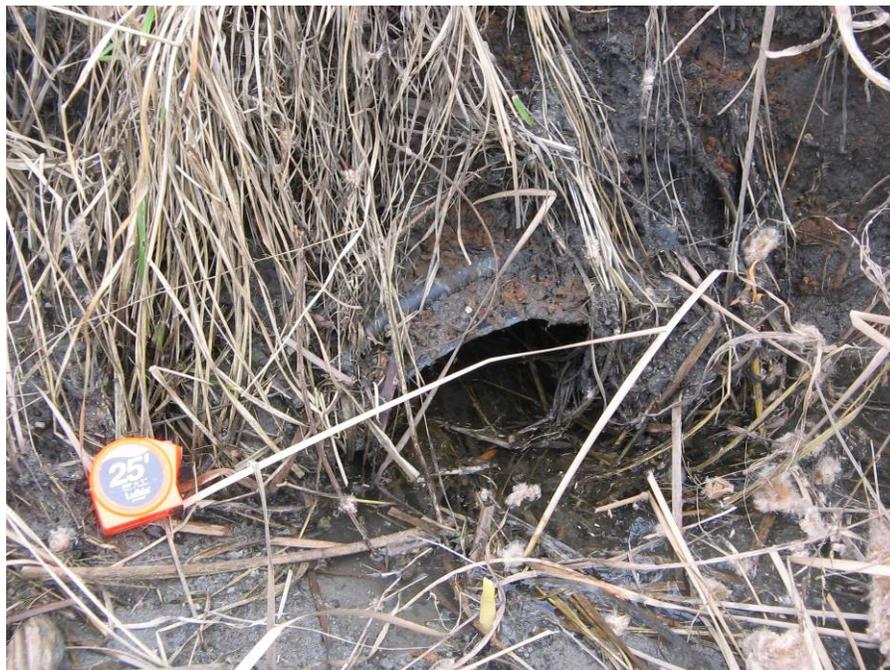
Drawing Mark DS-5-11 Perimeter ditch drainage pipe inlet where ditch crosses haul road, partly silted closed.

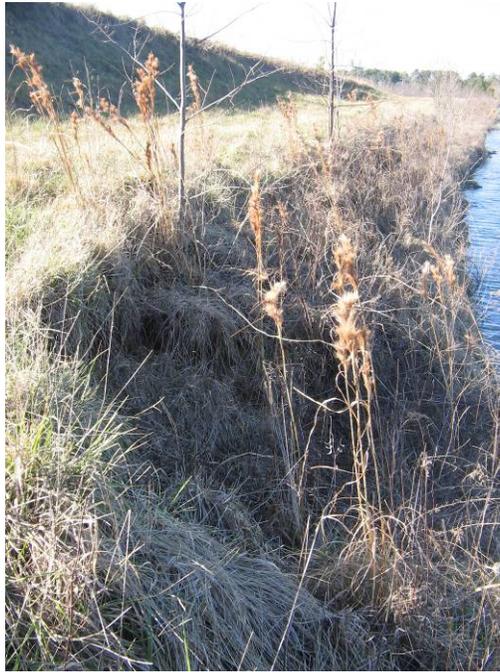
- A small sloughed area was noted along the interior slope of the southwest dike.
- The wood inlet structure located along the southeast side (where drainage from Disposal Area 5 enters pond) is leaning toward the pond.

Drawing Mark P-1-1 Small inner slope slough.

- Remove trees from exterior sides of northeast and northwest dikes.
- Cut and maintain heavy/tall cattail and grass growth on interior slopes of pond to allow better observations.
- Repair erosion and sloughed areas where noted on interior slopes of pond. Line interior pond slopes with rip-rap to help reduce future erosion.
- The spillway risers at Disposal Area 5 Drainage Basin may ultimately be modified or replaced, pending Stantec-TVA assessment of replacement system. Monitor the spillway systems until that time.
- Repair animal burrows where noted.
- Continue mowing program for grass-covered dikes. Establish new mowing program on northeast and northwest dikes following tree removal.
- Continue annual inspection program and execute recommendations.
- Perform soundings and monitor for storage capacity, and perform dredging as needed to maintain storage capacity.

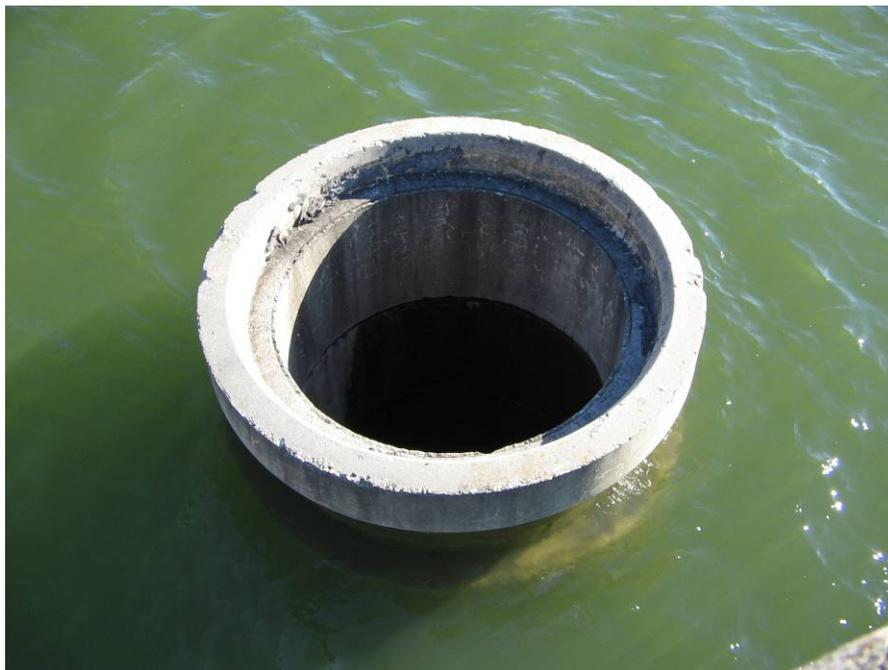
Drawing Mark P-1-3 Stacked RCP riser outlets.

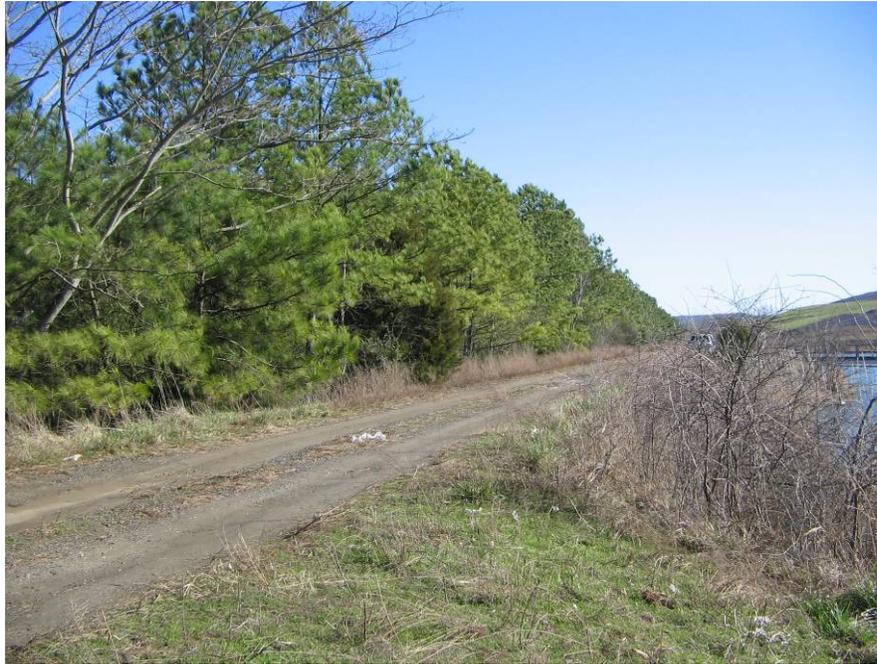
- The absence of an Emergency Action Plan, Operation and Maintenance Plan, as-built drawings and construction testing records is a concern.
- Trees located throughout the northeast and northwest exterior dike slopes are a concern. Recommendations for tree removal have been provided in past annual reports, but have not yet been performed.

Drawing Mark P-1-5 Tree growth on NE dike (to the left in photo).

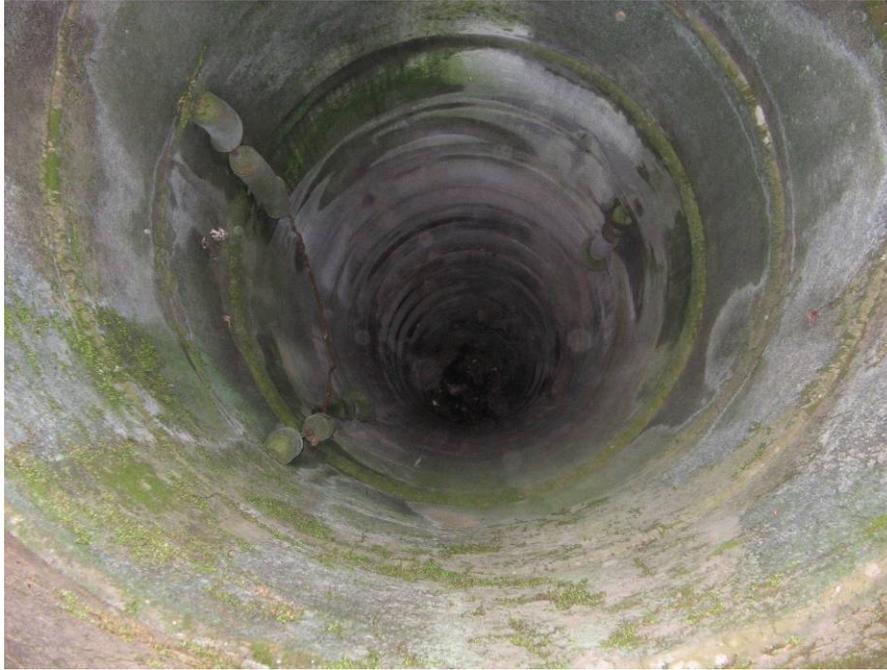
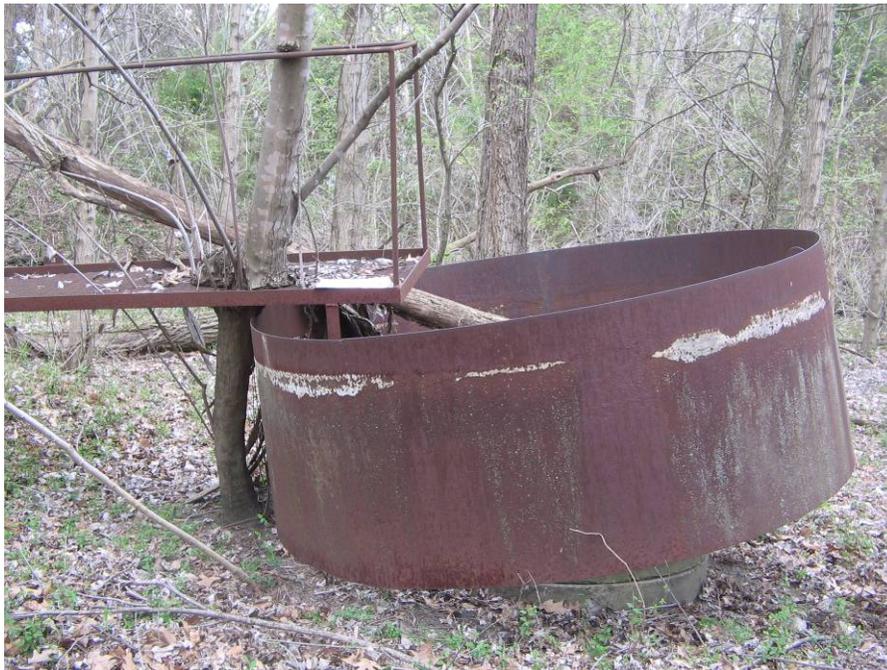
- The northwest weir inlet structure was found. It was open and no apparent abandonment/closure effort was observed. The southeast weir inlet was not found.
- Both RCP pipe outlet ends were found to be open with no apparent abandonment/closure effort observed.

Drawing Mark CDA-1-1 Northwest weir RCP inlet (looking down inlet).

Drawing Mark CDA-1-1 Northwest weir RCP inlet.

- It is recommended that the two old outlet structures be properly abandoned and closed by filling with grout or concrete to the extent practical. Filling should progress from both the inlet and outlet ends. Efforts to locate the possible buried southeast weir inlet should be made by excavating with a backhoe.
- Continue annual dike and facility inspections.
- Downed trees along the old dike crest should be removed and brush mowed/maintained to provide access for annual inspections.

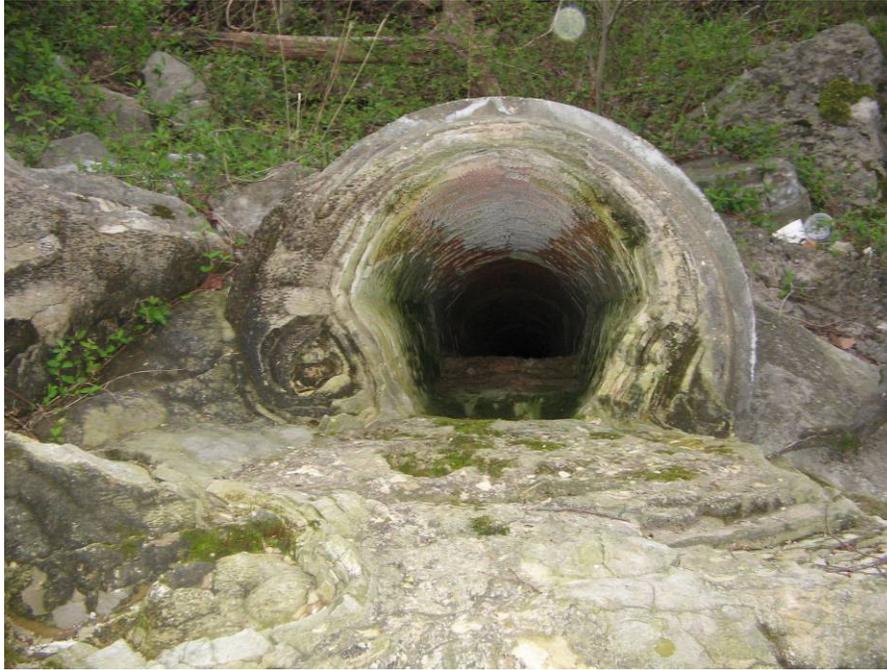
Drawing Mark CDA-1-2 Northwest outlet pipe.

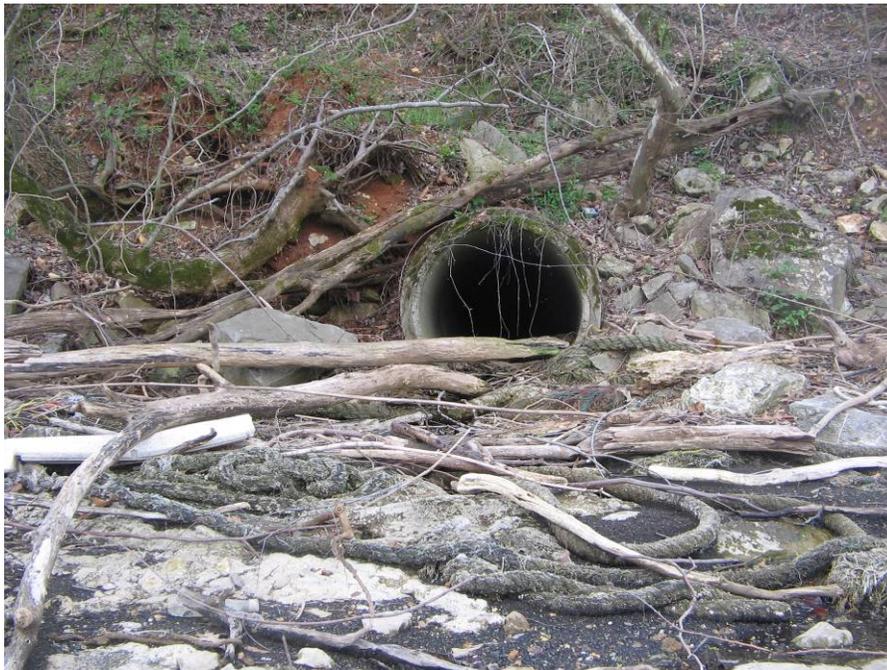
Drawing Mark CDA-1-5 Southeast outlet pipe.
