## TVA Disposal Facility Assessment Phase 1b Plant Summary Widows Creek Fossil Plant (WCF)

**TVA Disposal Facility Assessment  
Phase 1b Byproduct Disposal Facility Summary  
Widows Creek Fossil Plant Fossil Plant (WCF)  
Abandoned Ash Disposal Area (AADA)**

**TVA Disposal Facility Assessment  
Phase 1 Coal Combustion Product Disposal Facility Summary  
Widows Creek Fossil Plant (WCF)  
Gypsum Stack Stilling Pond  
Photos, Concerns/Photo Log**

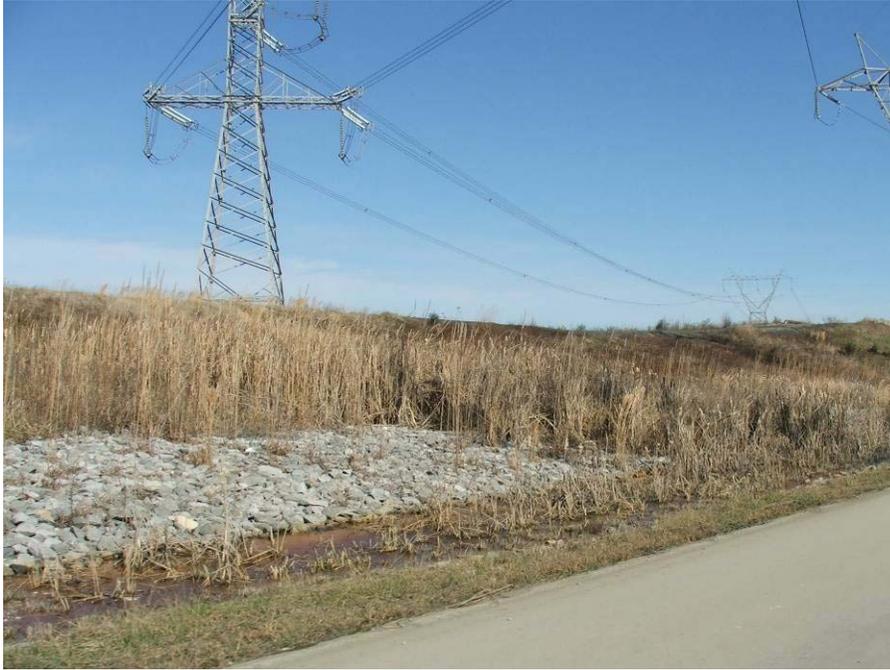
Vegetation:	Sparse vegetation observed.
Trees:	None observed.
Erosion:	Numerous areas of significant erosion particularly on the south side intermediate dike.
Instabilities:	Sloughing of the south side perimeter dike was observed. This instability has been reported in previous inspection reports dating back to 1985.
Uniform Appearance:	Observed to be uniform except for southern dike.
Seepage:	Observed on the south side perimeter dike adjacent to the Scrubber Road.
Benches:	Intermediate bench observed.
Foundations, Drains, Relief Wells, Instrumentation:	None observed.
Animal Burrows:	Few observed.
Slope:	<b>Measured:</b> 2H:1V <b>Design:</b> 2H:1V
Height:	<b>Measured:</b> 50 feet <b>Design:</b> 116 feet

Drawing Mark BAS-1-4 Bottom Ash Stack exterior slope. Slip area on south side of the stack.

- Repair erosion and rutting on exterior slopes.
- Monitor seepage through the embankment slopes.

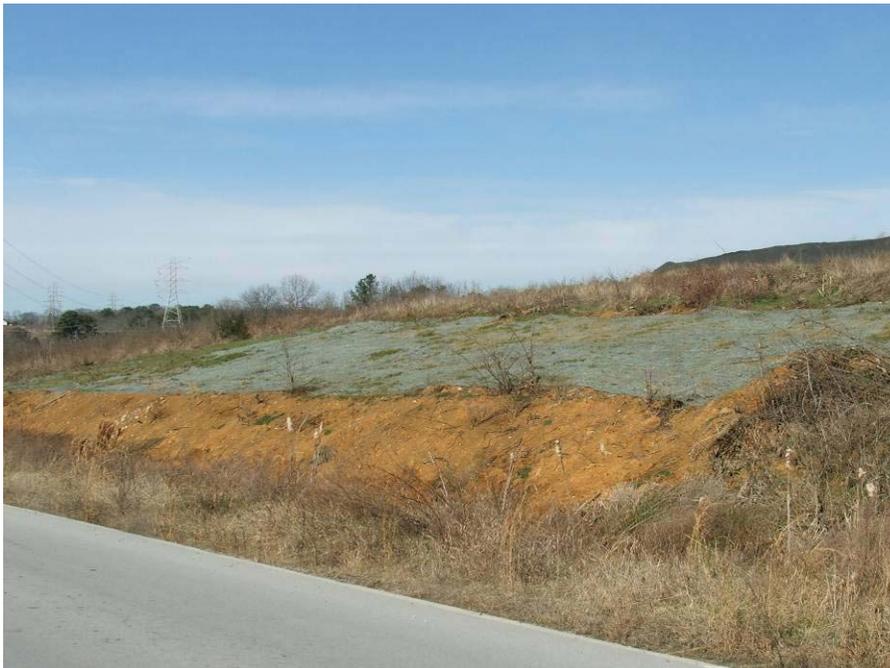
Drawing Mark BAS-1-4 Bottom Ash Stack exterior slope. Repaired slip area on south side of the stack.

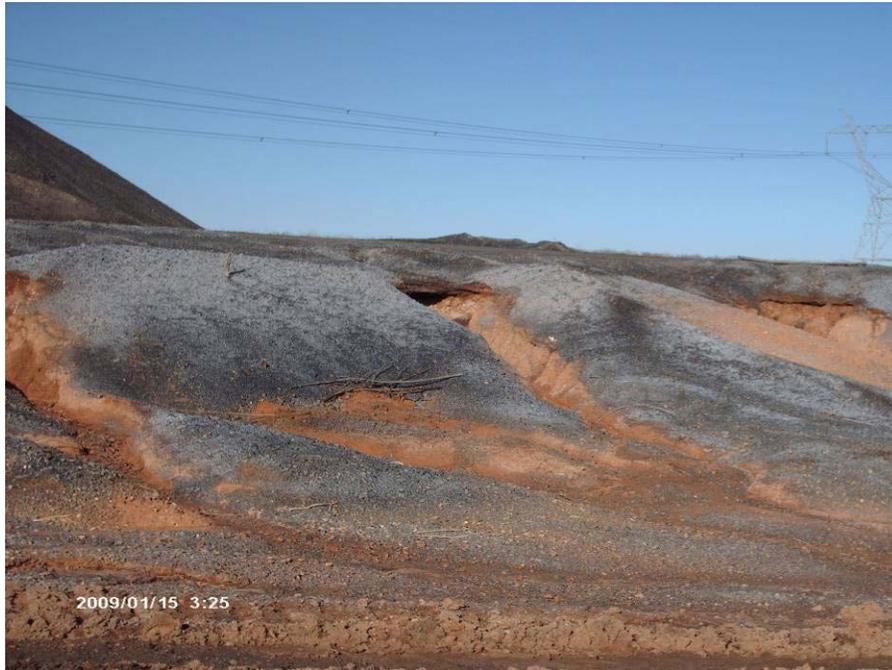
BAS-1

Typical erosion of the exterior slope without adequate clay cover. Photo taken on south side of the stack.

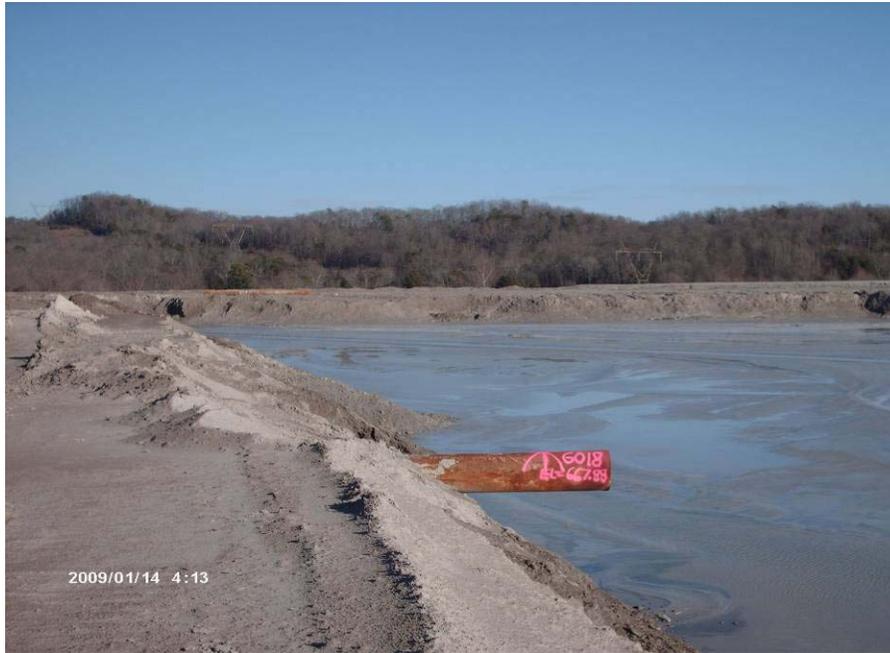
Drawing Mark GS-1-1 Weir structure located on intermediate dike of Pond 3 and Pond 2B.

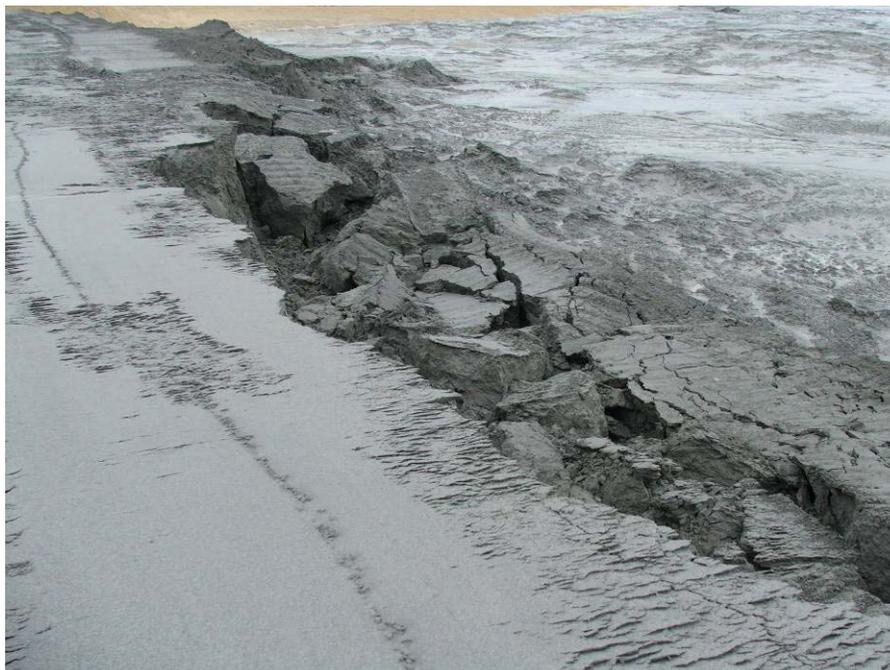
Vegetation:	Vegetation was not observed.
Trees:	Woody growth observed, approximately 15 feet tall.
Wave Wash Protection:	None observed.
Erosion:	None observed.
Instabilities:	Steep interior slopes with sloughing observed.
Animal Burrows:	None observed.
Freeboard:	<b>Measured:</b> 1.5 feet <b>Design:</b> 3.0 feet
Encroachments:	None observed.
Slope:	<b>Measured:</b> Approximately 1.5H:1V <b>Design:</b> 2H:1V

Drawing Mark GS-1-2 Interior slope on west dike of Pond 2B.

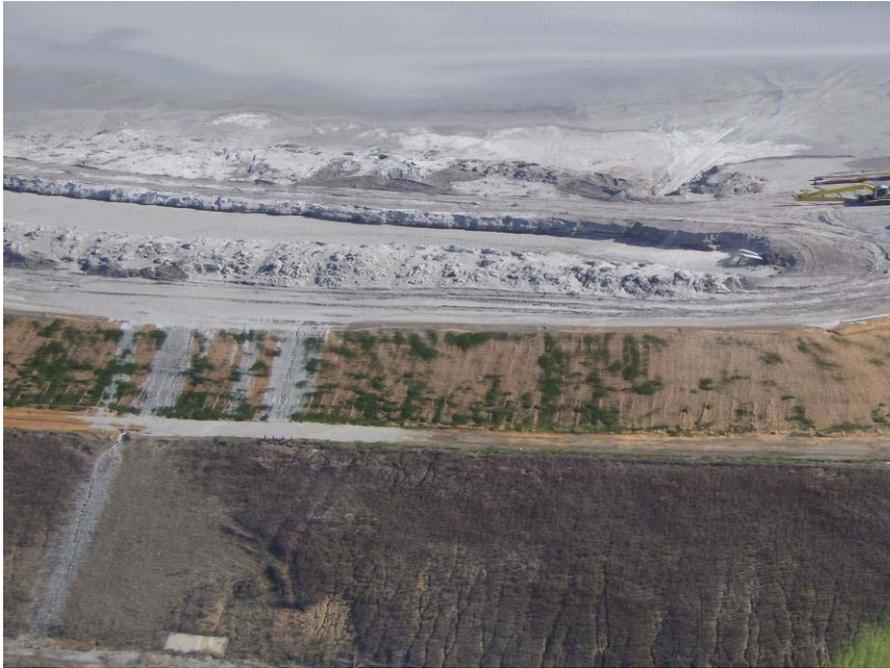
Crest Cover and Slope:	None observed on the three crests.
Erosion:	Surface erosion observed where the rim ditching operation was allowed to overtop.
Alignment:	Observed to be in marginal condition. Evidence of crest center lines not following the construction plans is apparent.
Settlement/Cracking:	None observed.

Drawing Mark GS-1-3 Overtopping of Pond 3 rim ditch.

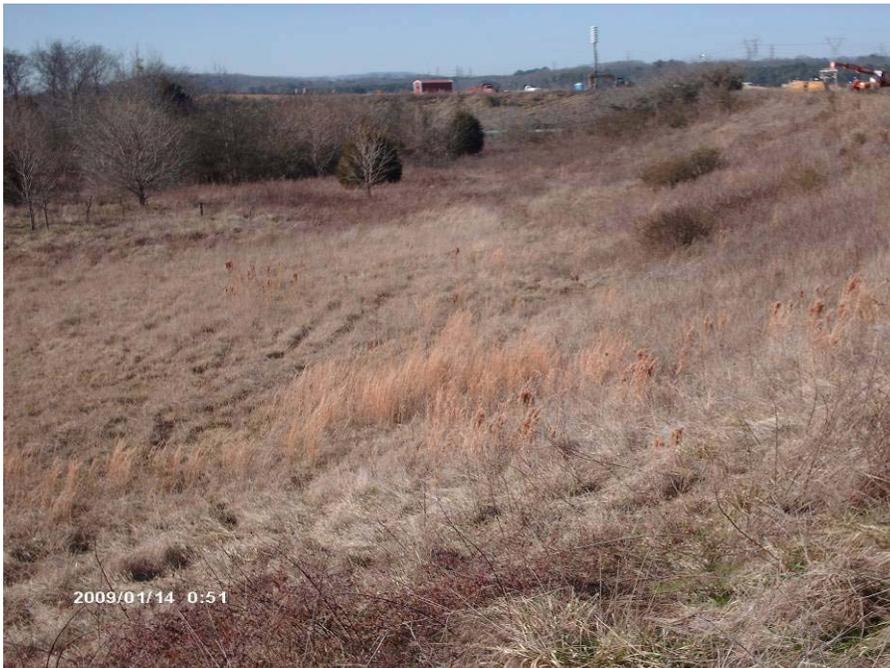
GS-1 Woody growth on southern exterior dike (Typ.).

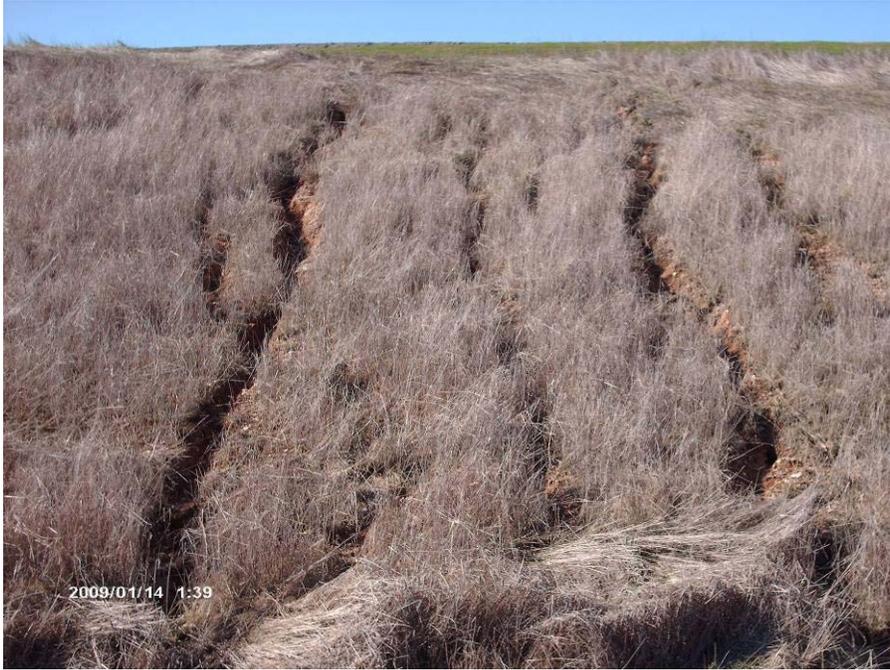
Drawing Mark GS-2

Erosion: Surface runoff erosion is present on all slopes around the perimeter. 8" - 12" deep and 6" - 8" wide. Erosion 1' - 6" deep 1'-4" wide x 25' long observed on the northeast groin. Reference is made to Work Plan 3 - field adjustments to Surface Drainage Plan.

Runoff erosion on east exterior embankment of Gypsum Stack (Typ.).

- Repair erosion and rutting on exterior slopes.
- Cut tall brush and cattails at seepage areas to permit better inspections and observations.
- Monitor seepage areas on west dike for change until engineering evaluation can be completed and remedial actions developed.

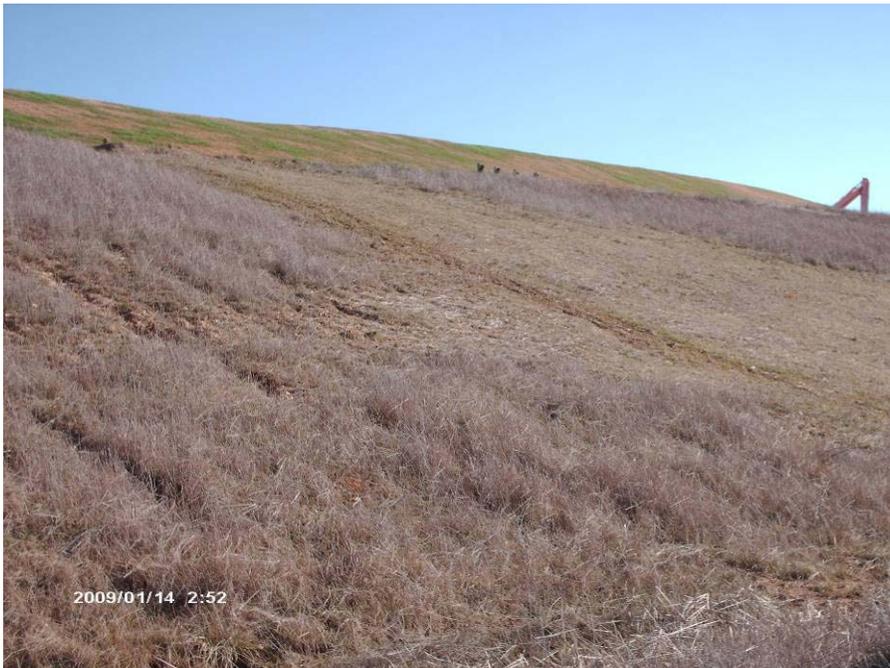
Drawing Mark GS-3

Instabilities: Abandoned decant weir failure observed on 01/09/2009. Evidence of three landslides were observed along the west side of the stack. Slope inclinometer was installed in January, 2009. Monitoring of these slopes is ongoing.

Repaired slide area on west exterior embankment (Typ.).

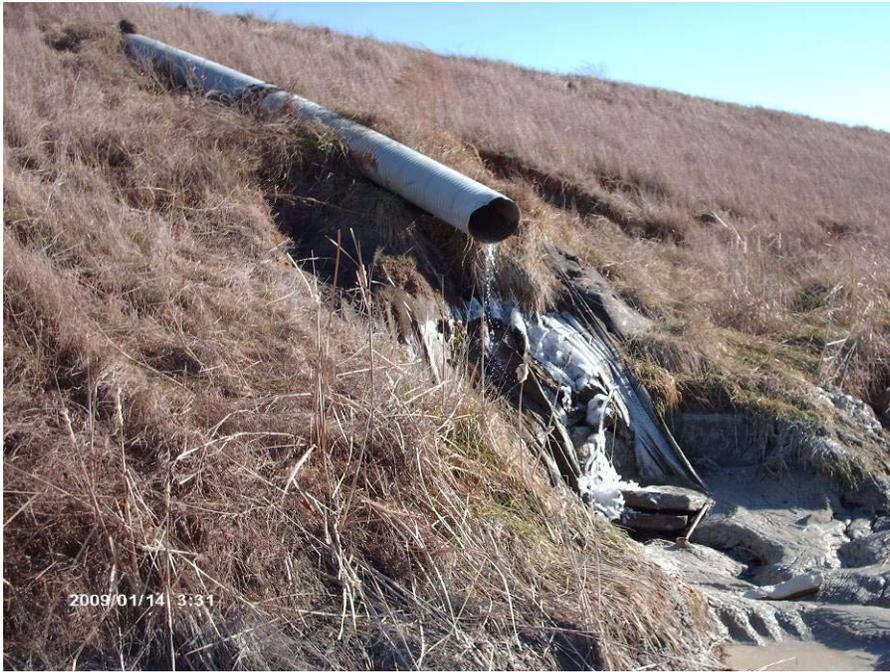
Drawing Mark GS-4      Pond 2B spillway outlet eroding embankment at discharge point.

- It is recommended the practice of terminating active spillway conduits above the toe of dikes or embankments be stopped immediately. In at least two cases, conduits outlets on the mid slope of dikes have caused surface erosion, rutting and sloughing. The new conduits should be designed and constructed in accordance with dam safety regulations with the proper material, pressure rating, anti-seep measures, and outlet energy dissipating provisions to operate as a spillway conduit. The conduit outlet should be supported by a designed concrete thrust block foundation with the last section of conduit turned up at the end to 30 to 45 degrees from horizontal depending on conduit slope, size and operating capacity. The outlet should extend into the stilling pond or ditch with erosion protection in the area of the splash pool using a serviceable concrete apron.

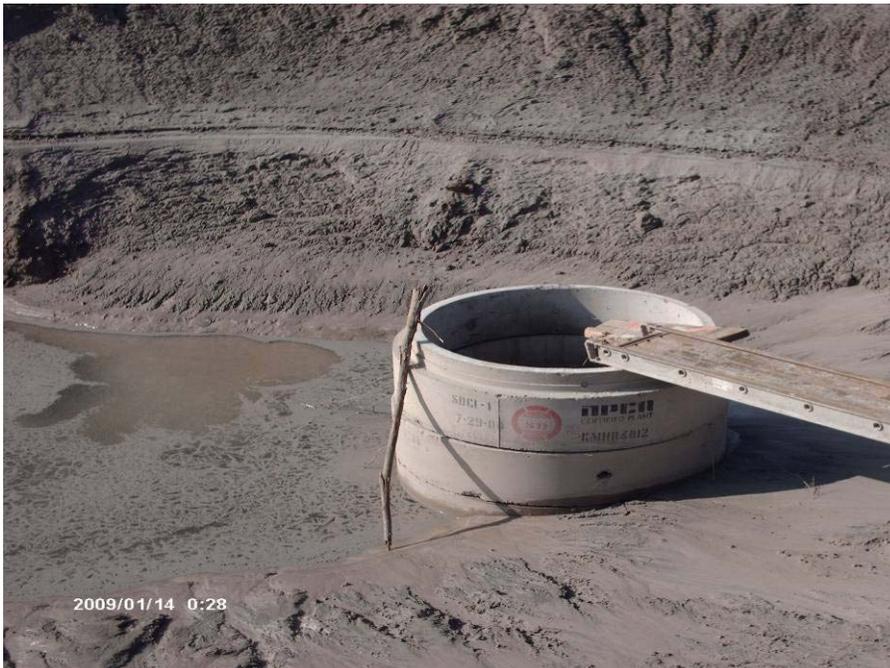
Drawing Mark GS-5      Spillway weir in Pond 2B.

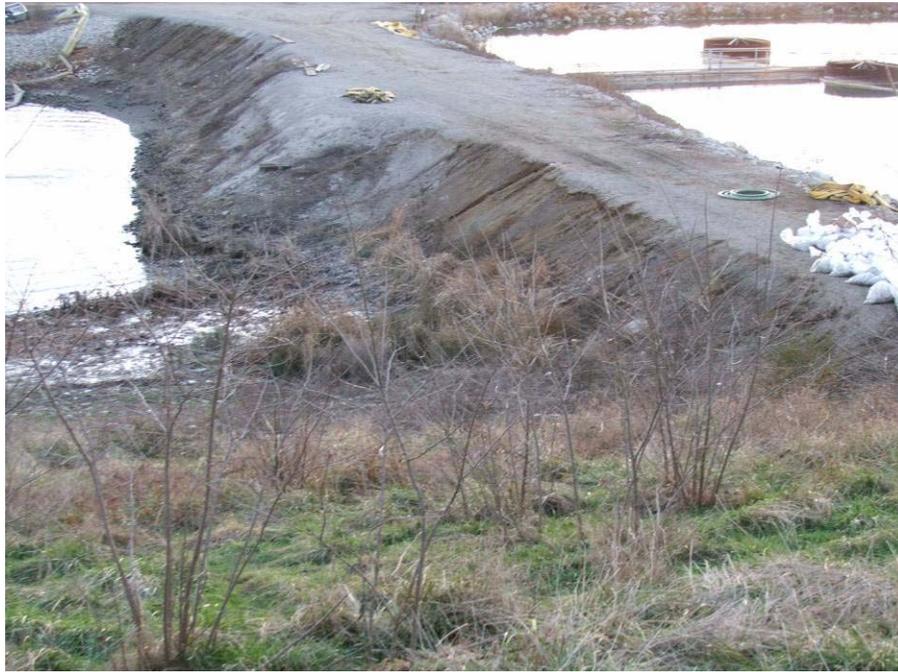
Drawing Mark LSP-1-6 Erosion on eastern exterior slope.

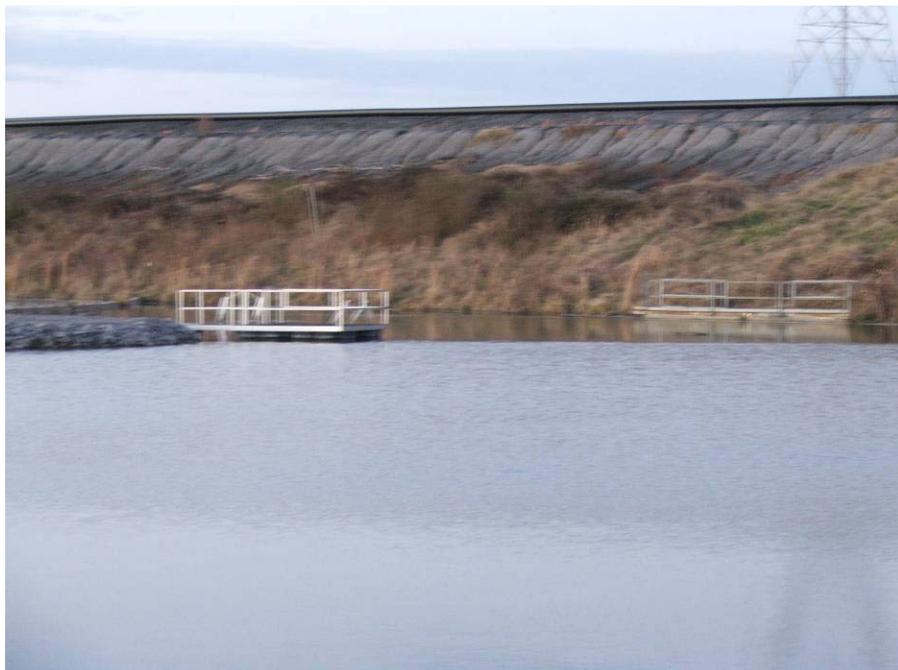
Drawing Mark LSP-1 Runoff erosion on northwest interior slope.

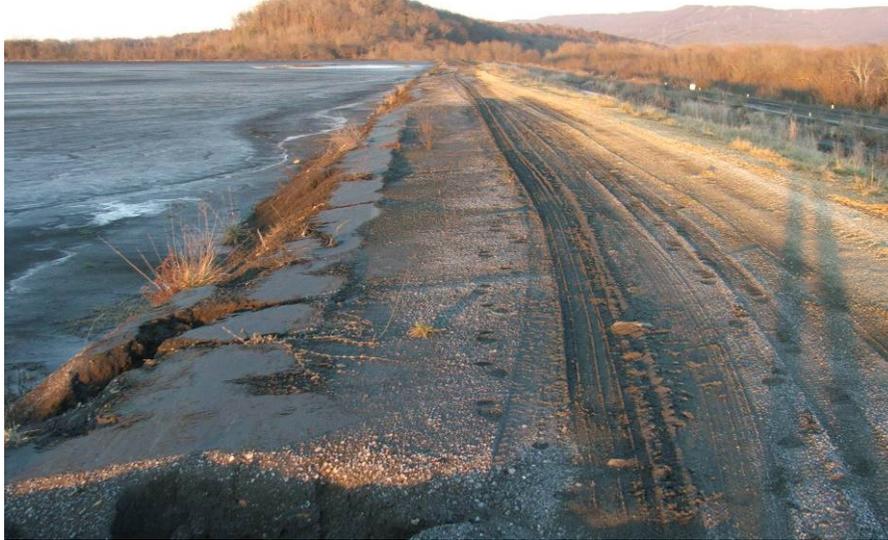
Drawing Mark DC-1 Freeboard of Dredge Cell.

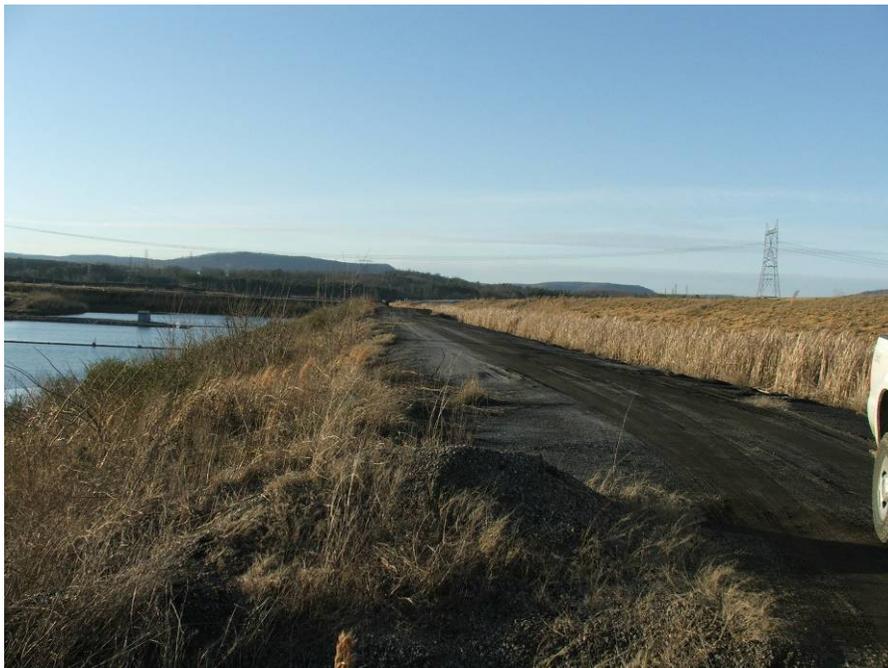
Drawing Mark DC-1 South dike vegetation on exterior slope, north of the Stilling Pond.

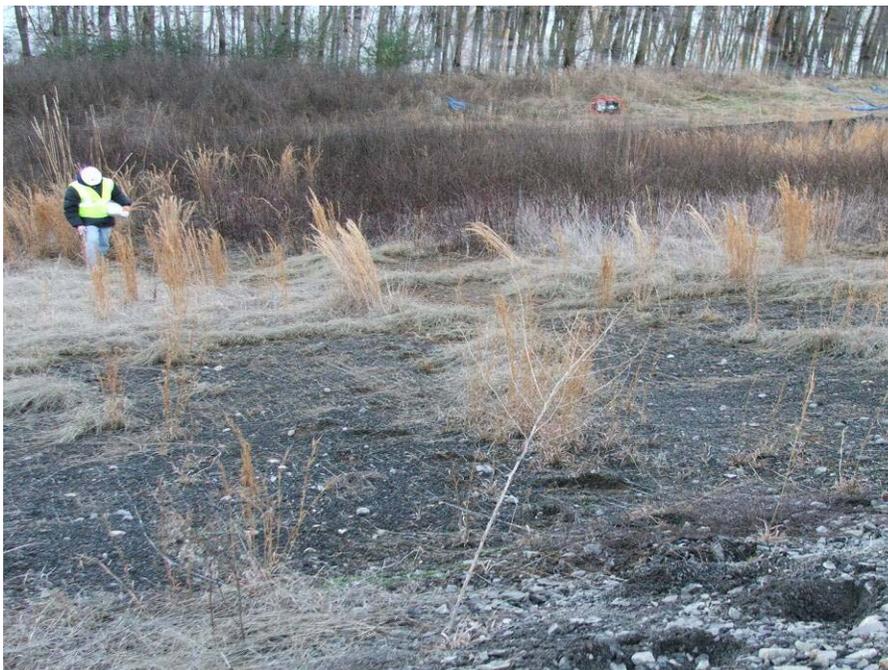
Drawing Mark DC-1-5 North east perimeter of the Dredge Cell, soft saturated area.

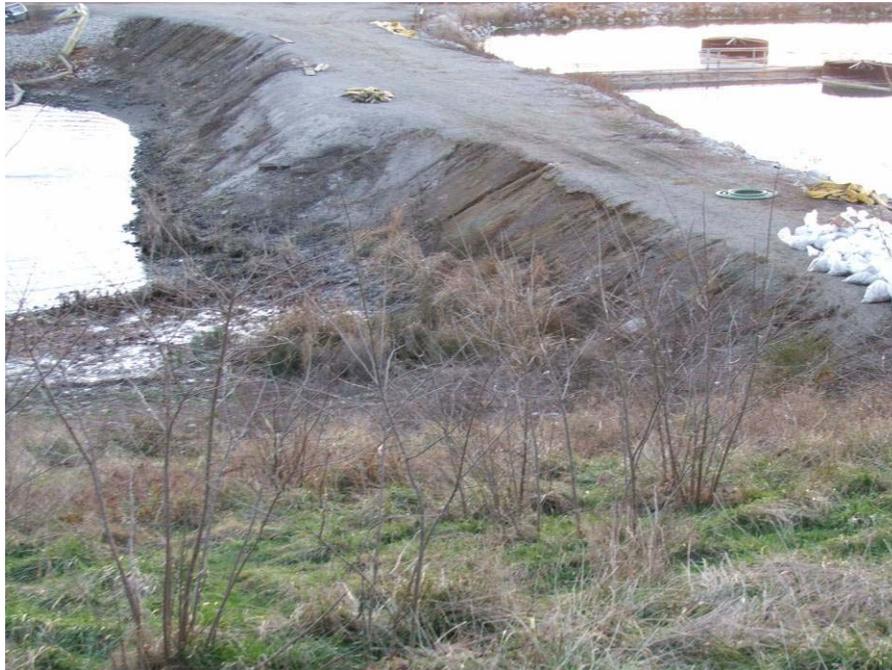
Drawing Mark PP-1 Erosion on western interior slope.

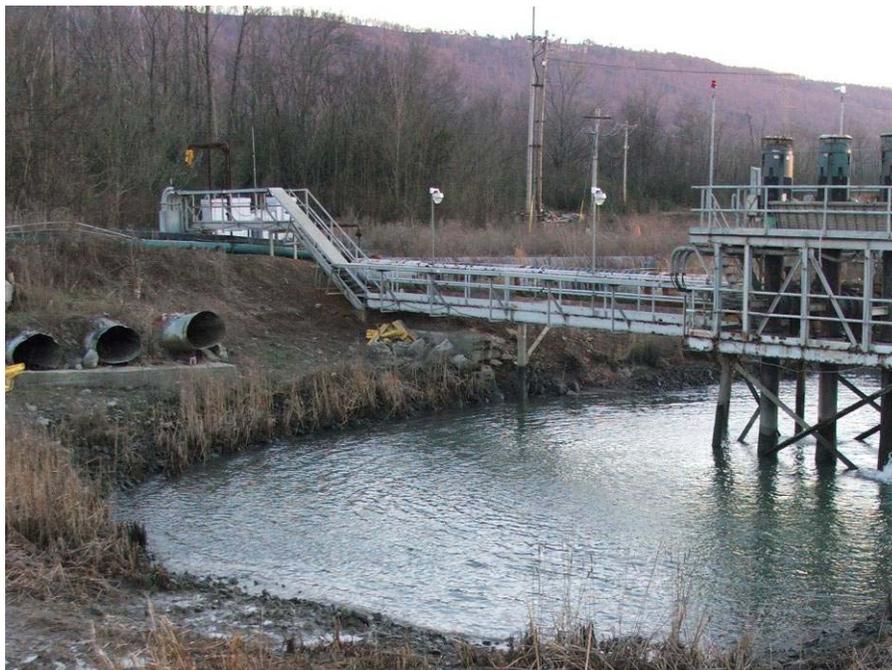
Drawing Mark PP-2 Pump Pond Pump Stations and the deformation of the overflow pipes on the eastern dike.
