## TVA Disposal Facility Assessment Phase 1 Plant Summary Shawnee Fossil Plant (SHF)

**TVA Disposal Facility Assessment**  
**Phase 1 Coal Combustion Product Disposal**  
**Facility Summary**  
**Shawnee Fossil Plant (SHF)**  
**Active Ash Pond No. 2 (AP2)**

**TVA Disposal Facility Assessment  
Phase 1 Coal Combustion Product Disposal  
Facility Summary  
Shawnee Fossil Plant (SHF)  
Consolidated Waste Dry Stack (DS)**

**TVA Disposal Facility Assessment  
Phase 1 Coal Combustion Product Disposal  
Facility Summary  
Shawnee Fossil Plant (SHF)  
Inactive Dredge Cell (CDA)**

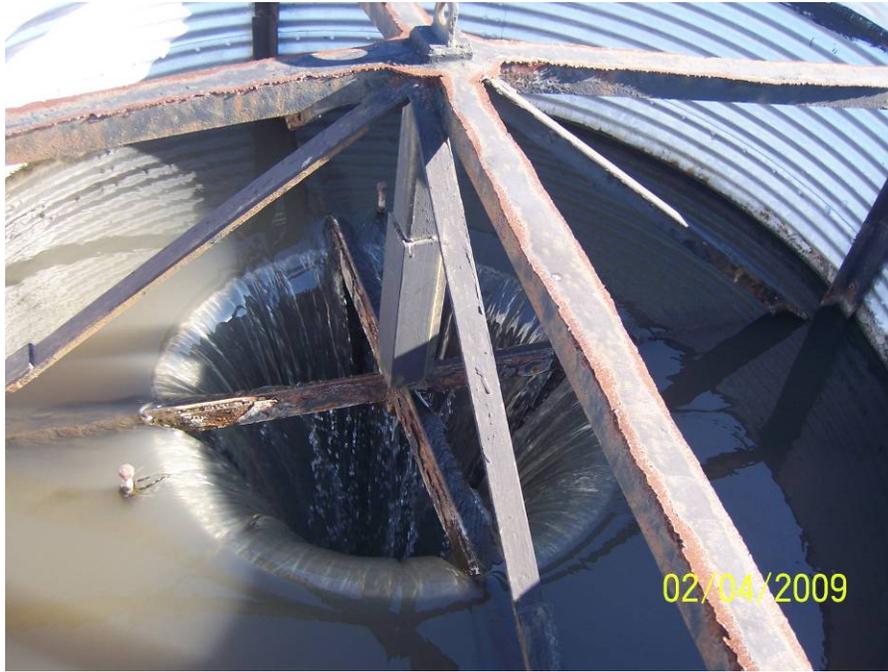
- Two of the five tall RCP push-together riser structure spillways have failed in the past. In addition, some separation in the discharge pipes has been previously reported. In the spillway evaluation performed in 2007, some minor tilting was also measured along the tops of the riser structures.

Drawing Mark AP-2-1 Top of RCP stacked riser spillway (Typ.).

- The RCP riser spillways at Ash Pond 2 may ultimately be modified or replaced, pending Stantec-TVA assessment of replacement system. Continue routine repairs and monitoring of the spillway systems until that time.
- It is recommended that the perimeter dikes for Active Ash Pond 2 undergo further geotechnical engineering study to evaluate slope stability and seepage. In addition, a hydraulic and hydrologic analyses should be performed to evaluate pond conditions.

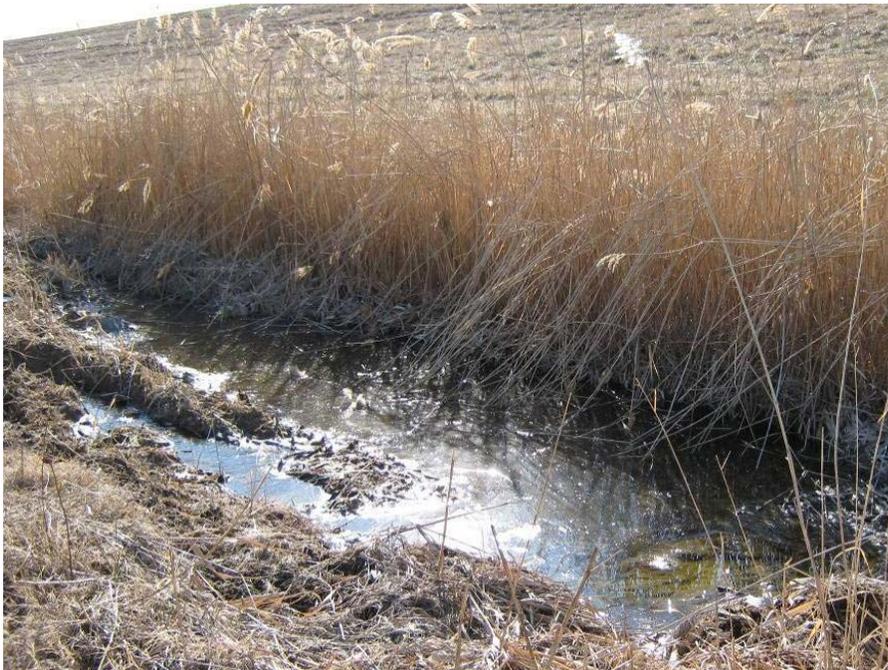
- Seepage along northeast dike along the toe of the slope is a concern. It has been reportedly ongoing for more than 20 years and has been monitored various times a year by TVA with little or no change being reported through the years.

Drawing Mark AP-2-2 Seepage along toe of northeast perimeter dike.

- The seepage observed along the toe of the perimeter dike at the northeast side of Ash Pond 2 should continue to be monitored. A seepage monitoring point consisting of a collection system and weir box or similar structure should be installed.

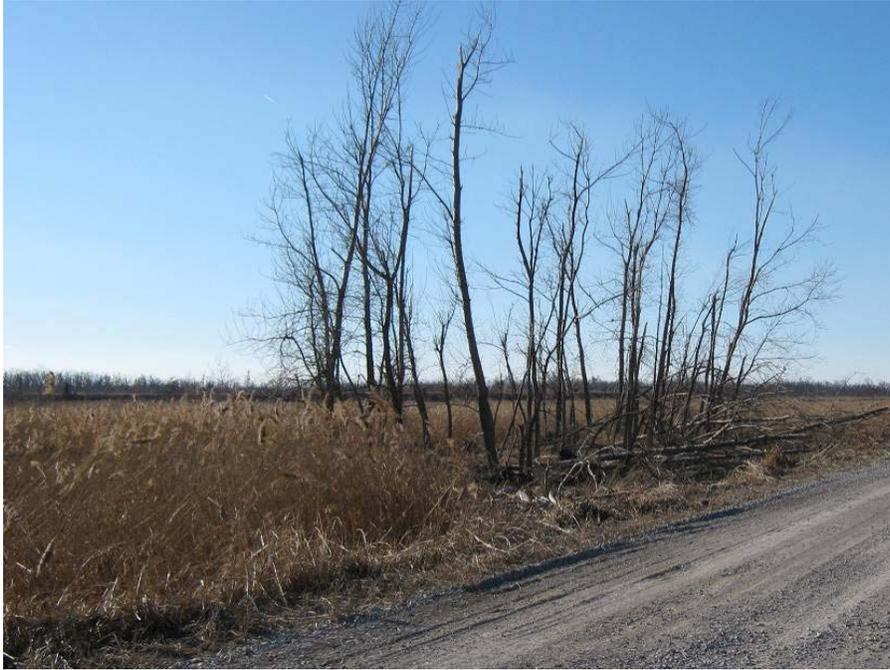
- Trees are located along the inner perimeter dike slopes and on the divider dike slopes in various portions of the pond.
- Animal paths were observed in several areas along the outer dike slope.

Drawing Mark AP-2-3 Trees along inner perimeter dike slope on north side.

- Remove trees from interior slopes and divider dikes of pond and repair slopes as needed following tree removal.
- Cut and maintain heavy phragmite and vegetation growth on interior slopes to permit better assessment.

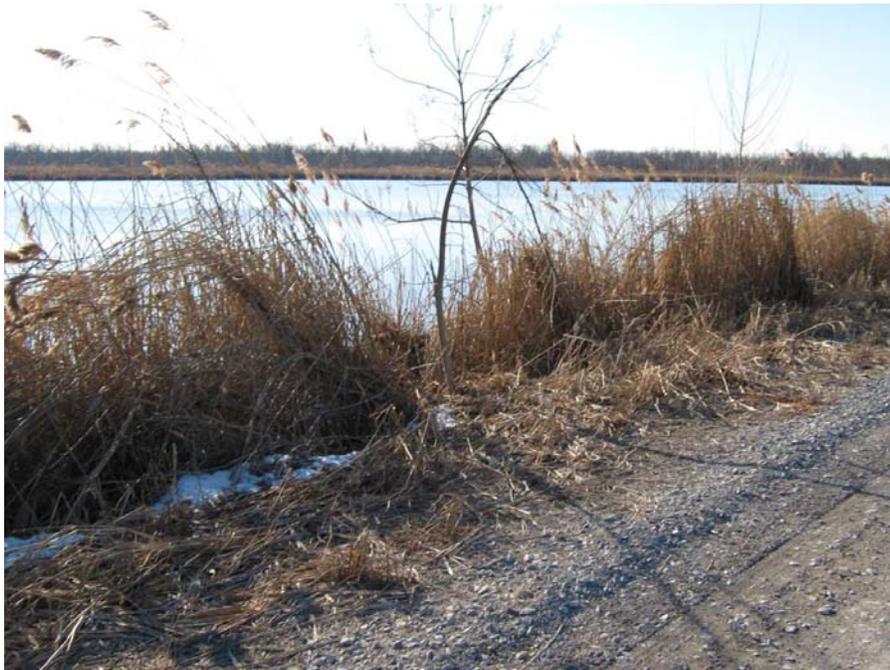
Drawing Mark AP-2-4 Smaller trees along various inner perimeter and divider dike slopes (Typ.).

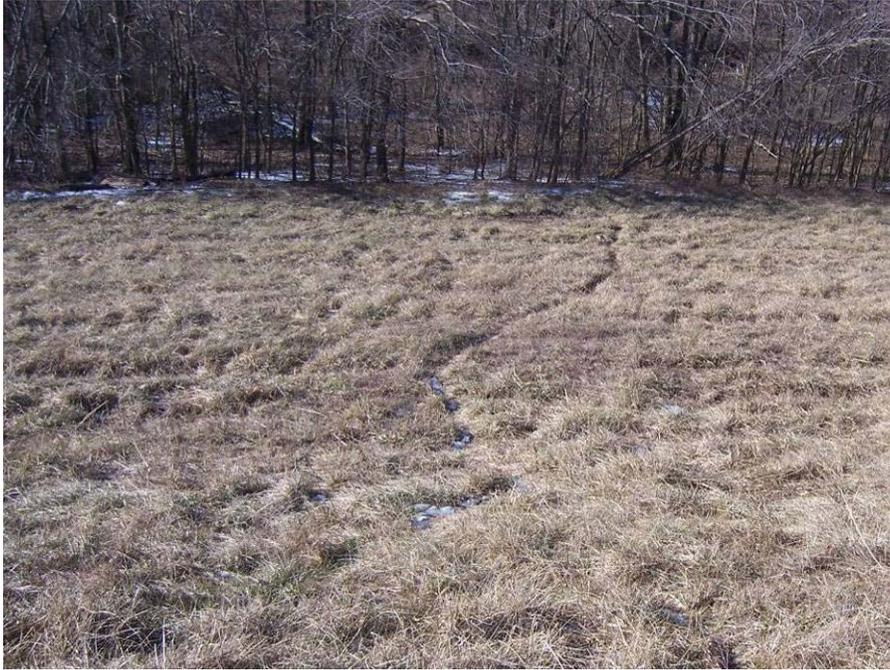
Drawing Mark AP-2-5 Animal paths at various locations along exterior perimeter dike slopes (Typ.).

- The animal paths present on the outer perimeter dike slopes of Ash Pond 2 should be monitored and repaired if erosion begins.
- Continue annual inspection program and execute recommendations.

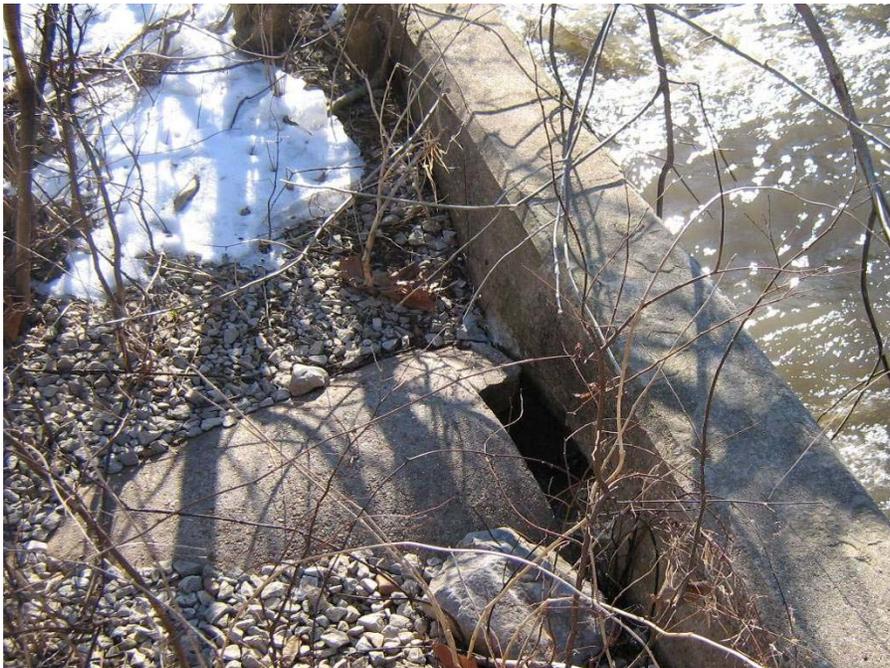
- Separation was observed at the spillway outlets between the headwall and the two northernmost discharge pipes.
- Previous inspection reports appear adequate, but there is a trend of not all maintenance recommendations being executed.

Drawing Mark AP-2-6 Separation of northernmost discharge pipe from headwall.

- Cut tall phragmite and vegetation from seepage area to permit better assessment and observation.
- The separation observed between the headwall and the two northernmost discharge pipes should be monitored. If the separation becomes greater and begins to cause erosion at the headwall and pipe interface, repairs should be made.

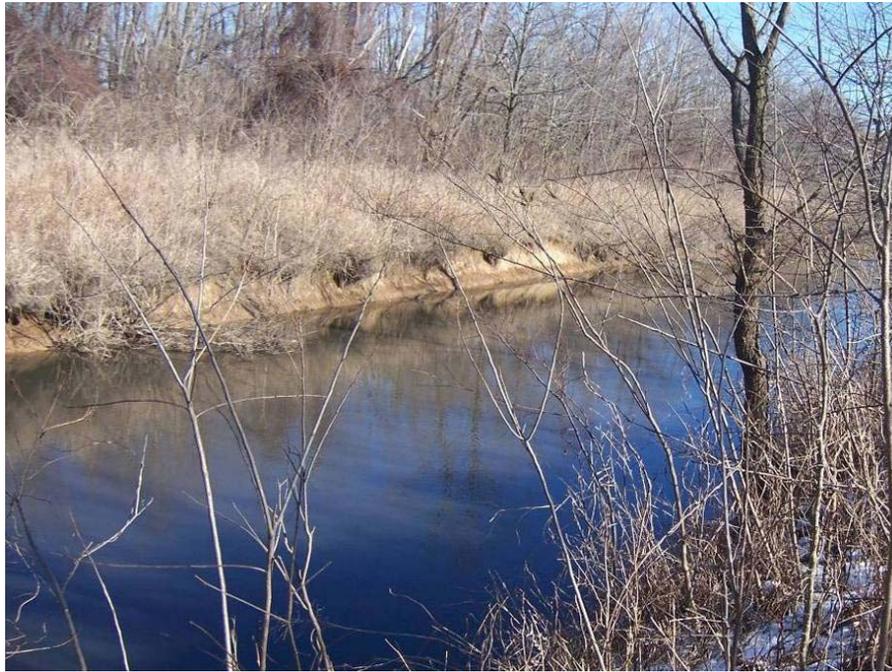
Drawing Mark AP-2-7 Discharge Channel (Typ.).

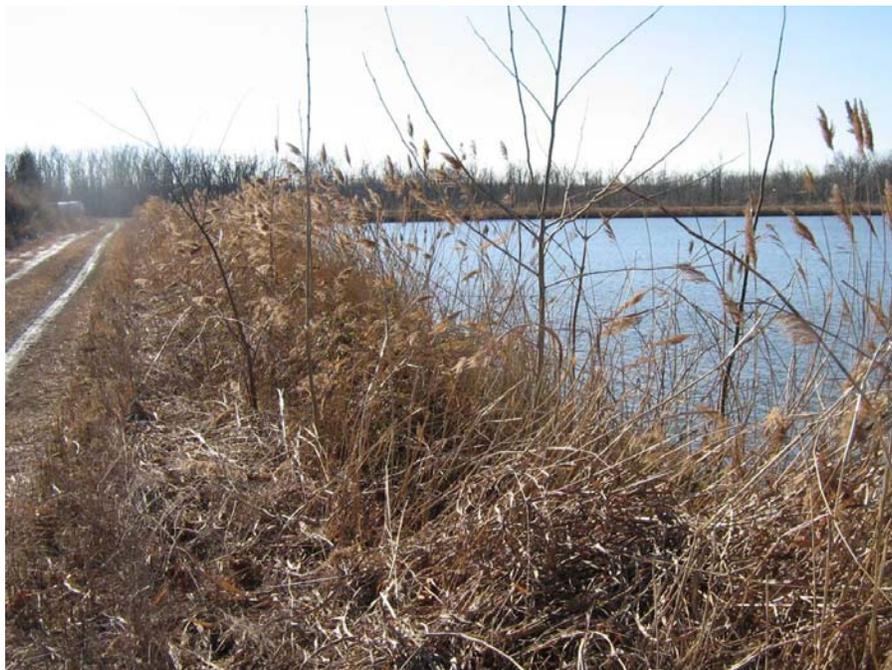
- Raising the dikes by using upstream construction over sluiced ash is a potential slope stability concern.
- Tall brush and phragmites are present on interior slopes and at exterior slope seepage areas where ground is soft.

Drawing Mark AP-2-8 Heavy phragmite and vegetation on interior perimeter slope (Typ.).

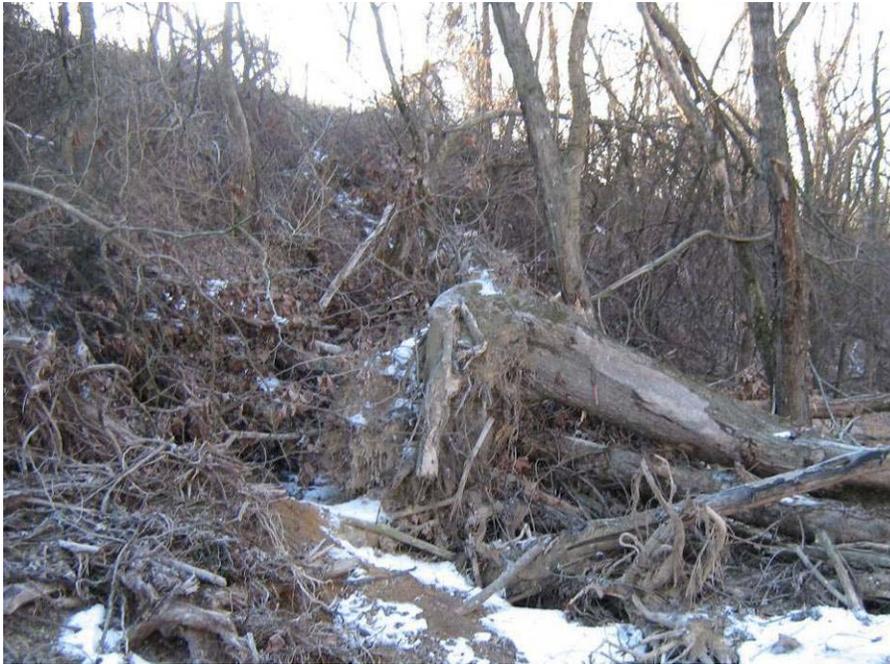
- The old ash pond was located in the area currently being used for the Consolidated Waste Stack. The stack was built over the old ash pond and is set back approximately 50 feet or more from the old pond perimeter dike to the west. The slopes along the old perimeter dike are as steep as about 1.5H:1V in parts and are heavily overgrown. Some shallow sloughing and fallen trees are present throughout.

Drawing Mark DS-1-1 Fallen trees, scarps and steep slopes along old perimeter dike southwest of stack (Typ.).

- It is recommended that the perimeter dike and exterior slopes for the original portions of the Consolidated Waste Dry Stack undergo further engineering study to evaluate slope stability. (not included in the FMSM 2006 work)
- It is recommended that an Operations and Maintenance Plan be developed for the facility.
- It is recommended that a program be established to develop as-built drawings and construction records for future maintenance and construction activities.

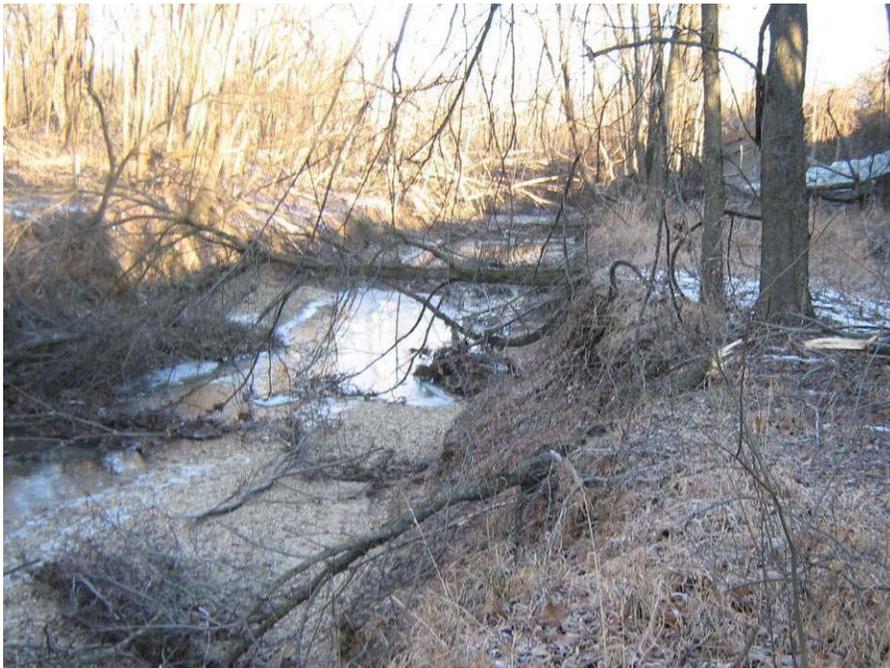
Drawing Mark DS-1-2 Toe of old perimeter dike slope along Little Bayou Creek (Typ.).

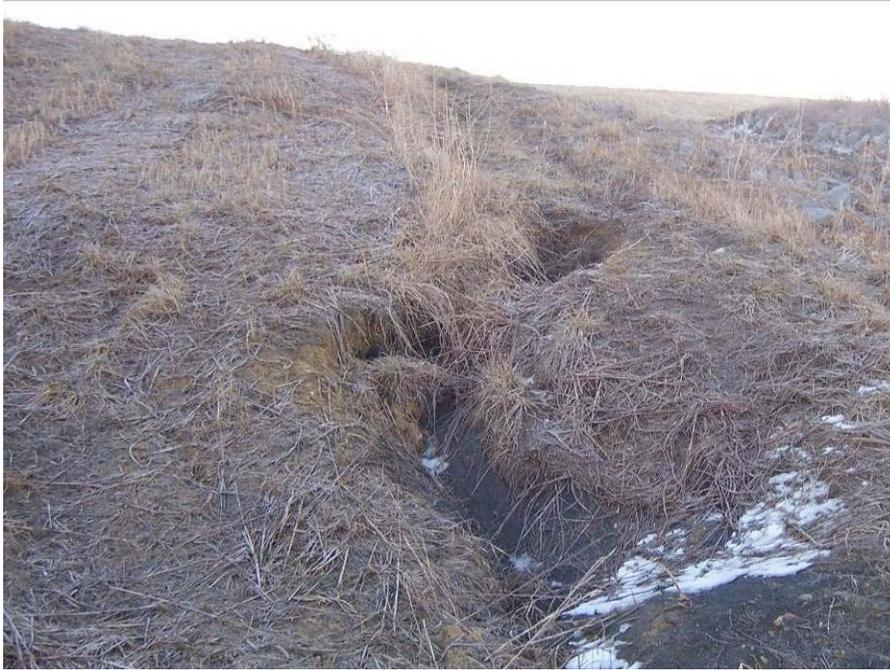
**Drawing Mark DS-1-3** Typical erosion rill along exterior slope of stack (Typ.).

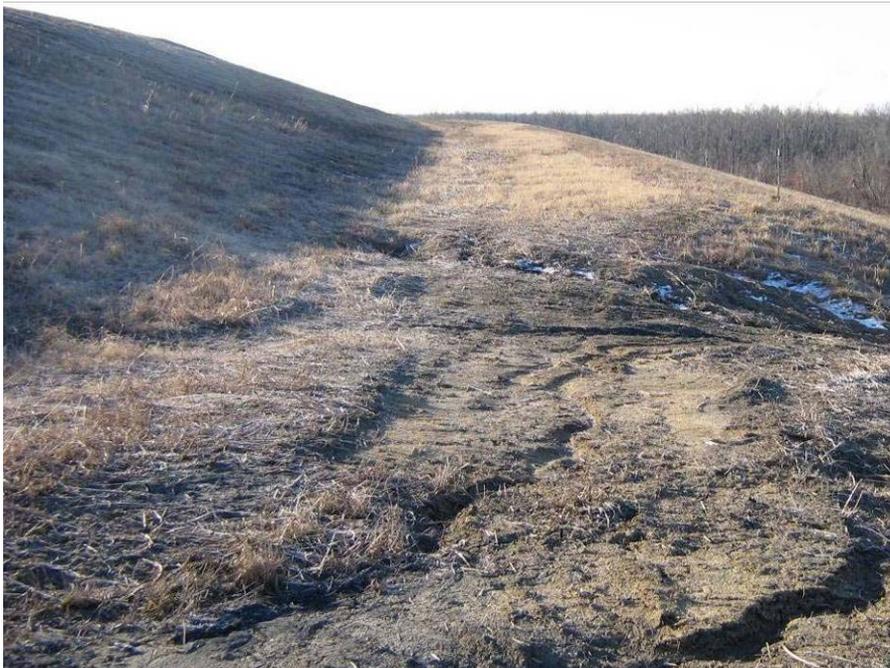
**Drawing Mark DS-1-4** Sedimentation and erosion along bench at top of down-drain (Typ.).

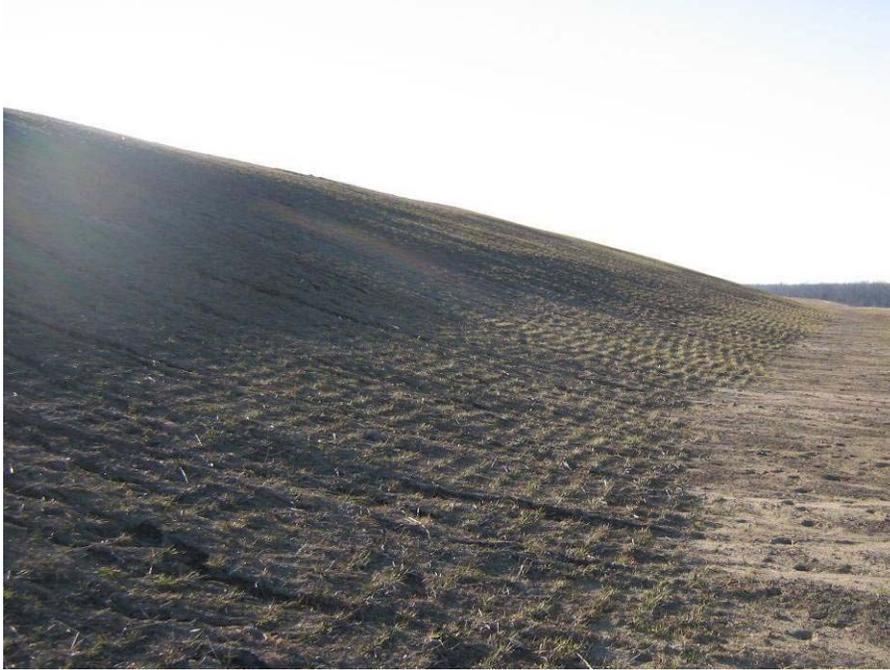
Drawing Mark DS-1-5 Lack of vegetation in previously repaired area with some minor erosion (Typ.).

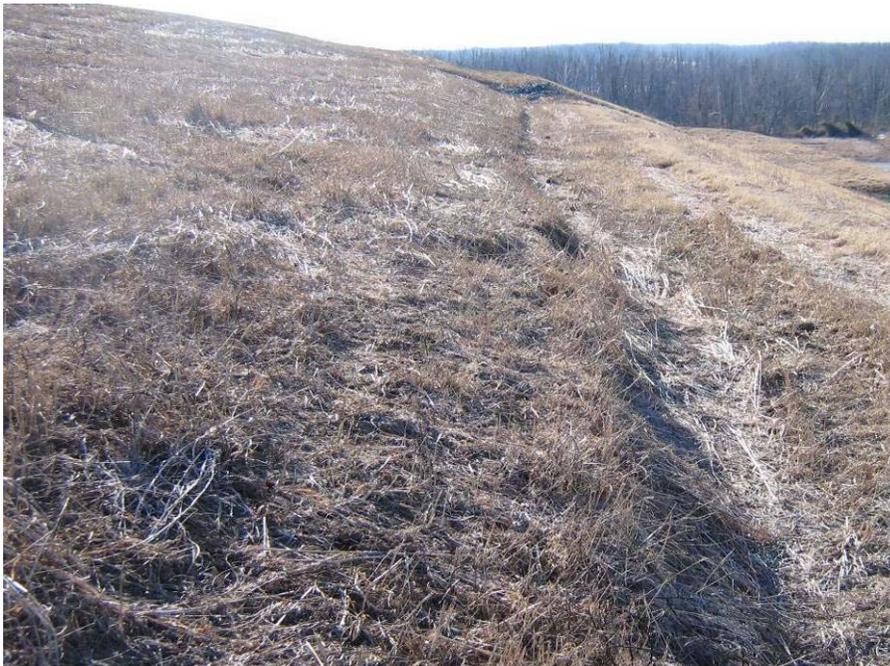
Drawing Mark DS-1-6 Scarps due to erosion along toe of slope and bench (Typ.).

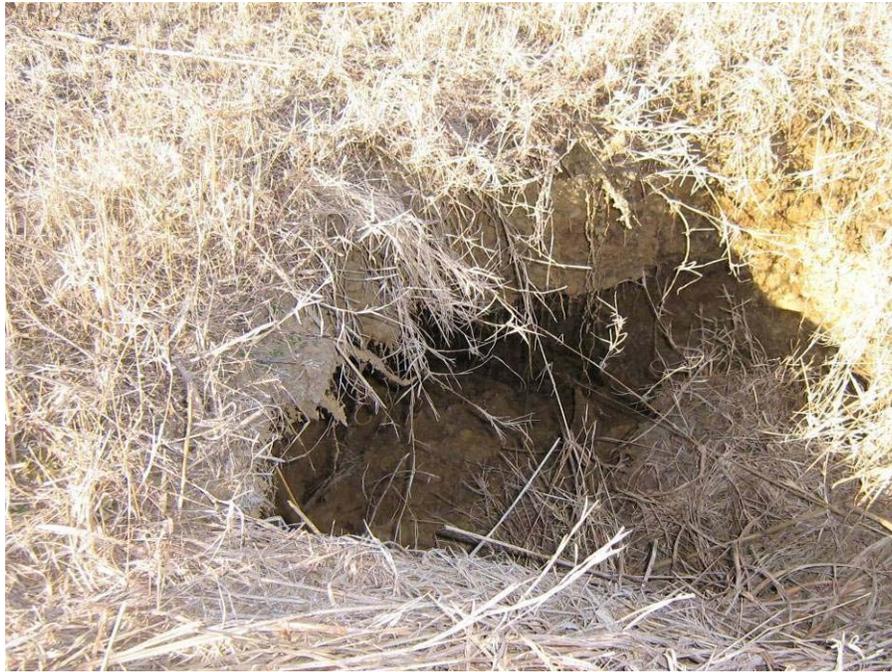
Drawing Mark DS-1-7 Deep washout along second bench (Typ.).

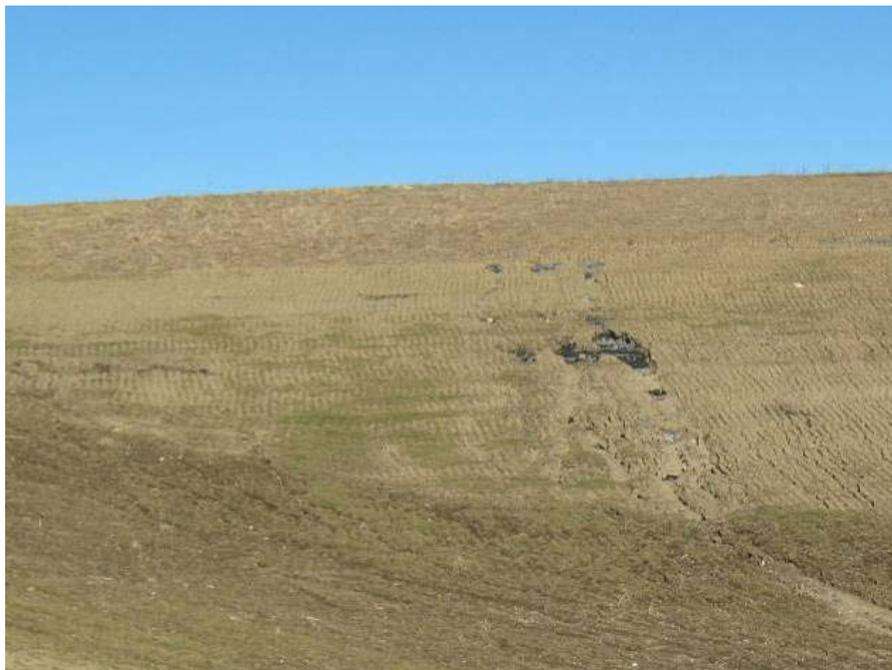
Drawing Mark DS-1-8 Washout and erosion on south face of newly completed area with lack of vegetation (Typ.).

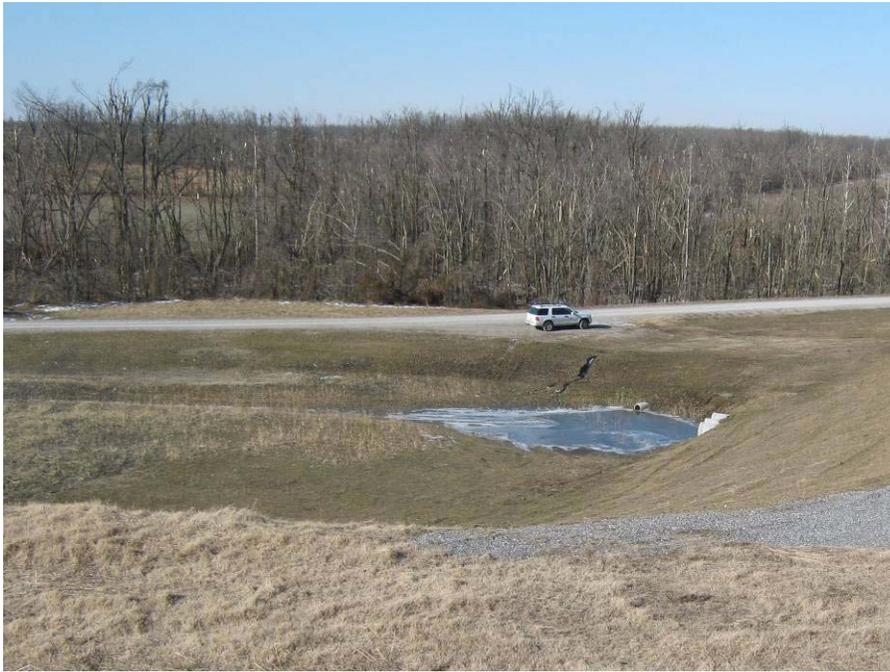
Drawing Mark DS-1-9 Erosion and standing water in perimeter ditch between stack and Inactive Dredge Cell (Typ.).

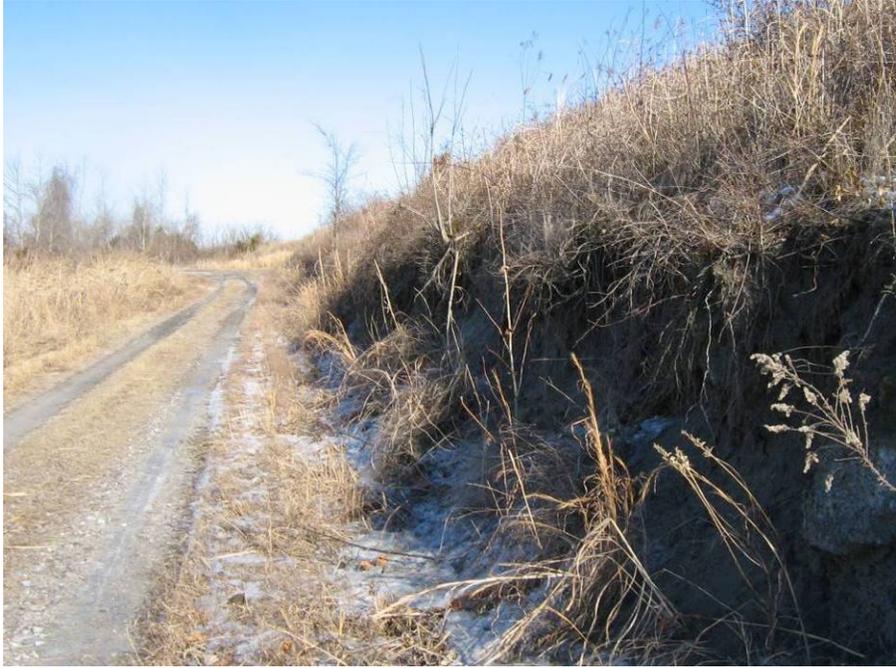
Drawing Mark CDA-1-1    Scarps along west shared ash dike (Typ.).

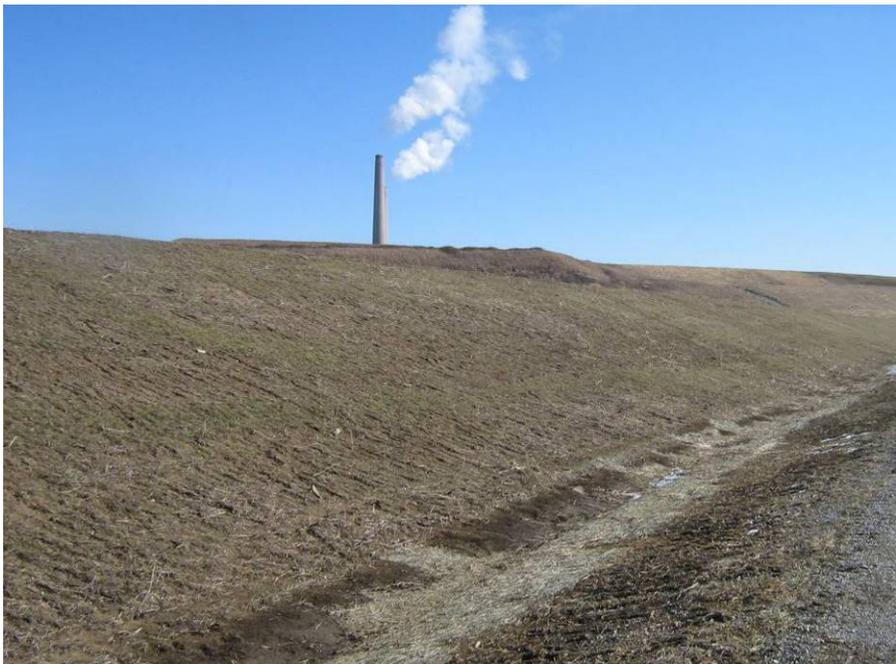
Drawing Mark CDA-1-2    Lack of established vegetation on exterior south dike slope.

- The southern perimeter dike of the Inactive Dredge Cell and the area extending to the adjacent Consolidated Waste Stack outlet pipes should be re-seeded to establish vegetation. Areas of erosion should be repaired as needed prior to seeding. The remaining perimeter dikes where sloughing, trees, and heavy vegetation was observed should continue to be monitored and repaired as needed.
- Continue annual inspection program and execute recommendations.

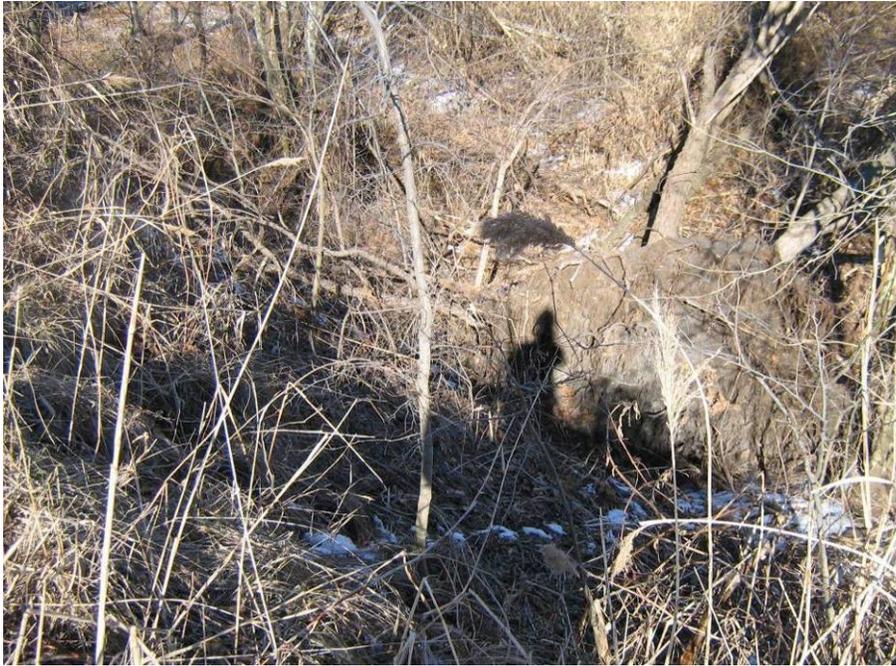
- The shared ash dikes along the north and west sides of the inactive dredge cell have a heavy stand of vegetation and trees throughout the majority of the perimeter. Some scarps, fallen trees, and slope instability were observed in several areas along these interior dikes.
- The southern perimeter dike consists of ash with a soil cover on slopes of 3H:1V. The area has been seeded but vegetation is not yet established on this slope and some minor erosion was observed.
- Along the southwest corner of the southern perimeter dike, some erosion was observed due to runoff of the adjacent Consolidated Waste Stack outlet pipes.

**Drawing Mark CDA-1-3**      **Landslide and fallen trees on north shared ash dike slope.**

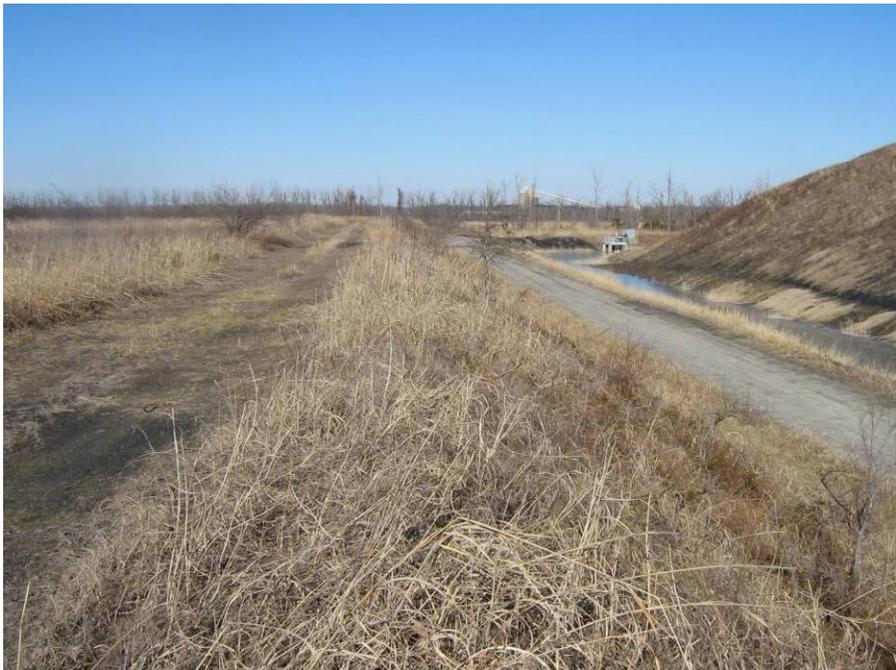
**Drawing Mark CDA-1-4**      **Steep slopes along southeast exterior dike.**

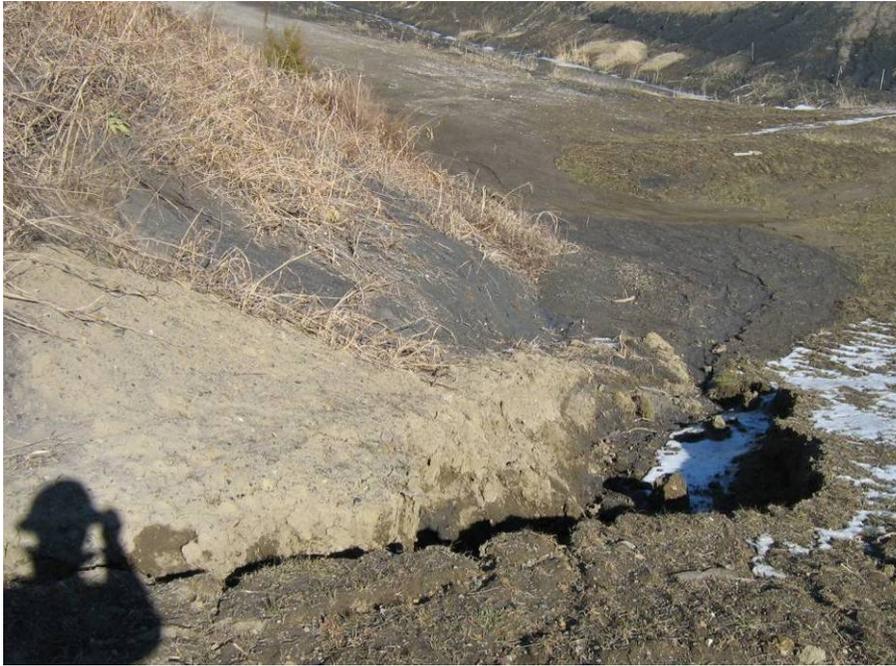
Drawing Mark CDA-1-5

Erosion due to runoff along southwest corner dike near adjacent Consolidated Waste Stack outlet pipes.
