## TVA Disposal Facility Assessment Phase 1 Plant Summary Bull Run Fossil Plant (BRF)

**TVA Disposal Facility Assessment  
Phase 1 Coal Combustion Product Disposal  
Facility Summary  
Bull Run Fossil Plant (BRF)  
Bottom Ash Disposal Area 1 (BAD-1)**

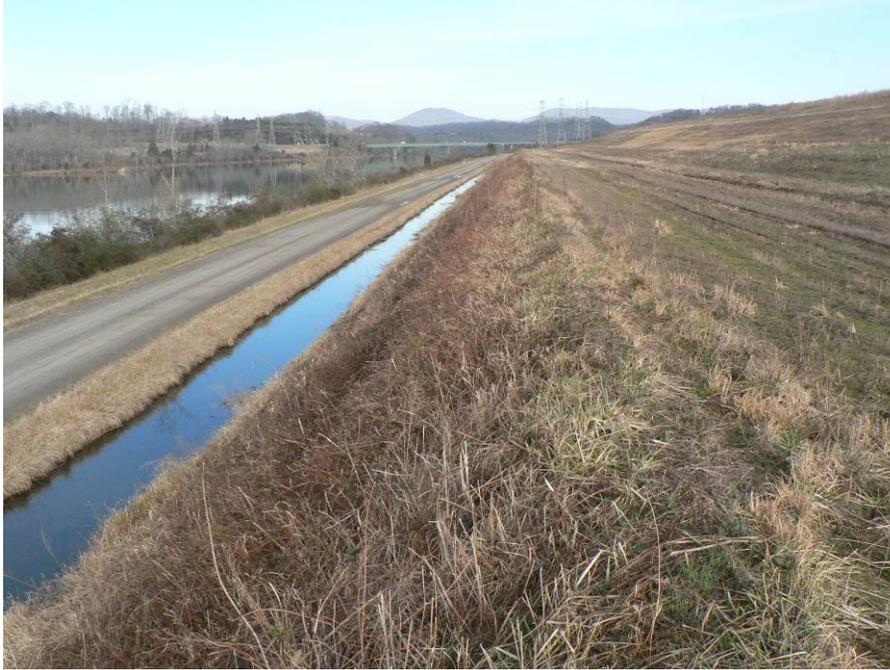
Drawing Mark BAD-1-1

- Standing water in the drainage ditch along the road of the west and south side of the Bottom Ash Stack is a concern. This drainage ditch begins upstream of the Chemical Pond and flows into the Ash Channel on the southeast corner of the Bottom Ash Stack. There appears to be very little gradient in this channel and the water is stagnant. This has been noted in past inspection reports as early as 1983. Past inspection reports have recommended cleaning and regrading of this area.
- Reddish discoloration was observed in the standing water on the west side of the Bottom Ash Stack. No movement was observed and it is unclear when or where this standing water originated.

Typical side slope on west side of bottom ash stack showing standing water in drainage ditch.

- It is recommended that Bottom Ash Disposal Area 1 undergo further engineering study to evaluate alternatives to alleviate the persistent standing water in the drainage channels. This may include detailed surveying of the discharge ditch and evaluation of alternatives to provide positive drainage.

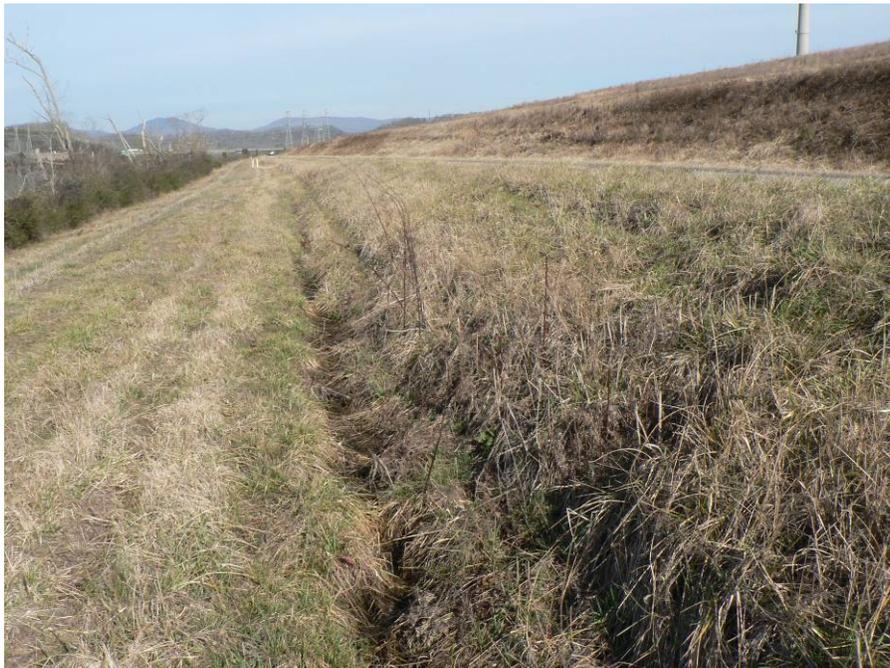
Drawing Mark BAD-1-2

- Inlet and outlet pipes for the lower channel between Area 1 and 2A were not located during the field assessment.
- Tire ruts are observed with ponding water on the southwest side of the Bottom Ash Stack on the bench above the road.

Tire ruts on slope and lower bench on west side of bottom ash disposal area.

- Repair tire ruts where noted.
- Repair animal burrows where noted.
- Remove trees from south side of Bottom Ash Stack on upslope from access road.
- Locate and maintain inlet and outlet structures to the lower channel between the Bottom Ash Stack Area 1 and the Gypsum Disposal Area 2A. Area should drain to Clinch River.
- Continue to monitor areas of noted seeps and wet areas on a consistent basis.

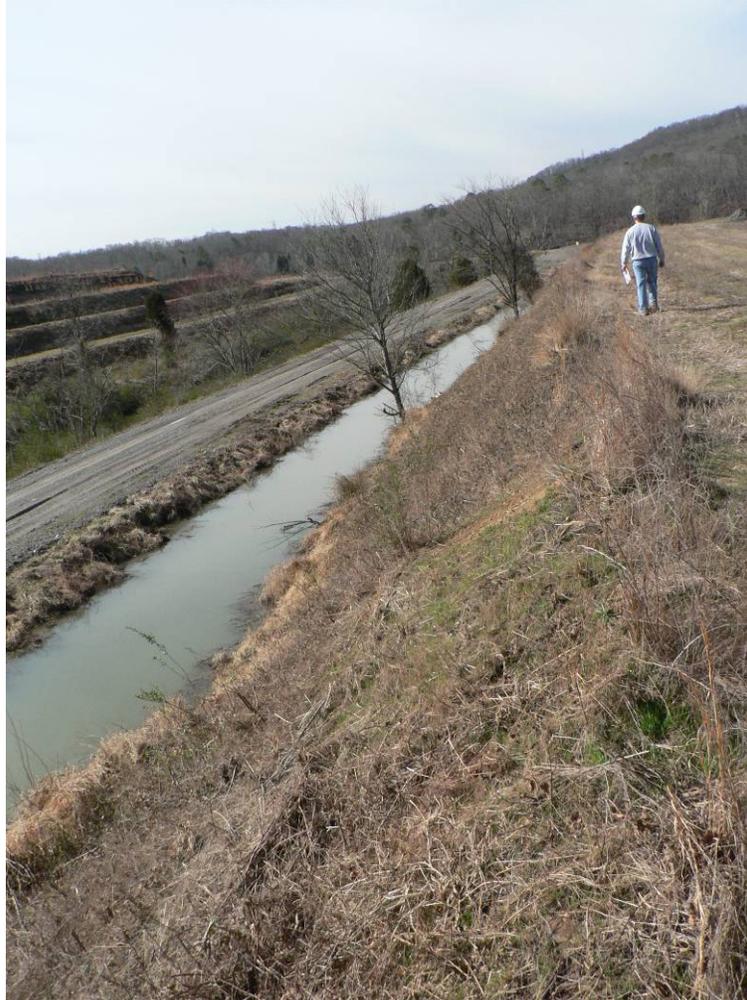
Drawing Mark BAD-1-3 View of side slope and standing water in drainage ditch on south side of bottom ash disposal area.

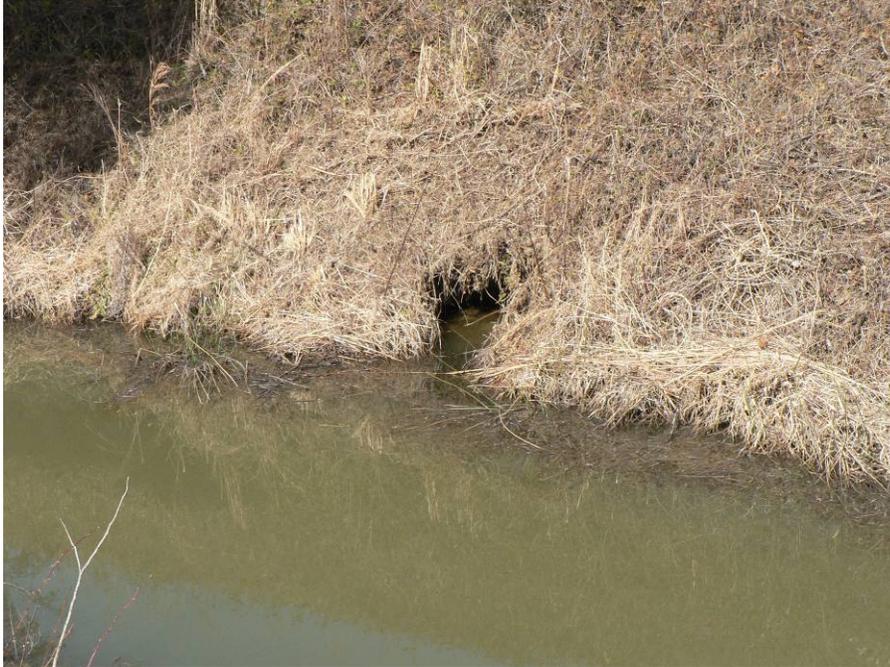
- Trees are located on south exterior slope, and at a few other isolated locations on the west dike.
- Two animal burrows were observed in the south exterior slope above the standing water in the drainage ditch.

Drawing Mark BAD-1-4 Possible animal burrow on south side slope near drainage ditch.

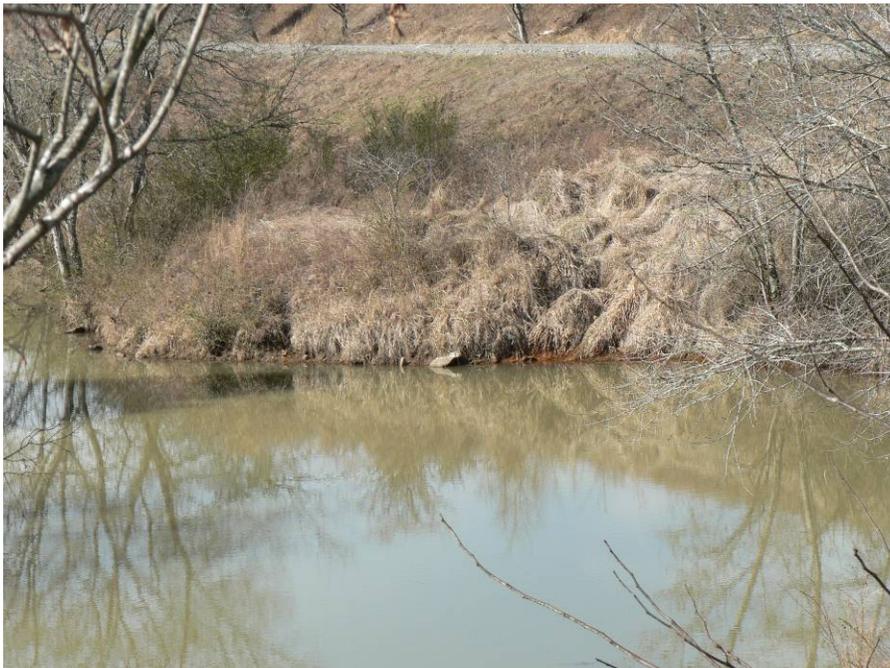
- A red water seep was noted on the lower southern slope of the Bottom Ash Stack, along the channel between Area 1 and 2A. The seep is located on the slope and just west of the confluence of the drainage channel and the ash channel. The bank was observed as soggy and some standing water was observed for a significant area. Redness was observed in the channel below. Heavy vegetation was present in the area of the seep. This seep has been noted in the previous inspection report (2008).

Drawing Mark BAD-1-5 Red water seep area on the lower south slope along channel between the Bottom Ash Disposal Area 1 and Gypsum Disposal Area 2A.

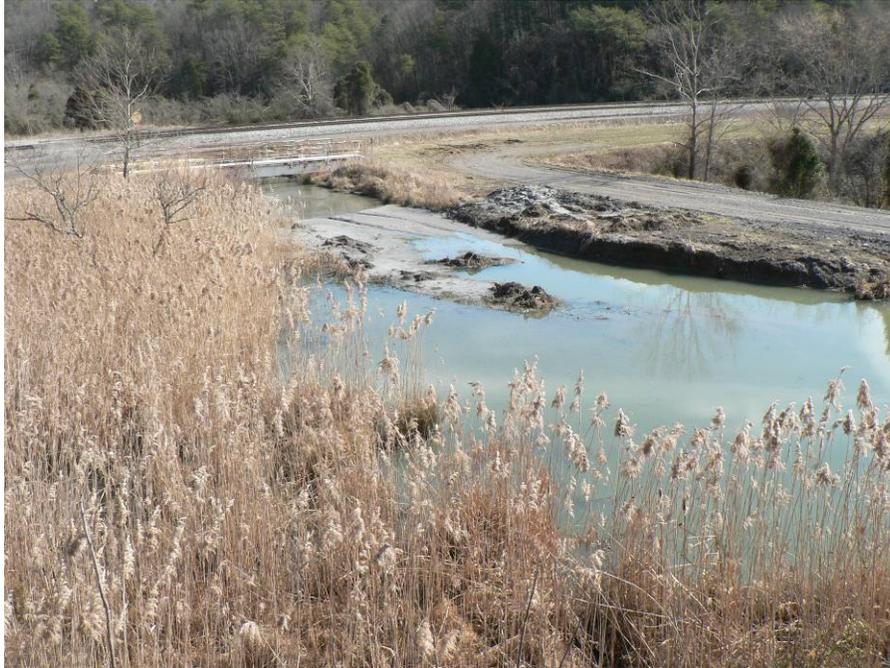
**Drawing Mark BAD-1-6** Confluence of ash channel and drainage ditch on south side of the bottom ash disposal area showing settlement of fly ash in channel.

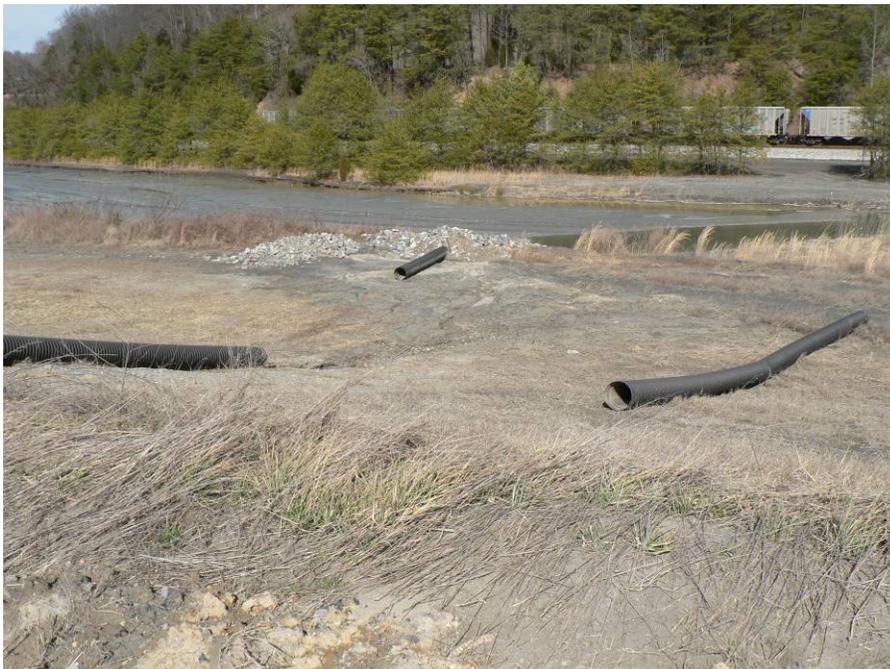
**Drawing Mark BAD-1-7** Disjointed discharge pipes from top of bottom ash disposal area.

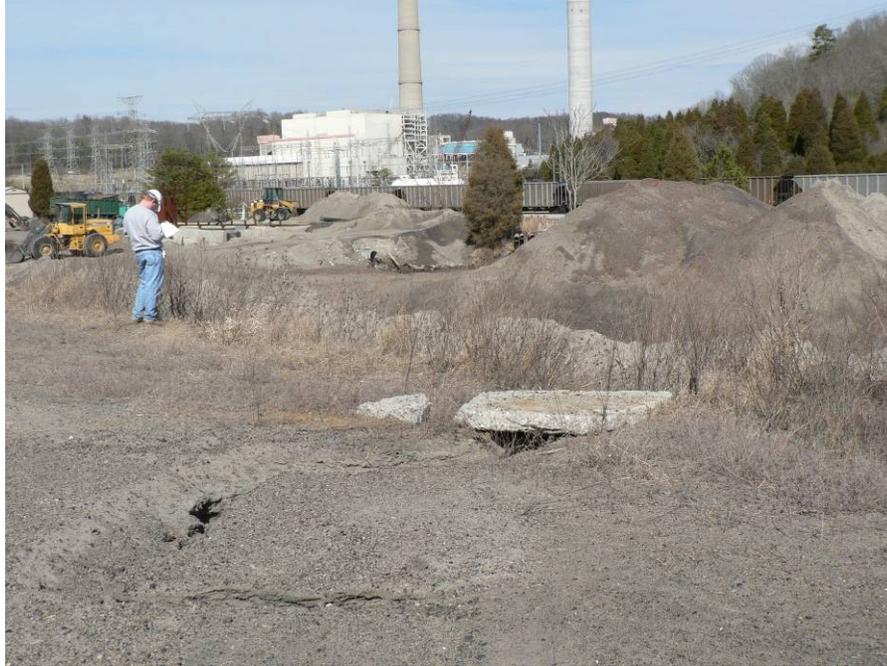
Drawing Mark BAD-1-8 Erosion gully near north end of ash pond with loose concrete slab covering edge of gully on east side of bottom ash disposal area.

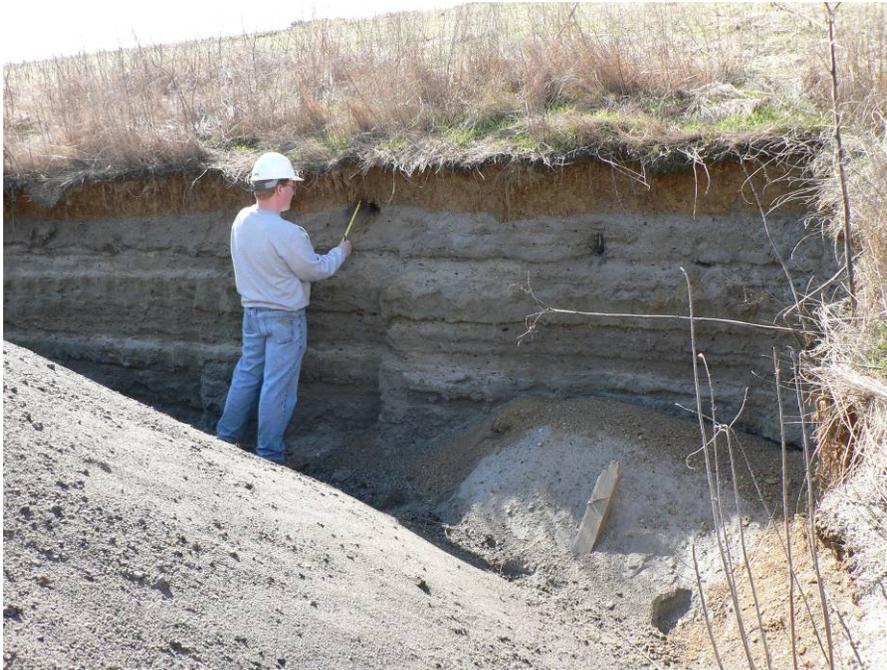
- The Bottom Ash Stack eastern slope has been excavated to make room for stockpiling ash. This is located near the inlets to the Bottom Ash Pond. A void was also observed at the interface between the soil and exposed ash in the slope.

Drawing Mark BAD-1-9 Cut in stack for stockpile area showing void between soil layer and ash.

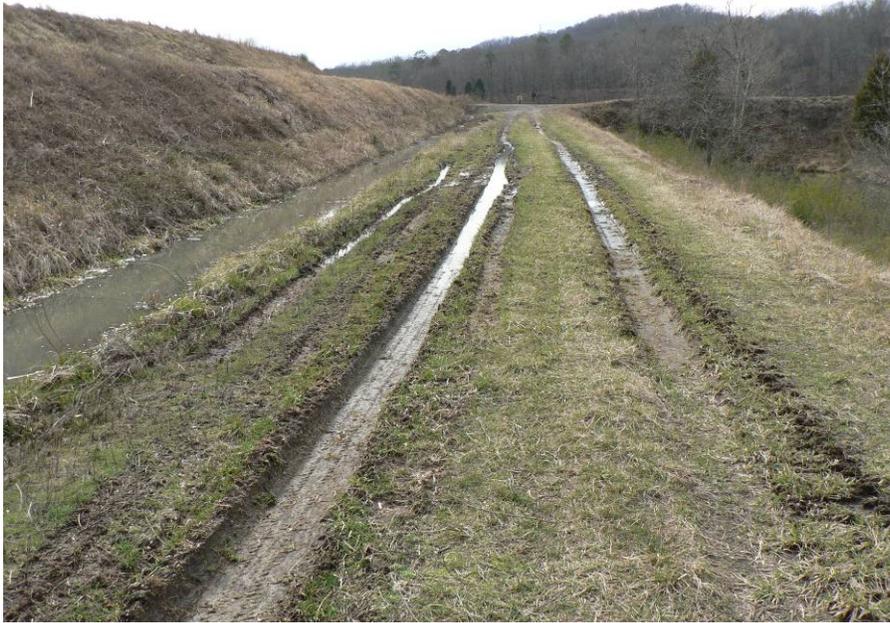
Drawing Mark GDA-2A-1

Standing water in roadside drainage ditch on north side of Gypsum Disposal Area 2A.

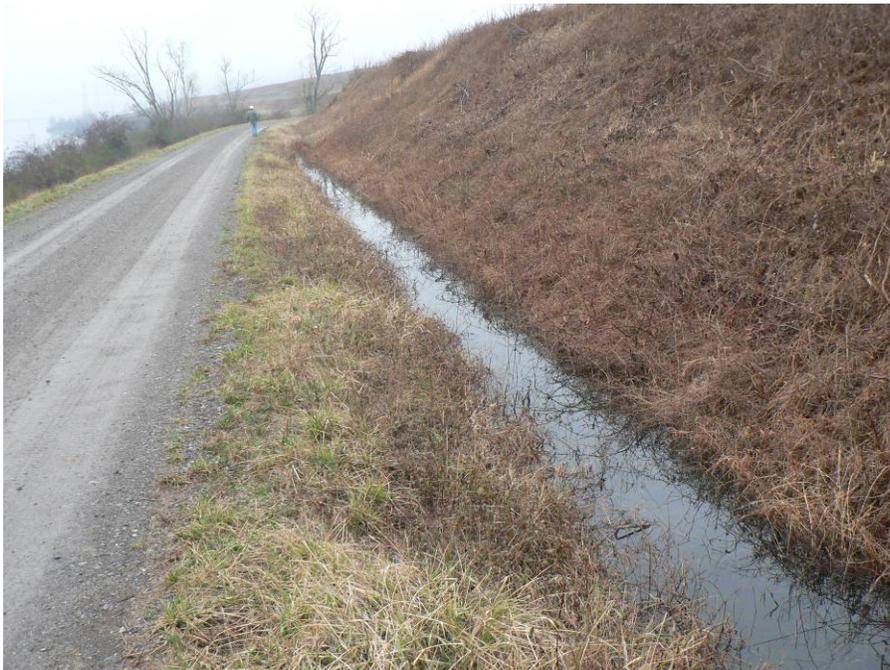
Drawing Mark GDA-2A-2

Stagnate water in drainage channel on north end of west side of gypsum disposal area.

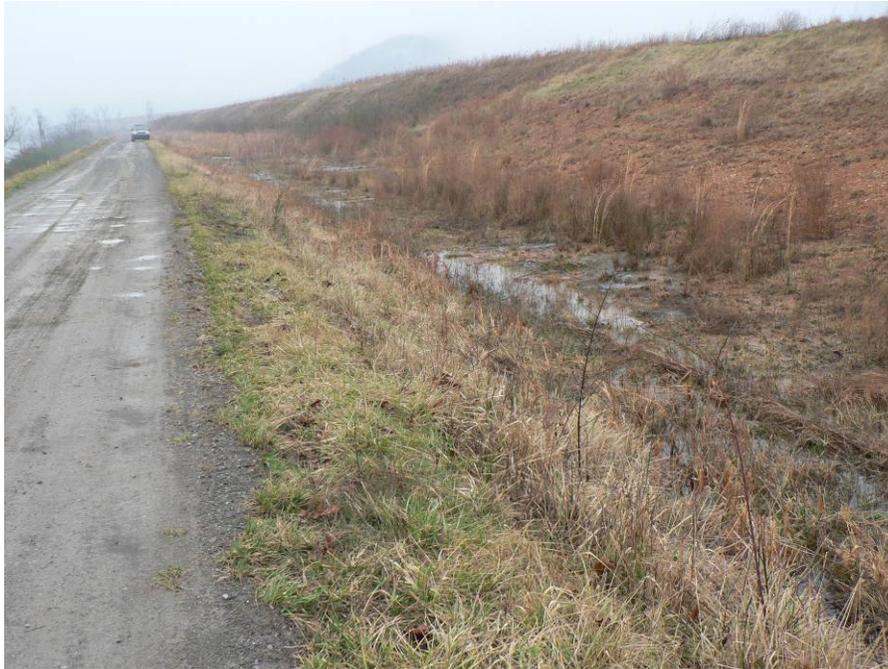
Drawing Mark GDA-2A-3 Ponding water in drainage channel on west side of gypsum disposal area.

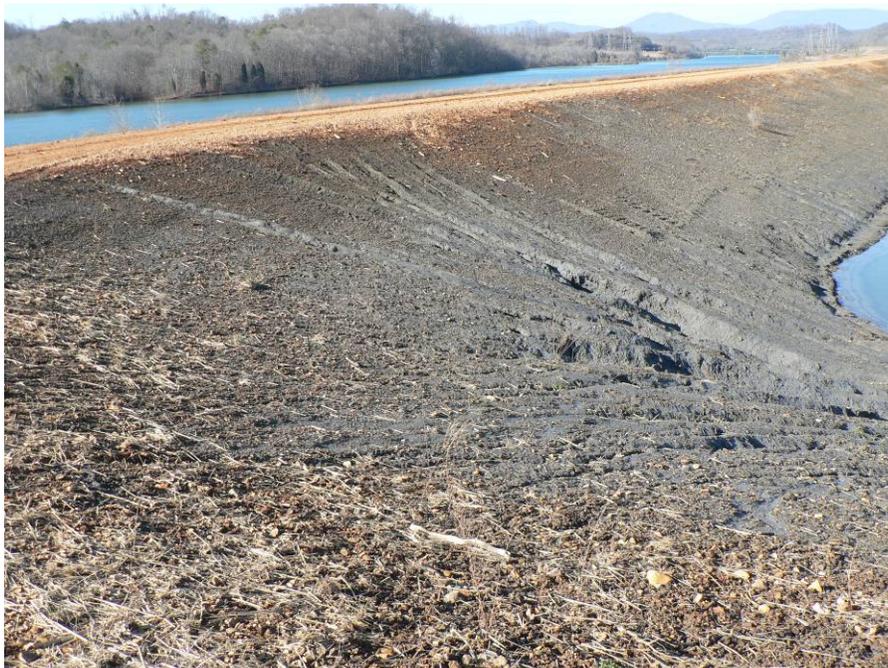
Drawing Mark GDA-2A-4 Interior slope erosion (typical) within the gypsum disposal area.

- Repair erosion and sloughed areas where noted on interior slopes of ponds. Line interior pond slopes with rip-rap to help reduce future erosion.
- Clean siltation and repair separated joints from lateral drainage pipes on south and east side of Gypsum Disposal Area 2A.

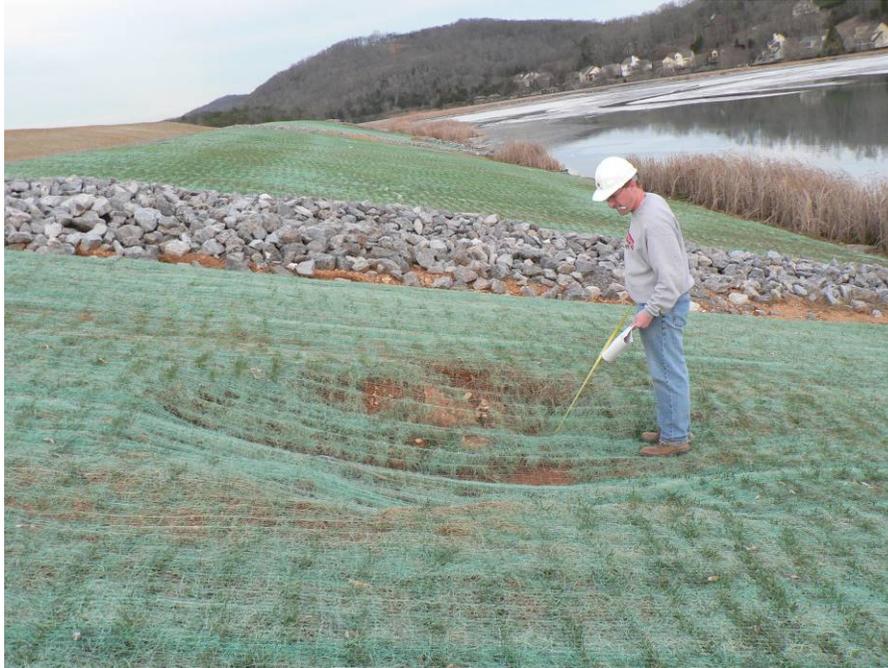
- Several depressions were noted on the lower south slope into the ash pond. One of these depressions is large in size (approx. 8.5 feet by 13 feet by 1 foot deep) and appears to be in line with the western most discharge pipe from the gypsum pond.

Drawing Mark GDA-2A-5 Depression on south end of gypsum disposal area.

- It is recommended that Gypsum Disposal Area 2A undergo further engineering study to evaluate the cause of the depressions and erosion on the south side and slope stability to evaluate the proposed stacking configuration.

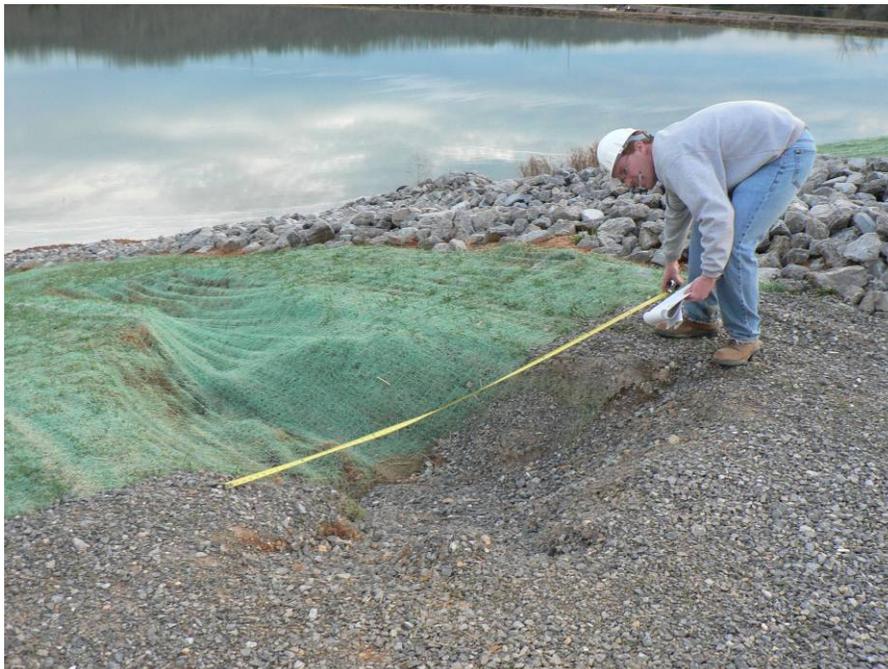
- Two erosion areas were noted on lower south slope to ash pond. First area is next to west most rip rap channel measuring 5 feet wide, 2 feet deep starting at top of slope at access road and continuing down slope. Worst portion is within 20 feet of access road. Second erosion area is located 15 feet west of east most rip rap channel measuring 2 feet wide by 6 inches deep by 6 feet long (down the slope).

Drawing Mark GDA-2A-6 Erosion gully on south end of gypsum disposal area

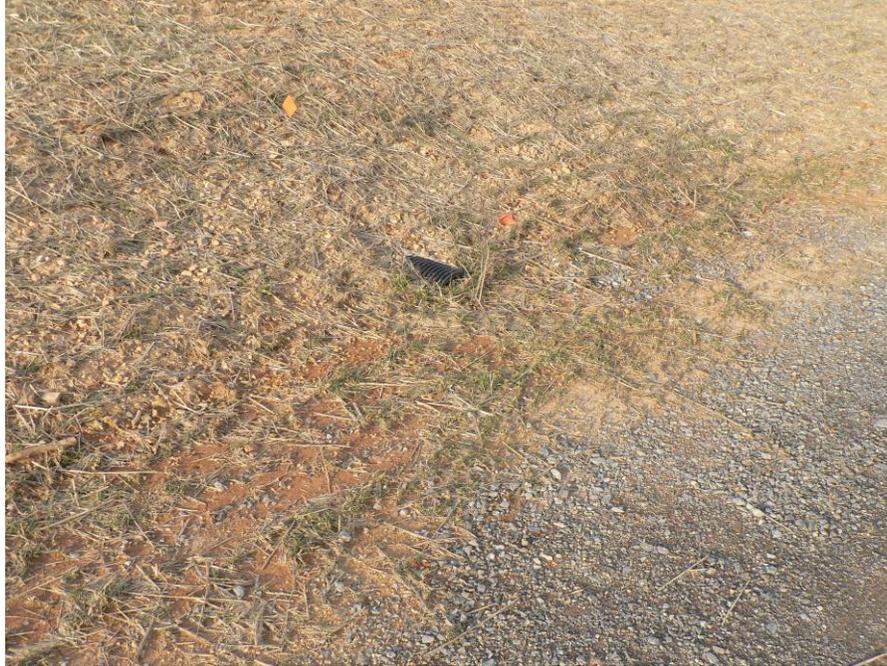
Drawing Mark GDA-2A-7 Partially soil filled lateral outlet pipe on south side intermediate bench.

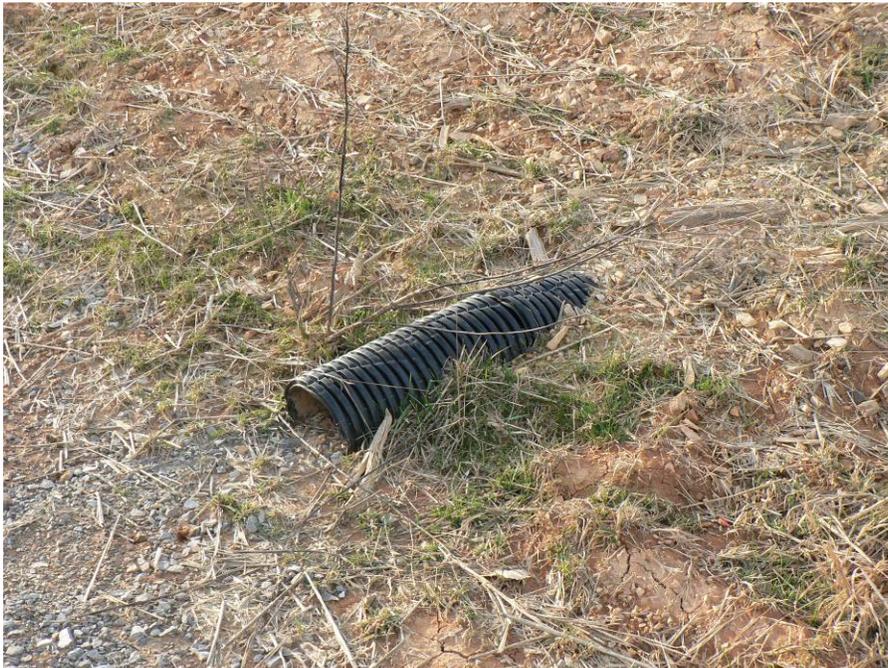
Drawing Mark GDA-2A-8 Damaged lateral outlet pipe on south side intermediate bench.

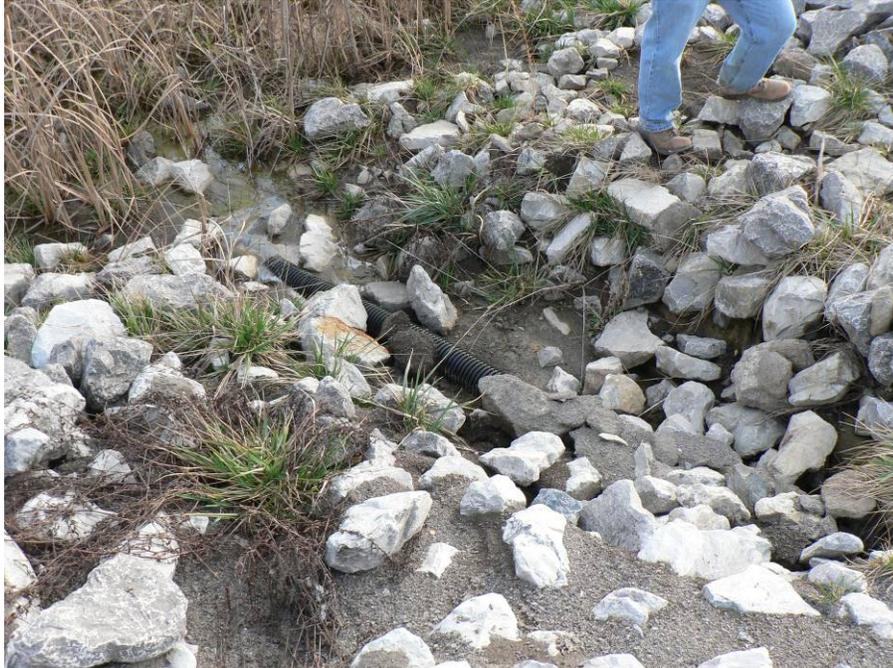
Drawing Mark GDA-2A-9 Covered lateral outlet pipe at base of south side of gypsum disposal area entering fly ash pond.

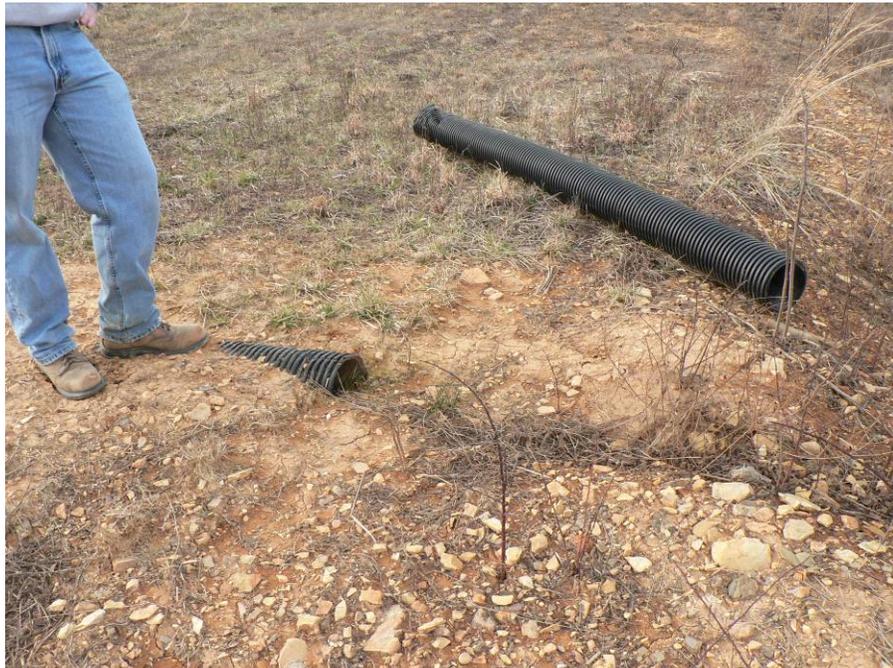
Drawing Mark GDA-2A-10 Separated and partially soil covered lateral outlet pipe on east side of gypsum disposal area.

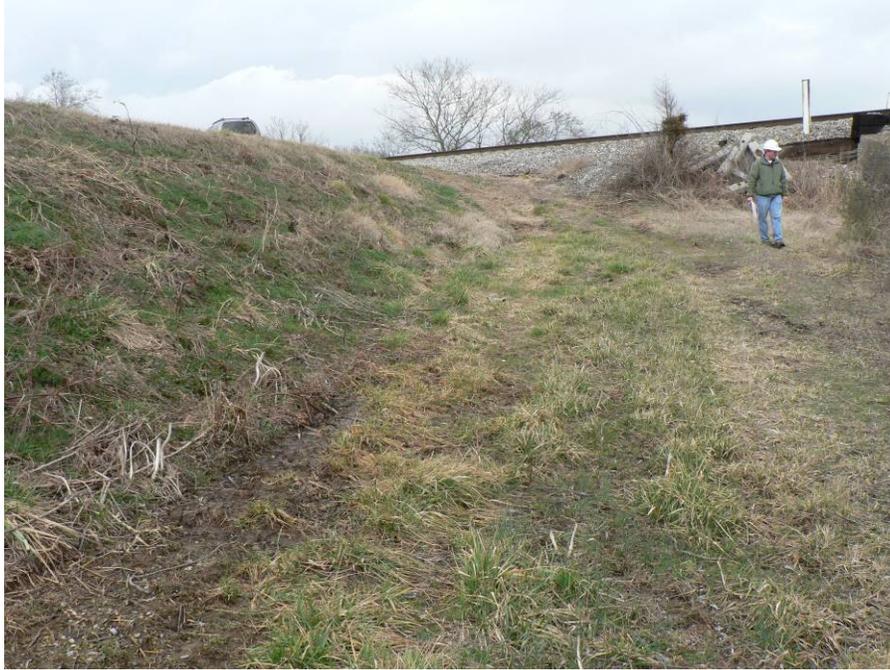
Drawing Mark FAP-2-1

- Tire ruts were noticed on the exterior bench, toe and slope. These tire ruts are ponding water on the toe of the exterior slope. This was observed along the entire length of the exterior slope.

Tire ruts and wet area on south side, east corner of fly ash pond.

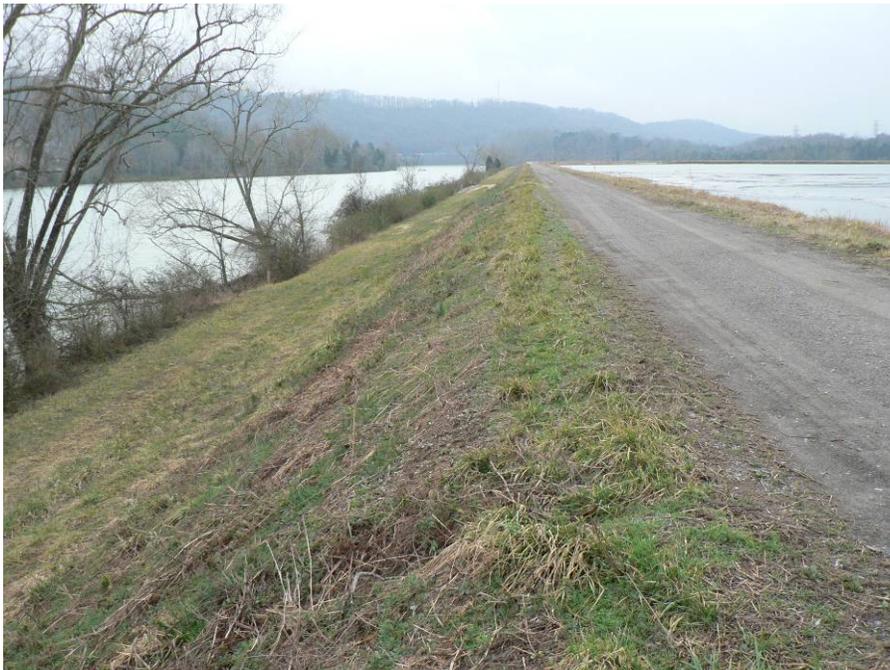
Drawing Mark FAP-2-2

- Steep slopes were seen on the interior and exterior slopes of the ash pond. Several areas were observed on the interior slope where banks have slid towards the pond and are now protected with rock. These slopes were observed at steeper than 2H:1V in numerous places.

Steep exterior slope on south side fly ash pond.

- It is recommended that a geotechnical evaluation be done for the Active Fly Ash Pond/Stilling Pond Area 2 based on slope stability concerns. This evaluation could include implementation of a monitoring program including installation of piezometers and inclinometers. Based the results of this evaluation, further analysis might be needed.
- Due to the field observations of the quantity of ash being deposited in the pond as well as the lack of adequate freeboard, it is recommended that a hydrologic and hydraulic analysis be done to accurately determine the current maximum storage capacity within the pond.

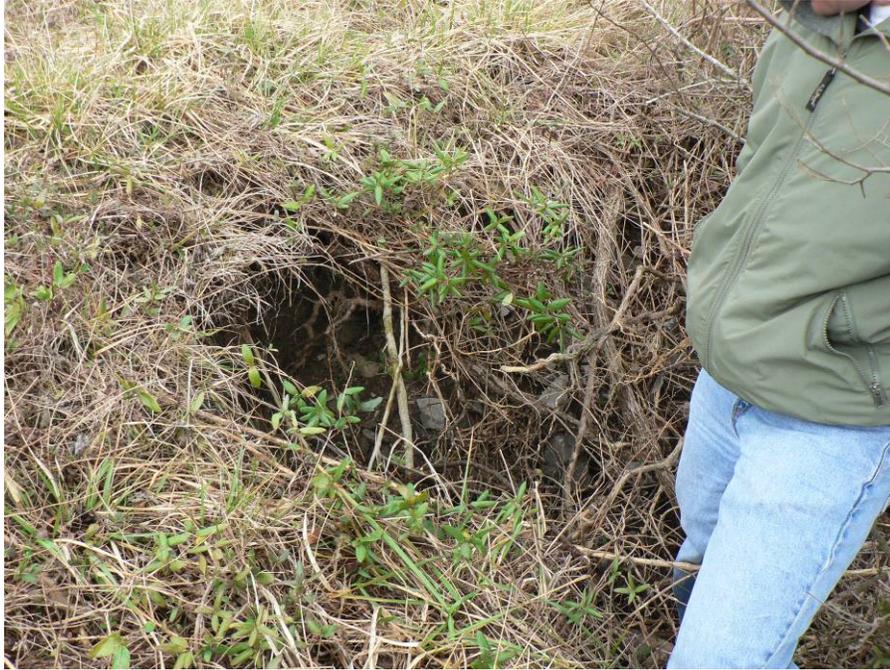
Drawing Mark FAP-2-3

Possible beaver burrow on south side of fly ash pond near outlet of concrete pipe along creek.

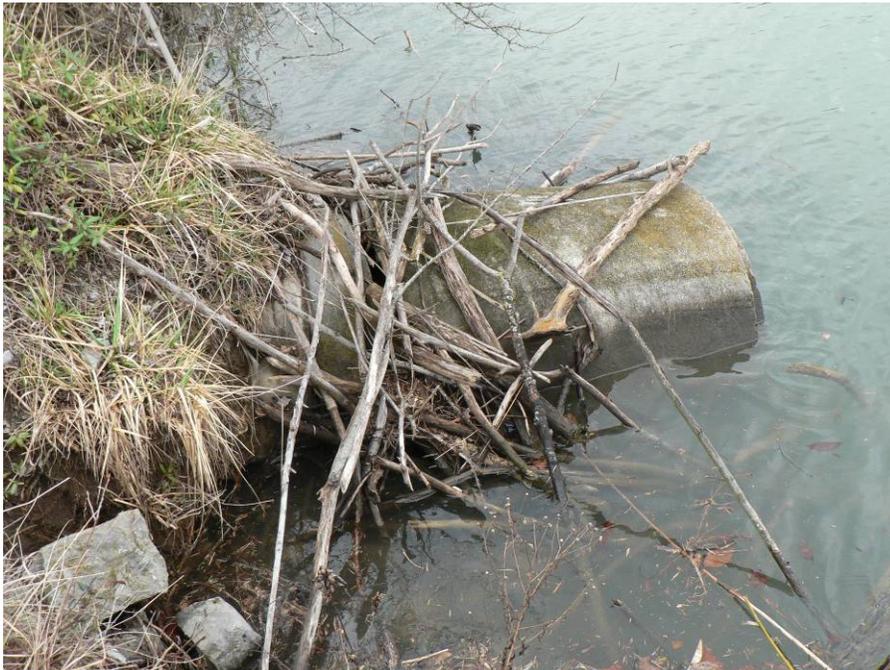
Drawing Mark FAP-2-4

Separated concrete pipe of unknown origin entering creek.

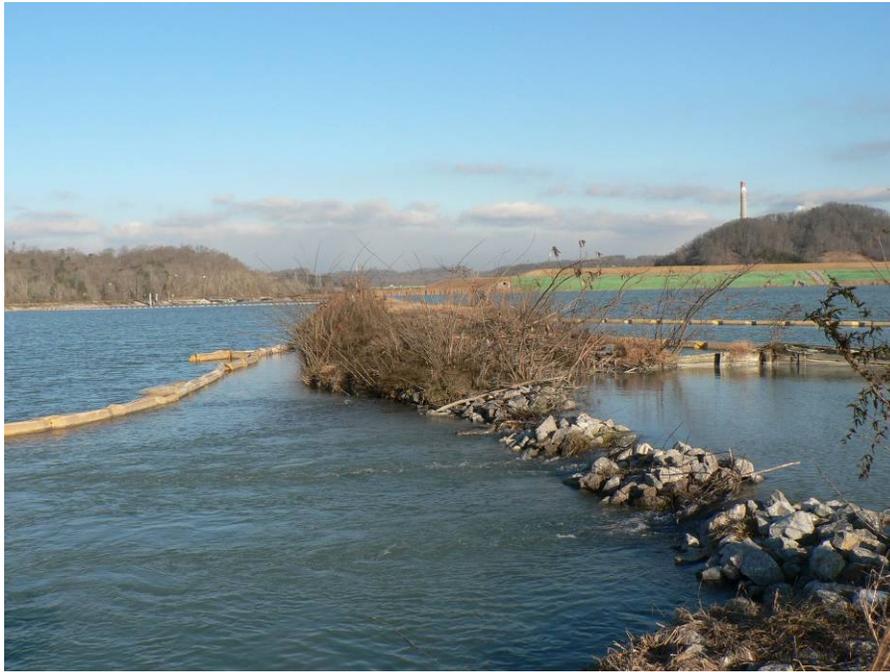
Drawing Mark FAP-2-5 Weir area at southeast portion of pond..-

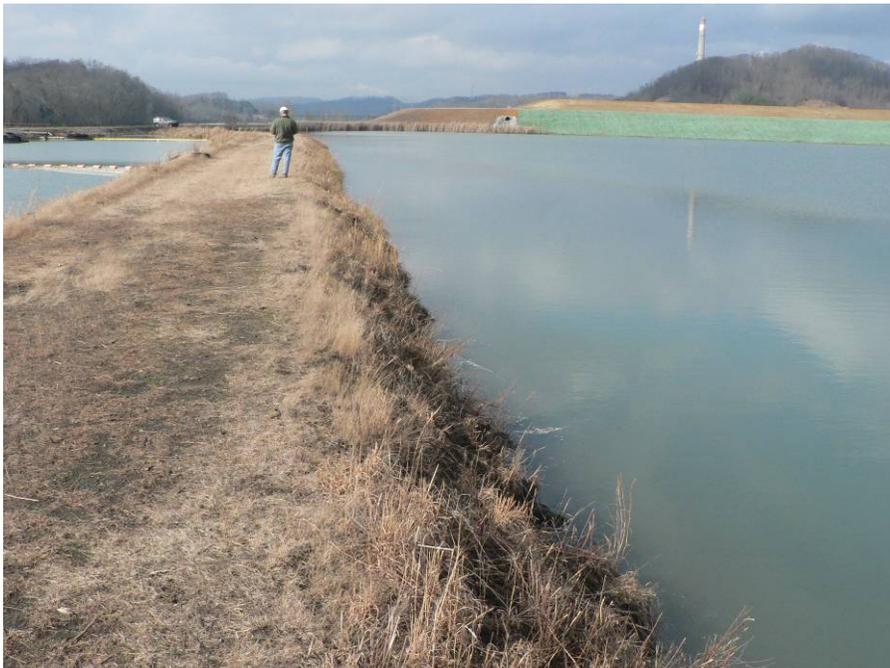
Drawing Mark FAP-2-6 Steep, irregular slopes and overall conditions of inner levee between fly ash pond and stilling pond.

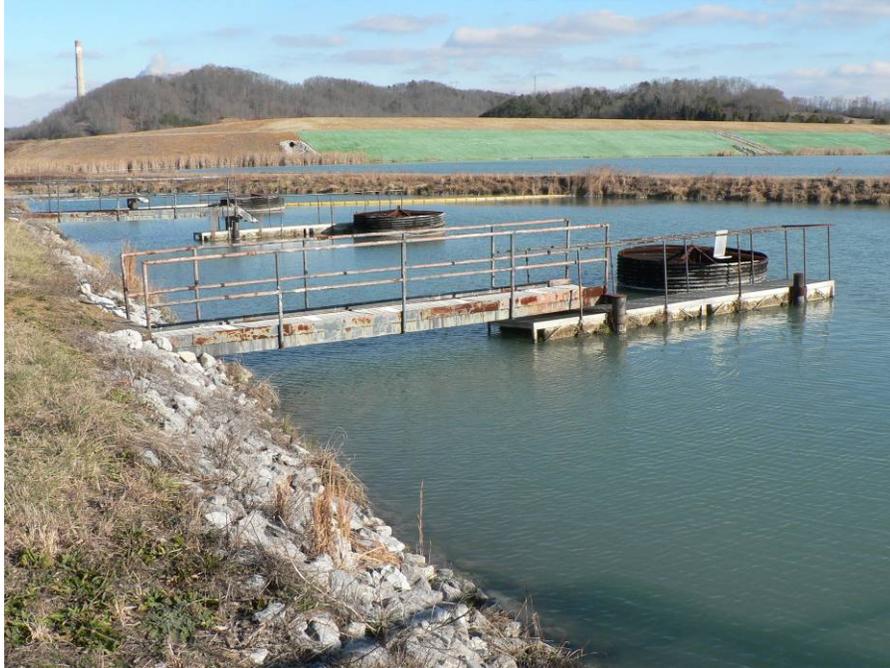
- Outlet from stilling pond is through three concrete riser structures discharging into the Clinch River. RCP push-together riser structure spillways are a concern. Some minor surging was noted during the field assessment.

**Drawing Mark FAP-2-7** Three spillway structures on northwest side of pond.

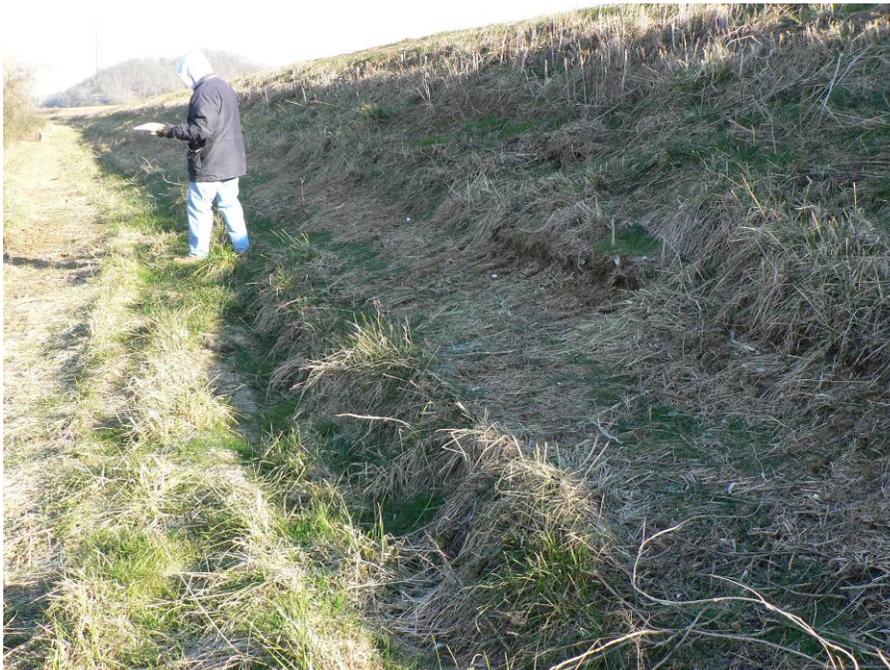
**Drawing Mark FAP-2-8** Steep slopes with tire ruts and possible slumping on west side of stilling pond.

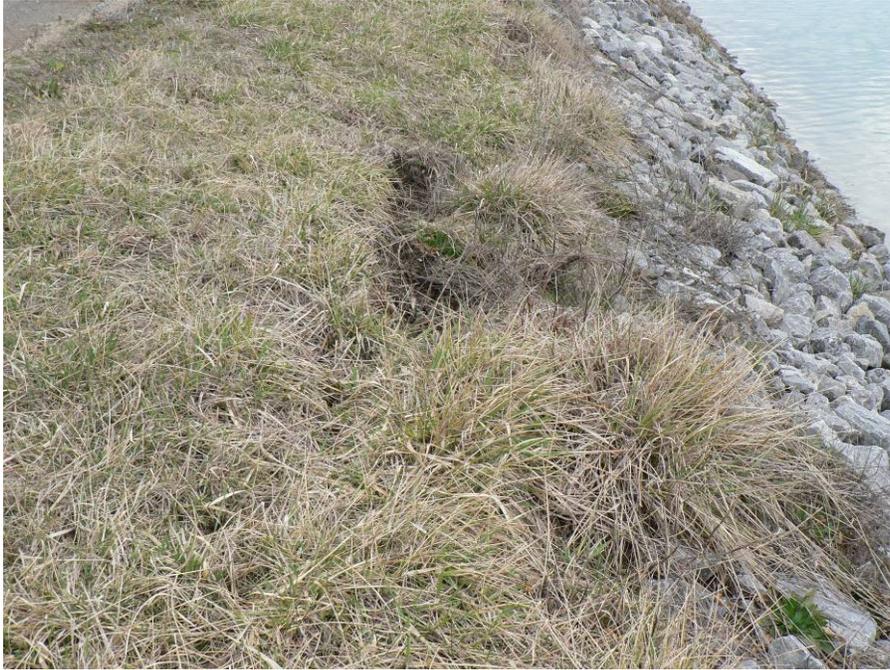
- Two animal burrows were noted on the exterior slope near the SW corner of the stilling pond.
- A small slough was noted on the west interior slope of the stilling pond above the rip rap. This occurred south of the riser structure spillways.

Drawing Mark FAP-2-9      Slump on interior cresting of stilling pond along west side dike.

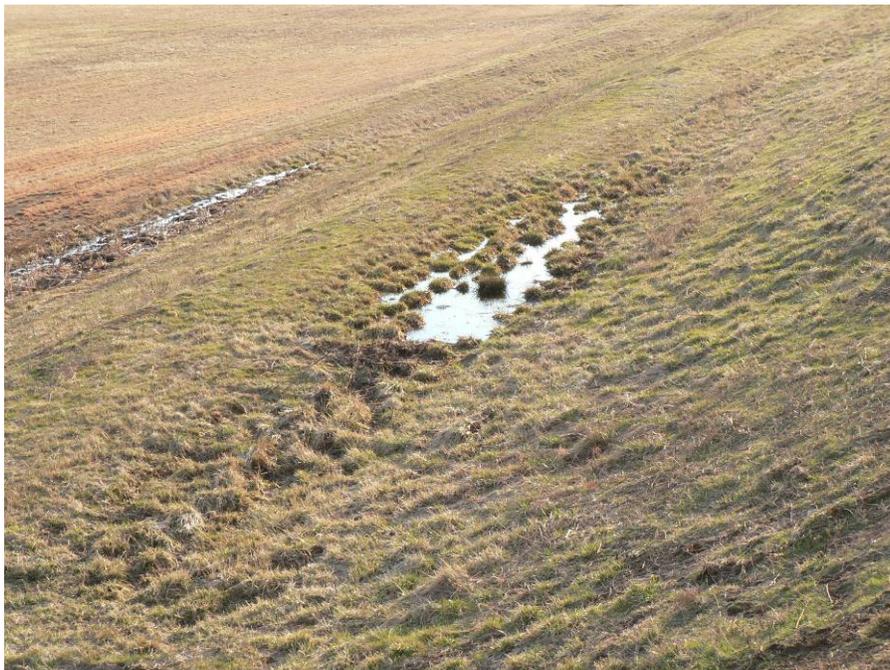
Drawing Mark EWDC-1-2 View of east side lower slope and bottom area showing standing water and reddish soils.

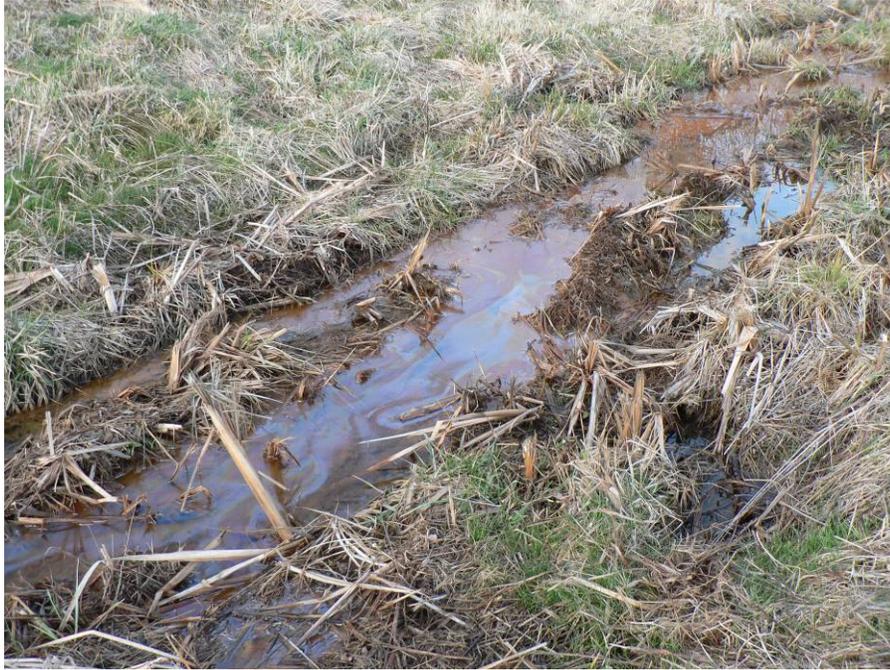
Drawing Mark EWDC-1-3 Red water seep and standing water at bottom of slope on east side of dredge cell.

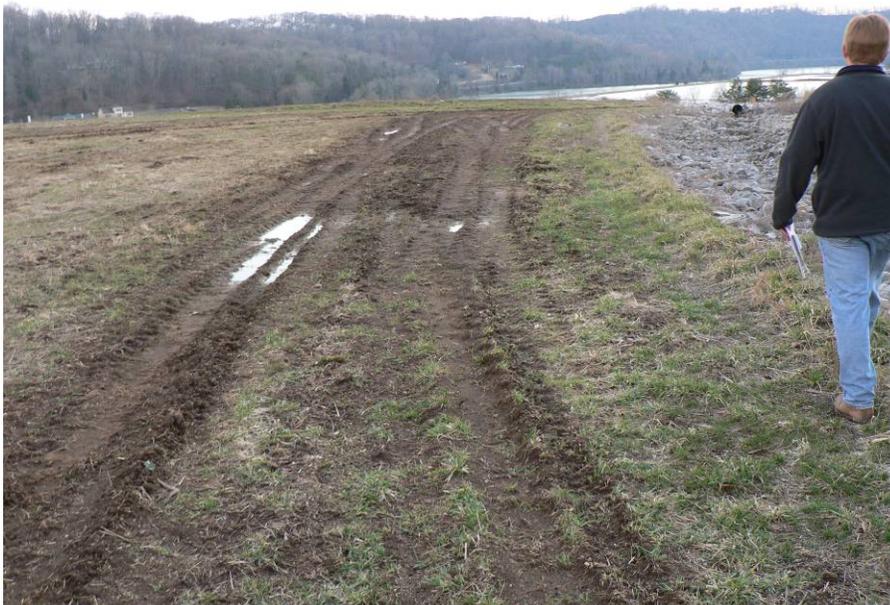
Drawing Mark EWDC-1-4 Tire ruts creating a depression and wet area on top of dredge cell.

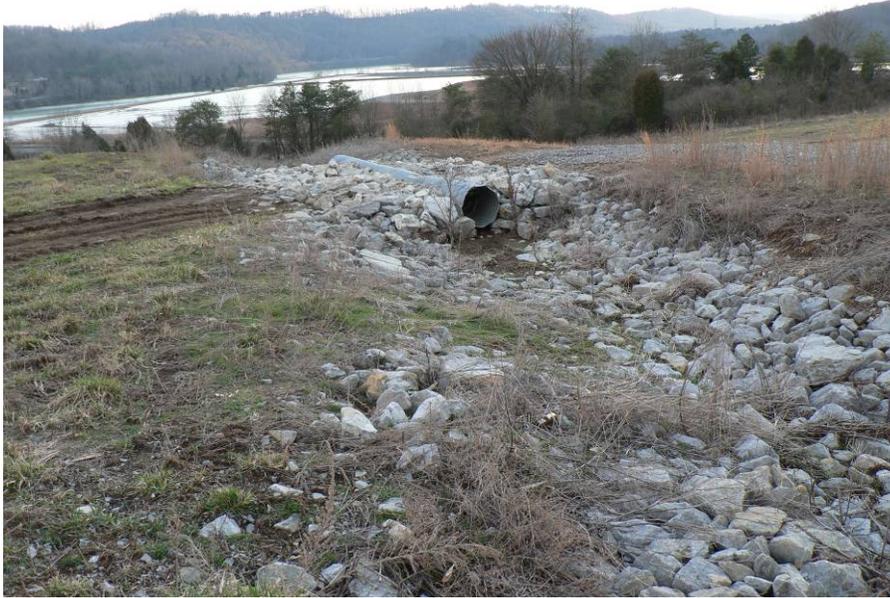
Drawing Mark EWDC-1-5  
CMP culvert on top of stack that is partially covered, dented, and appeared to drain the wrong direction.

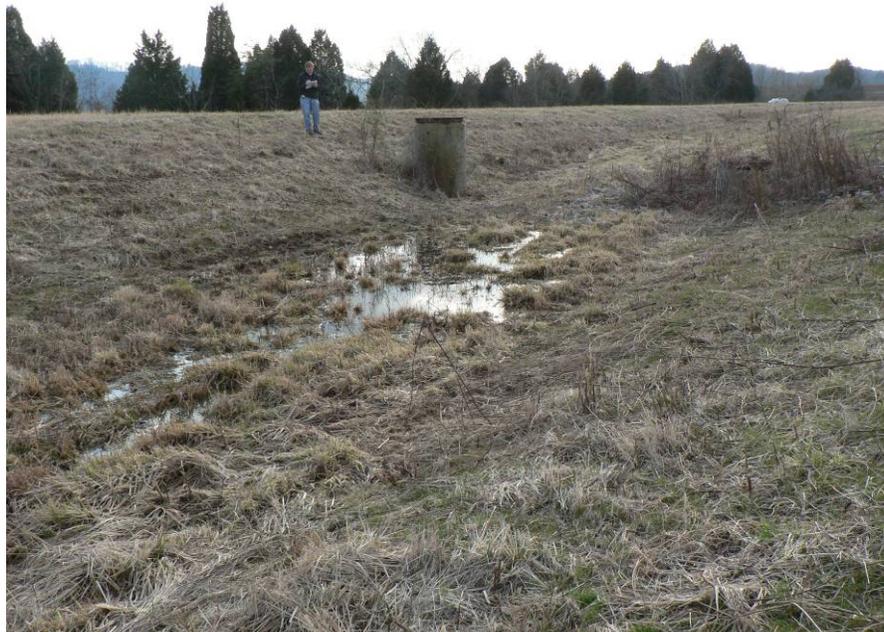
Drawing Mark EWDC-1-6  
Standing water around outlets on the southeast side of the East and West Dredge Cells.

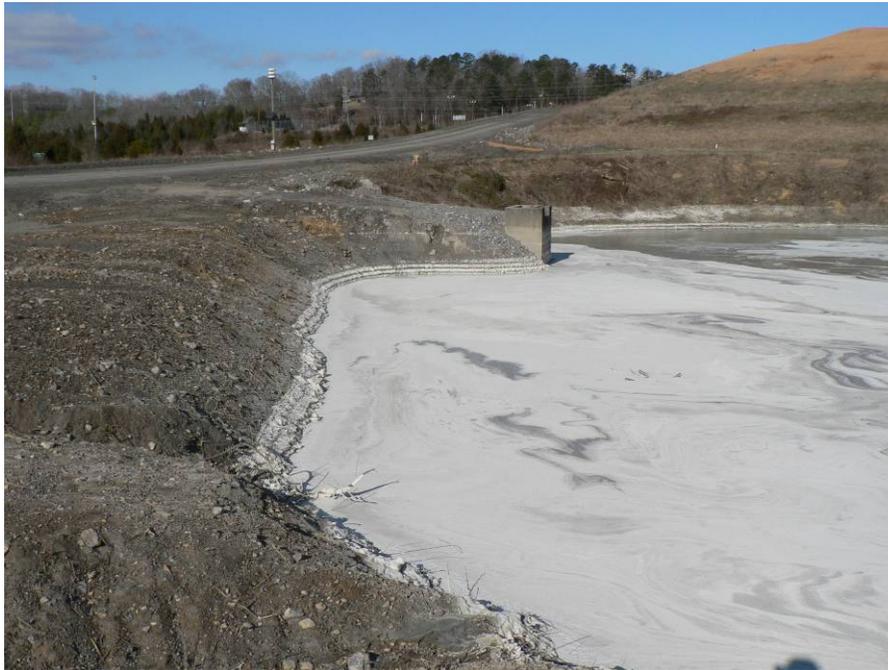
Drawing Mark DSP-1-3      Bare slopes near outlet to ash stack sediment pond.
