## TVA Disposal Facility Assessment Phase 1 Plant Summary Bull Run Fossil Plant (BRF)

**TVA Disposal Facility Assessment  
Phase 1 Coal Combustion Product Disposal  
Facility Summary  
Bull Run Fossil Plant (BRF)  
Bottom Ash Disposal Area 1 (BAD-1)**

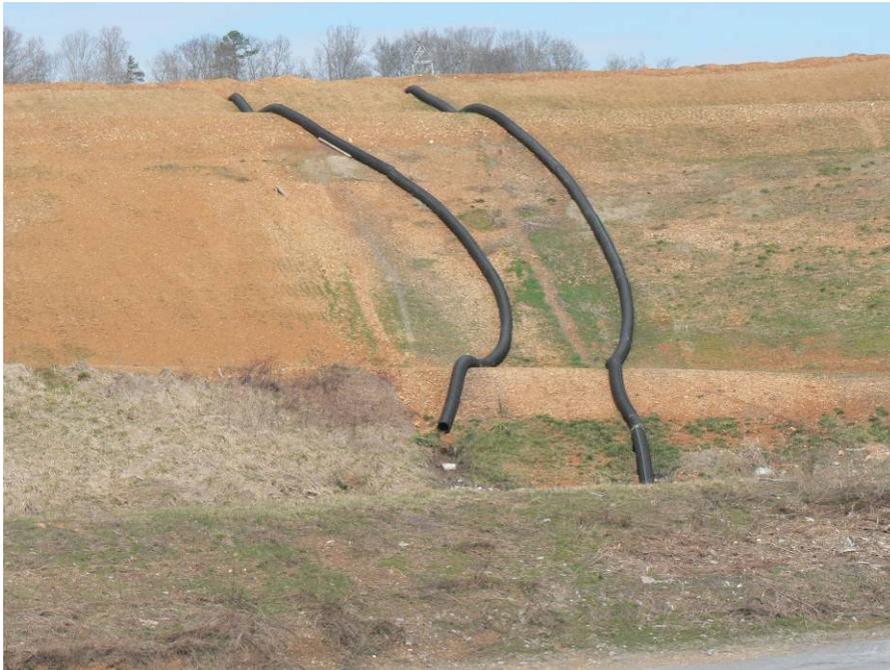
Drawing Mark DS-1-1

Inlet pipes down embankment slope to sediment pond diversion, shifted on slope from past storm event.

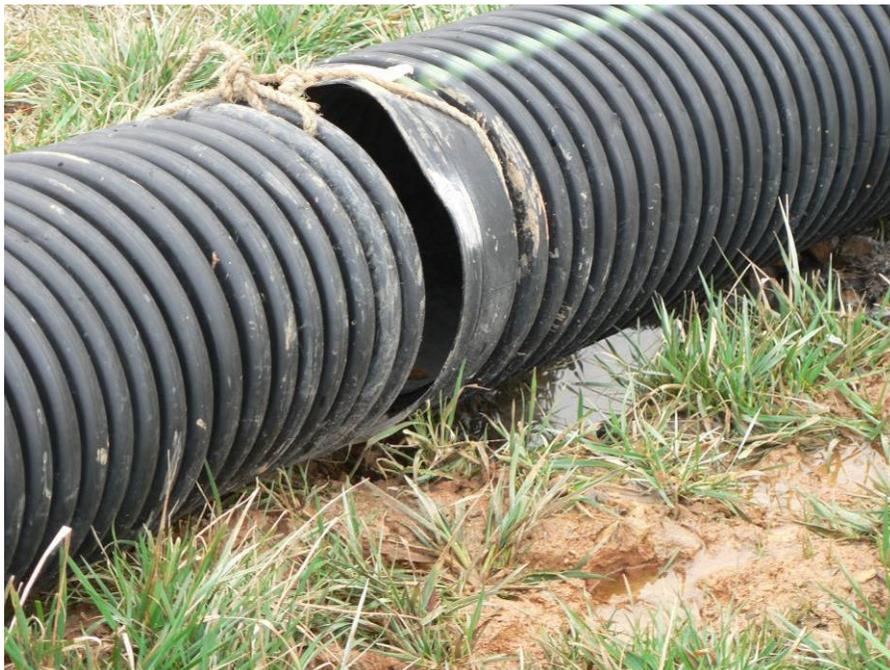
Drawing Mark DS-1-2

Tied discharge pipes at separation on bench on the southern side of Dry Fly Ash Stack.

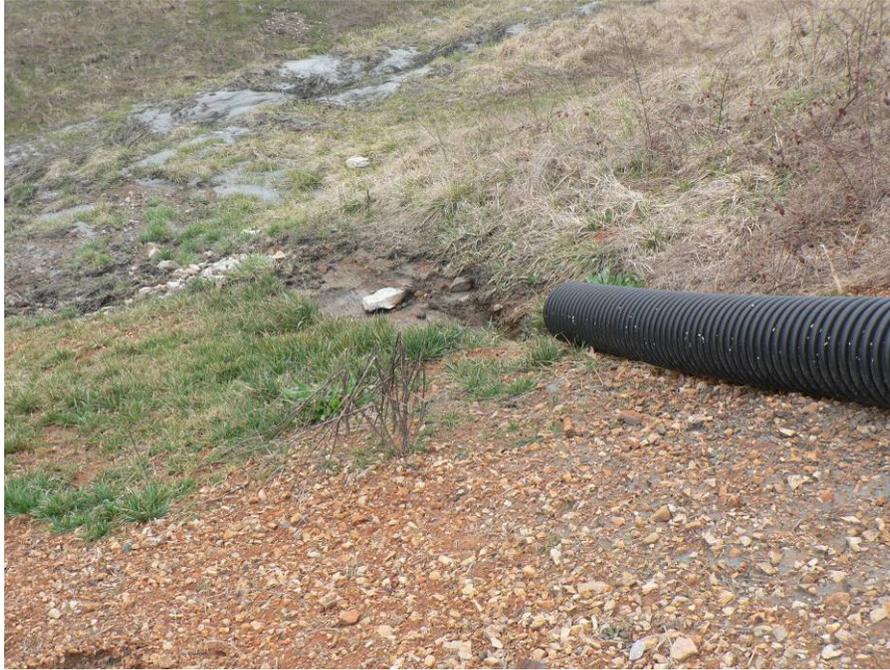
Drawing Mark DS-1-3

Erosion at outlet end of ash drainage discharge pipe at diversion ditch to sediment pond.

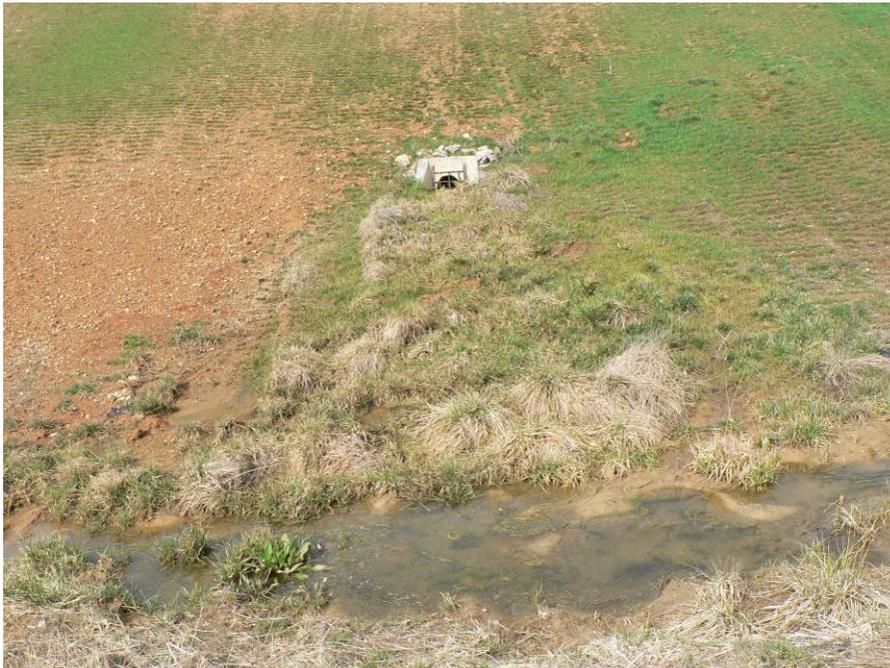
Drawing Mark DS-1-4

Silted concrete pipe and headwall on southern portion of Dry Fly Ash Stack. Note water below outlet.

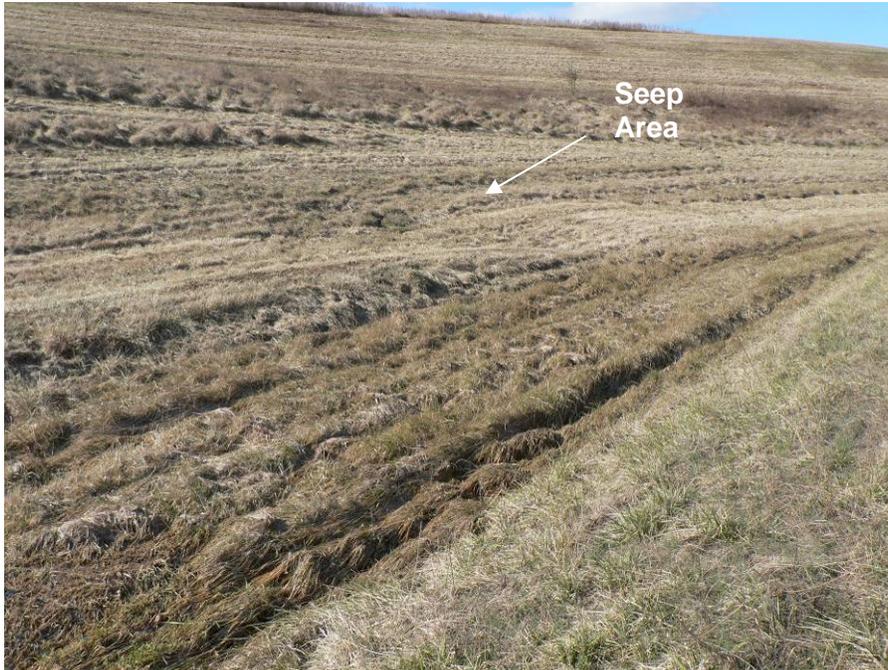
Drawing Mark DS-1-5

Typical slopes near seepage area on northeast portion of lower slope of Dry Fly Ash Stack.

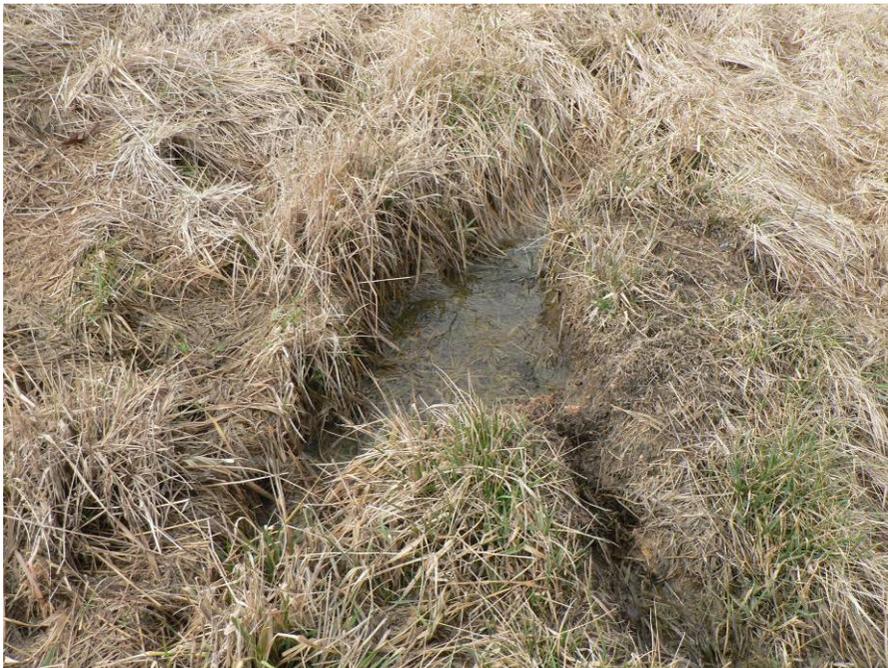
Drawing Mark DS-1-6

Closeup of standing water in seep area on northeast portion of Dry Fly Ash Stack.

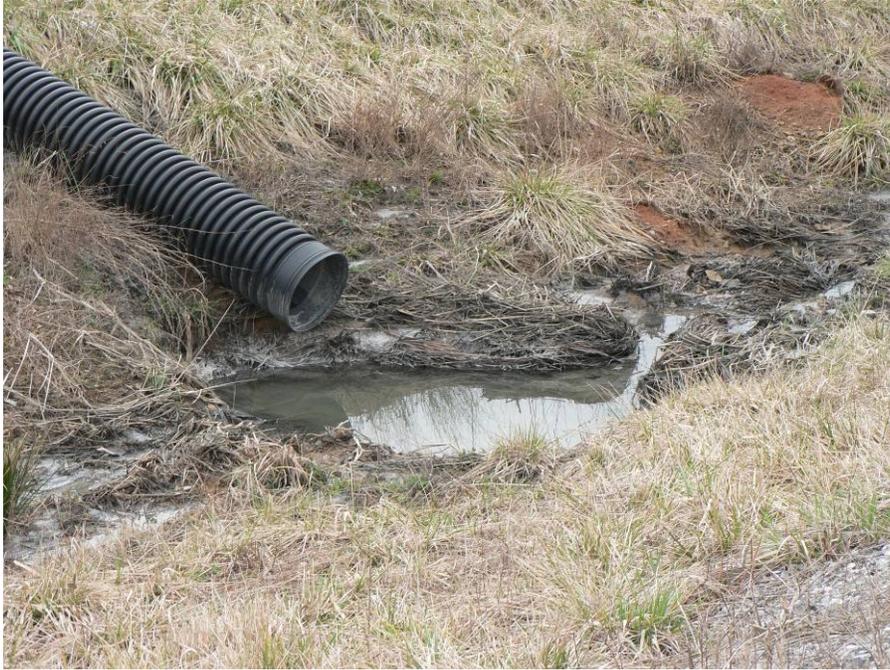
Drawing Mark DS-7

Erosion pool below outlet pipe on the east side of Phase I area of dry stack.
