## TVA Disposal Facility Assessment Phase 1 Plant Summary John Sevier Fossil Plant (JSF)

**TVA Disposal Facility Assessment  
Phase 1 Coal Combustion Product Disposal  
Facility Summary  
John Sevier Fossil Plant (JSF)  
Dry Fly Ash Disposal Area (DFADA)**

Field Assessment Dates: January 16, 2009 and February 23, 2009

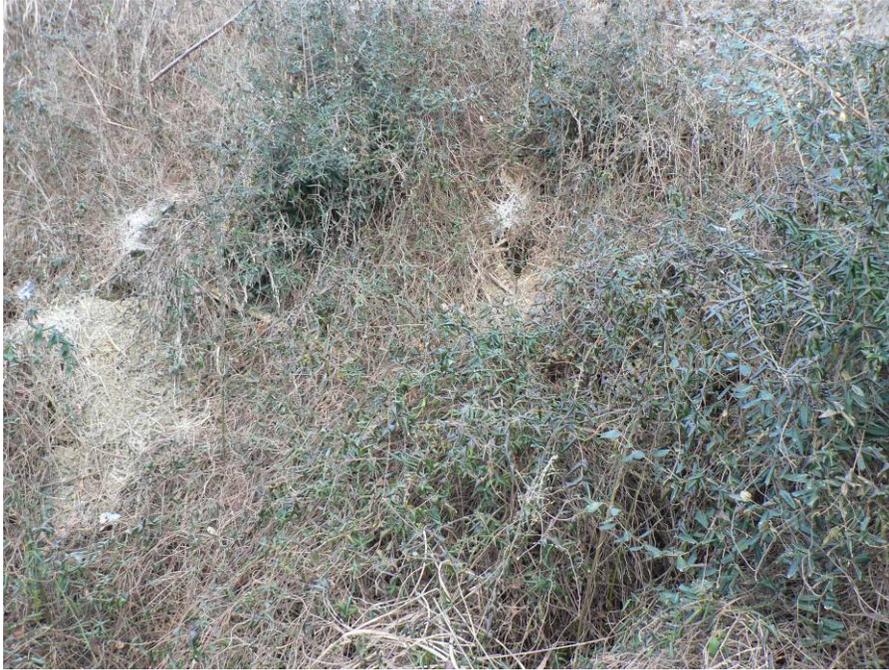
- Several animal burrows were noted in the northeast exterior slope near the ash silos.
- On the north side on the upslope from the Perimeter Road, a dip in the stack grade was noted. This low area had ash in the drainage channel below it and appeared to convey runoff from the exposed ash in the stack to the drainage channel below.

Drawing Mark DS-1-1      Animal burrows (typical) on Dry Ash Disposal Area.

- Repair animal burrows where noted.
- Clean out ash deposited in drainage channels along the Dry Fly Ash Disposal Area and regrade channels to drain towards Sediment Pond West (former Stilling Pond).

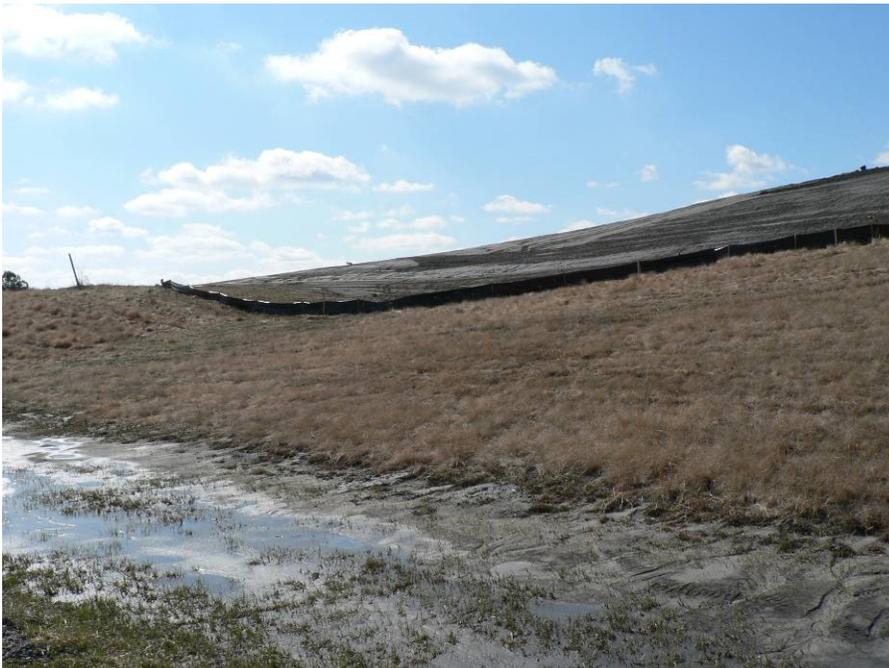
Drawing Mark DS-1-2      Dip in dry stack grade on northeast side of Dry Fly Ash Disposal Area.

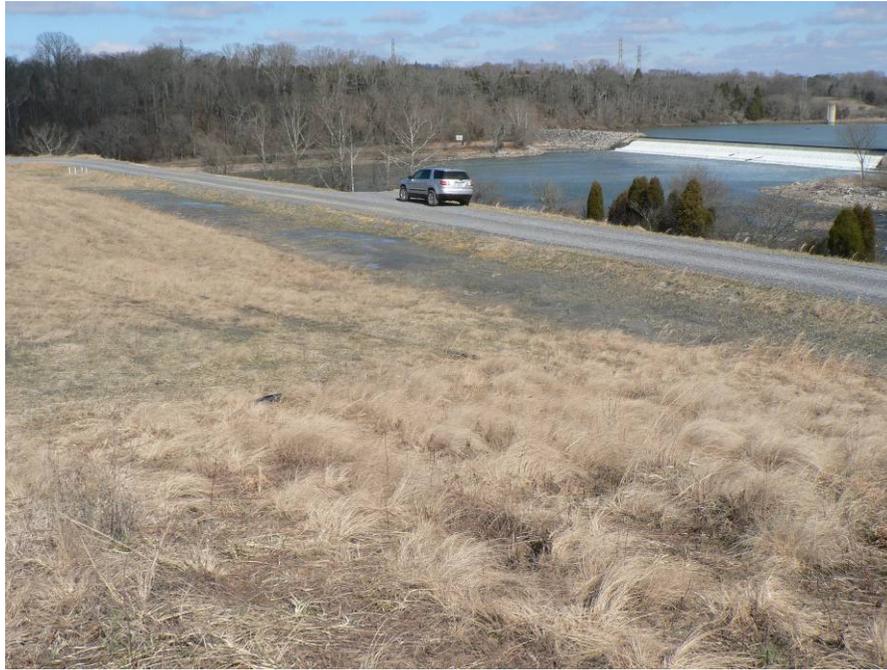
Drawing Mark DS-1-3

- The clay berm that surrounds the exposed ash at the top of the stack has failed in several places due to heavy rains in January 2009. The resulting failure deposited ash into the drainage channel below. Standing water and ash deposits were observed in the drainage channel along the perimeter road.

Drainage channel along perimeter road with standing water and ash deposits.

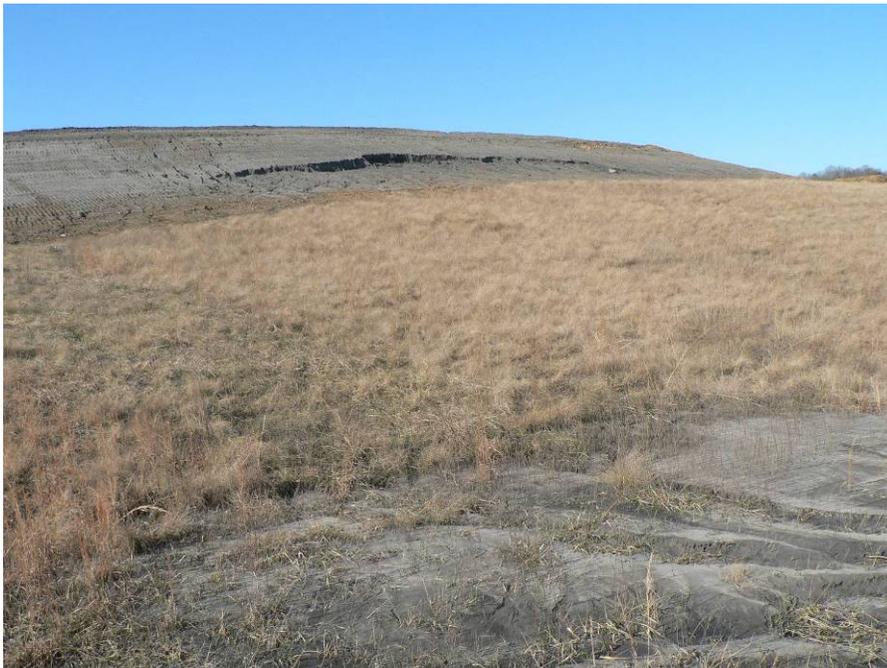
Drawing Mark DS-1-4

Slump in exposed ash situated on east side at the top of ash stack.

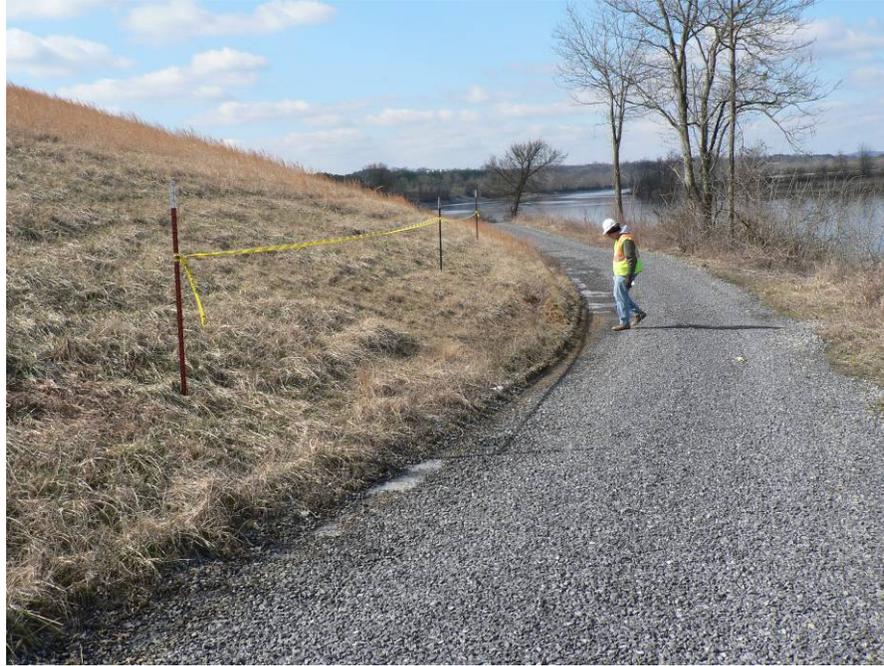
- Wetness is observed along the access road in several places, most notably in the northeast corner in the area of the 2007 slough. Ponding water was noticed under the gravel in the road. Recent wet conditions at the site may be contributing to this.

Drawing Mark DS-1-5 Wet area on access road near northeast corner of Dry Fly Ash Disposal Area.

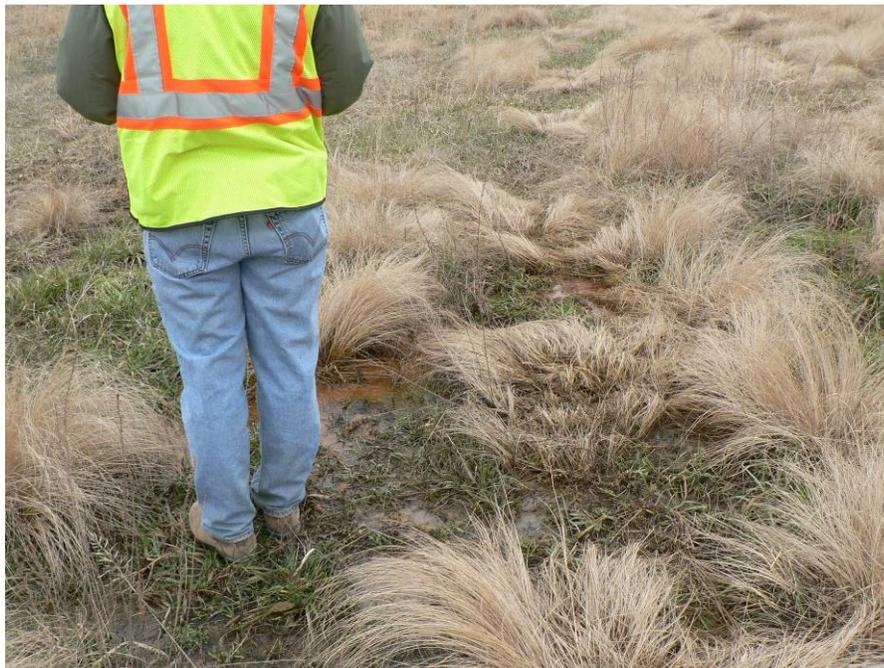
- The red water seep noted above was observed approximately 240 feet west of the northeast riprap channel on the slope between the ash berm and the perimeter road. The red seep area measured 9 feet by 10 feet and a small flow was observed in 3-4 separate areas. This seep area is located almost directly above the wet area on the access road on the slope below.

Drawing Mark DS-1-6 Red water seep on slope above perimeter road in northeast corner of Dry Fly Ash Disposal Area.

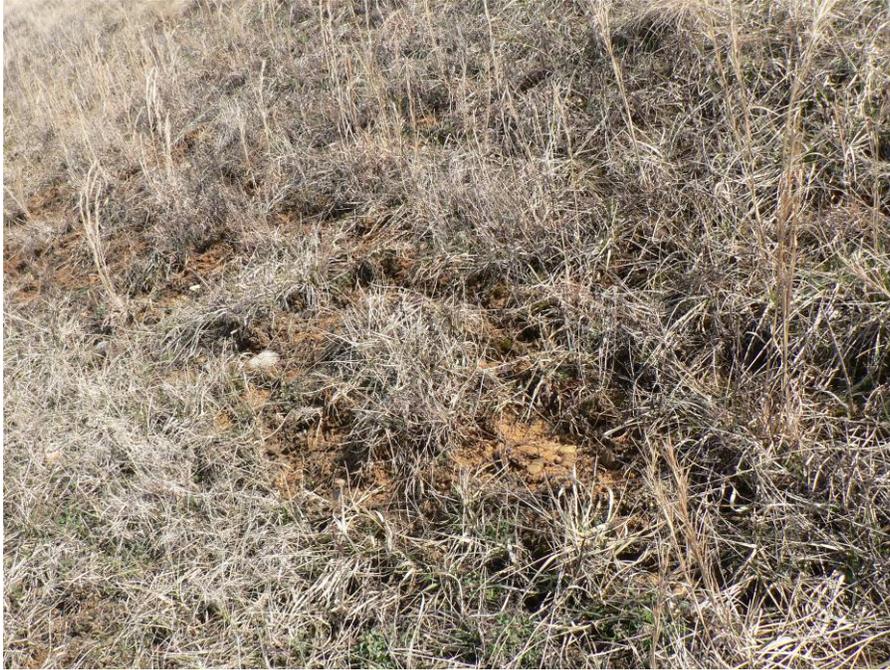
Drawing Mark DS-1-7

- A wet area and possible seep was located between the two sump pumps on the north slope. Standing water was noted upslope from the west most pump and soggy soils extended approximately 300 feet east to the other pump. Loose, soggy soils were also noted near the eastern pump around the rusted standpipe. This area has had some seepage issues in the past due to presence of old clay pipes and should be monitored.

Wet area, possible seep, between leachate collection pumps.

- Continue to monitor noted seeps and wet areas for change of conditions.
- Continue mowing program on slopes but avoid leaving deep ruts from mowing on side slopes.

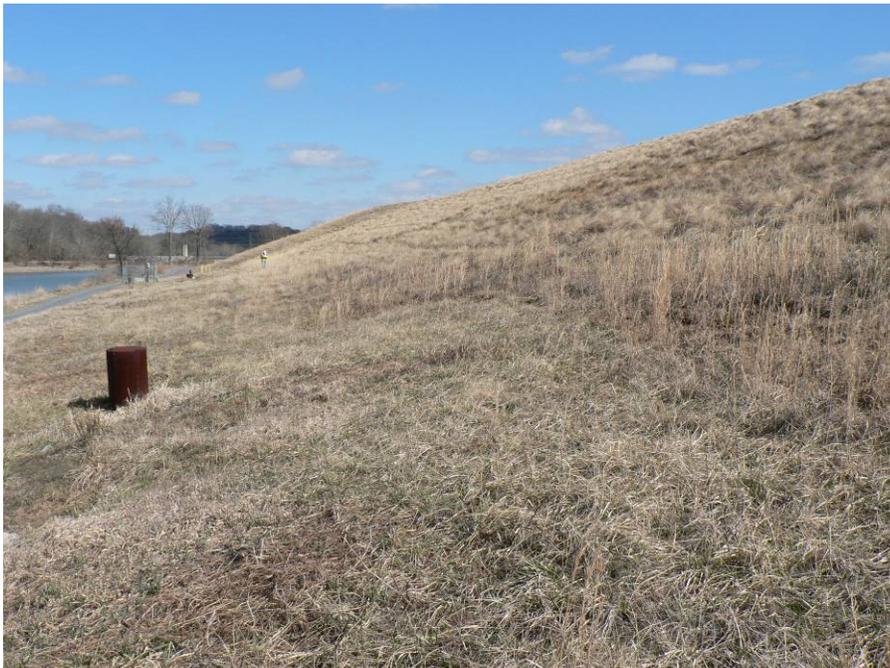
Hillside between two ground water relief pumps in vicinity of wet areas on the lower lift of the embankment.

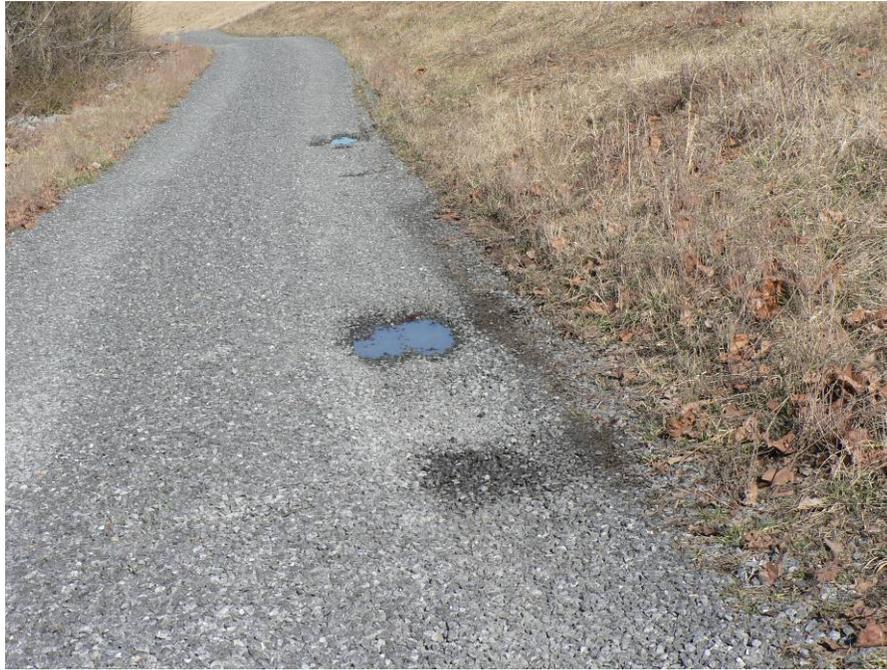
Drawing Mark DS-1-9 Localized wet areas on access road.

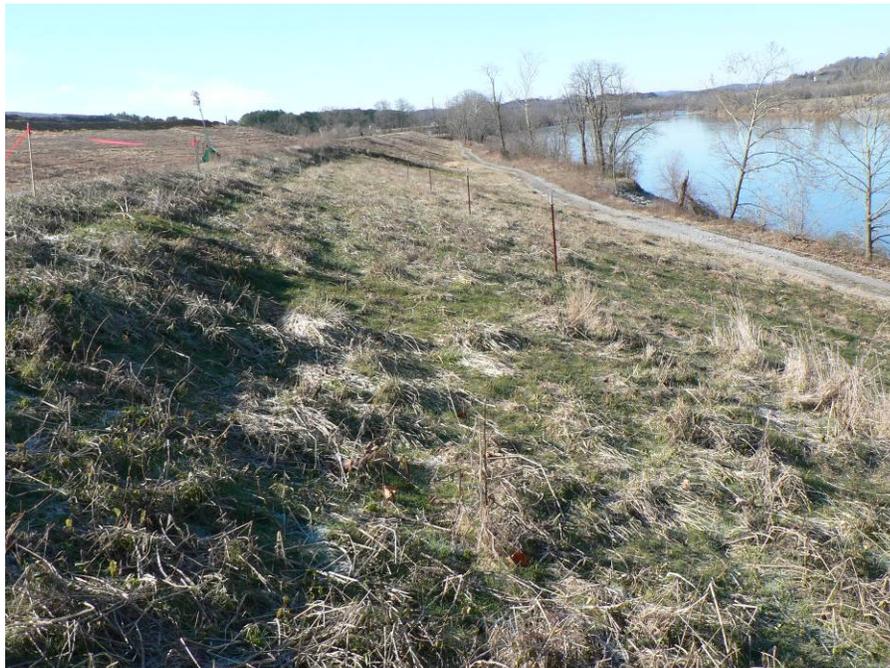
- An apparent slumped area along perimeter road measuring approximately 400 feet long.
- A raised area was observed starting at the east end of the slide noted above. The raised area was approximately 2 feet above the neighboring ground, 18 feet wide and extending the entire slope between the perimeter road and the access road.

Drawing Mark DS-1-10 Vegetated apparent slope slump just downslope of perimeter road.

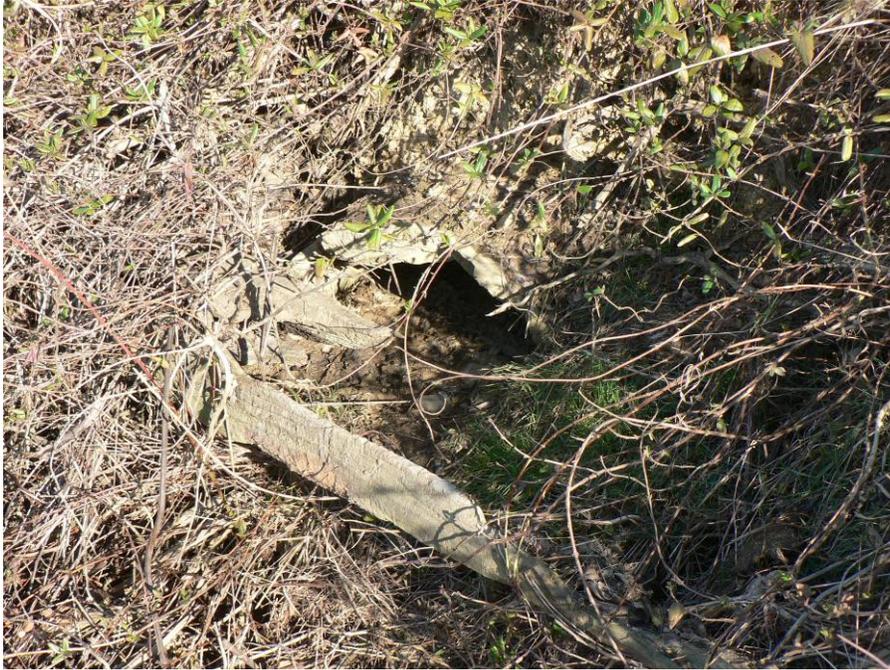
- A 24 inch concrete pipe was observed in the slope between the access road and the perimeter road, just east of the noted raised area in the slope. This appears to be the former spillway outlet pipe from Area F. Pipe was cracked and half filled with silt. Wetness was noted in the vicinity of this pipe. A concrete riser structure was noted upslope of this pipe on the next bench and they are believed to be connected. It is unknown how this pipe was abandoned or if it is still active.

Drawing Mark DS-1-11 24 inch CMP located in north slope near raised area.

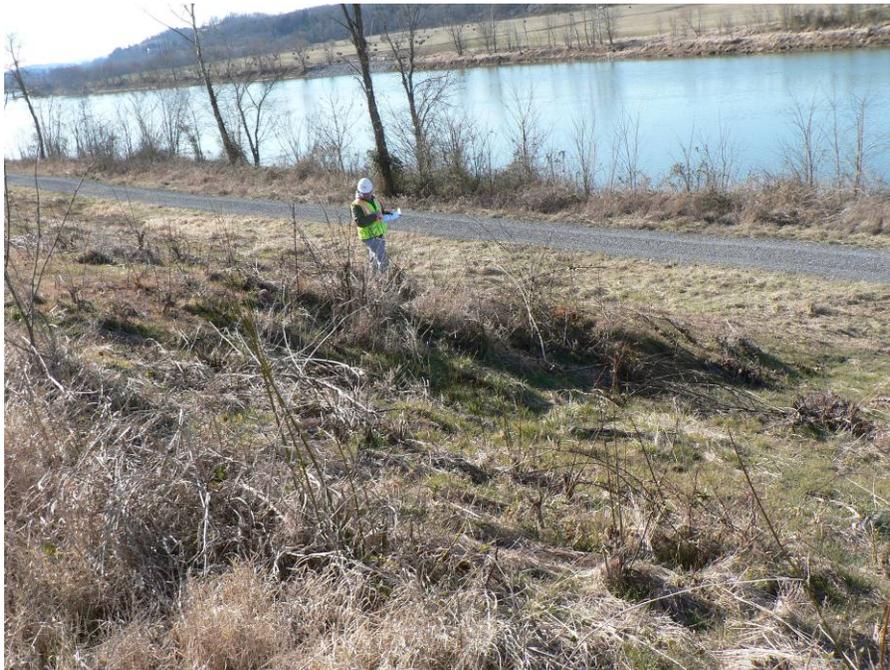
Drawing Mark DS-1-12 Raised area on slope west of apparent slope slump.

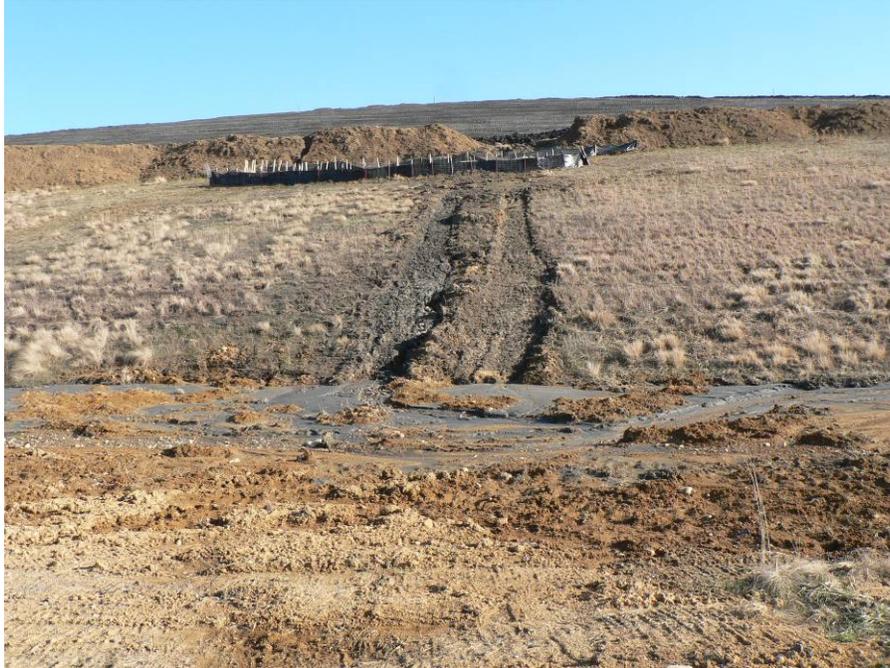
Drawing Mark DS-1-13 Clay berm opening on top of reclaimed slope on north side of dry stack area.

- Provide temporary vegetation or widen clay berm in areas of ponding water to eliminate further release of ash into the drainage channel in the Dry Fly Ash Disposal Area. Monitor clay berm during and after heavy rainfalls for potential signs of failure.

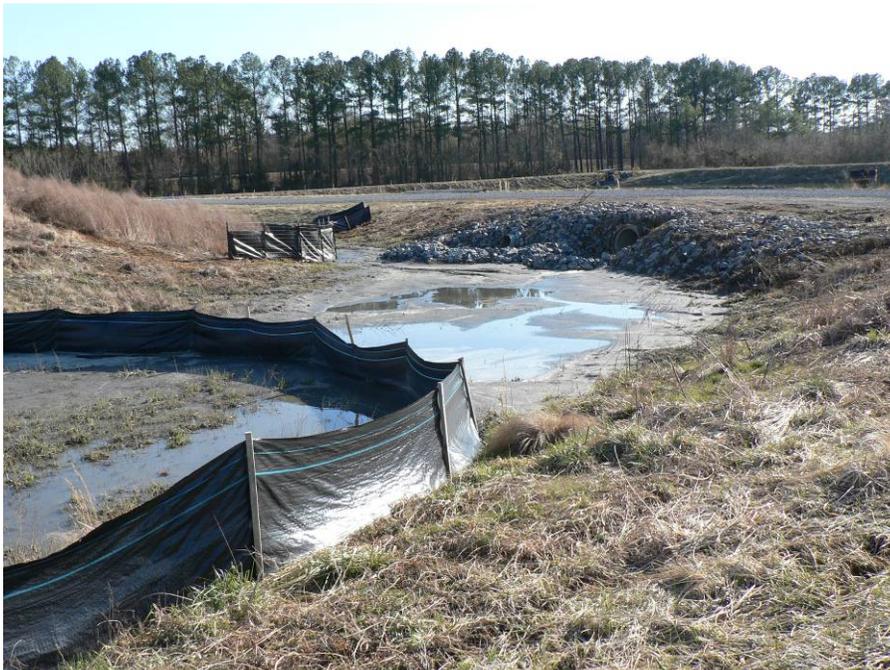
Drawing Mark DS-1-14 Ash in drainage channel near inlet to stilling basin at northwest corner of dry stack area.

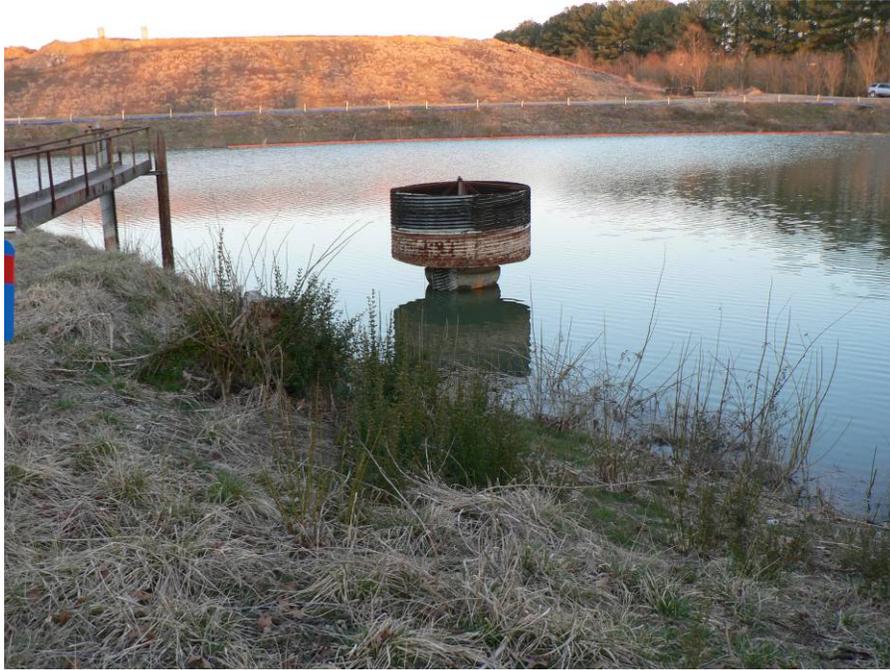
Drawing Mark P-W-1 South riser structure on west side of Sediment Pond West.

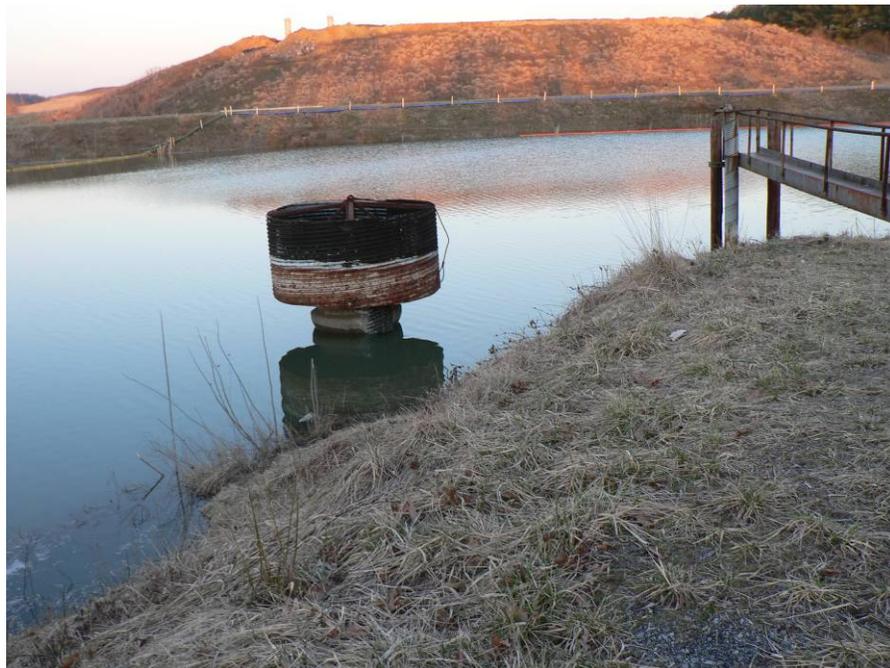
Drawing Mark P-W-2 North riser structure on west side of Sediment Pond West.

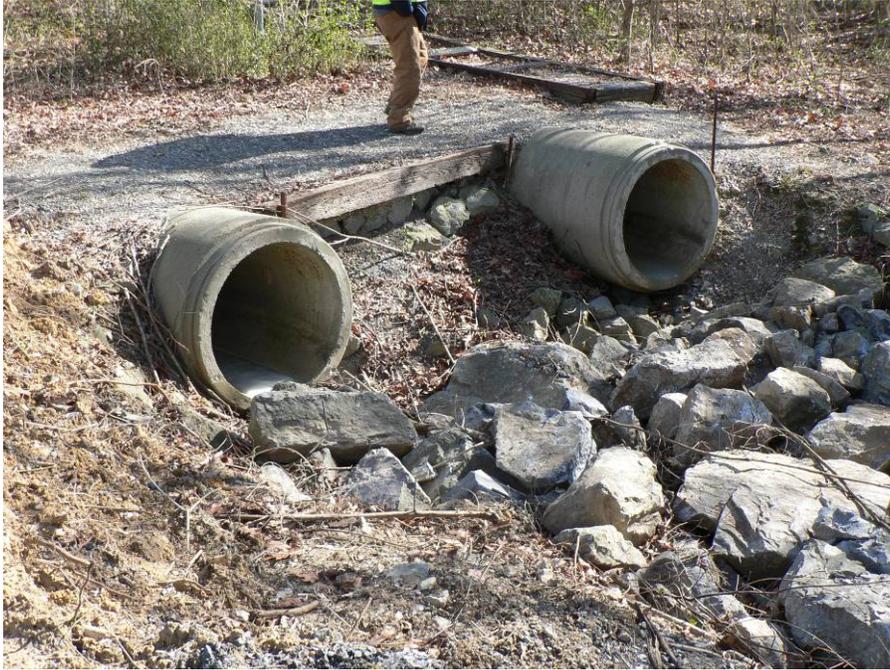
Drawing Mark P-W-3 Outlet pipes from the spillways of Sediment Pond West.

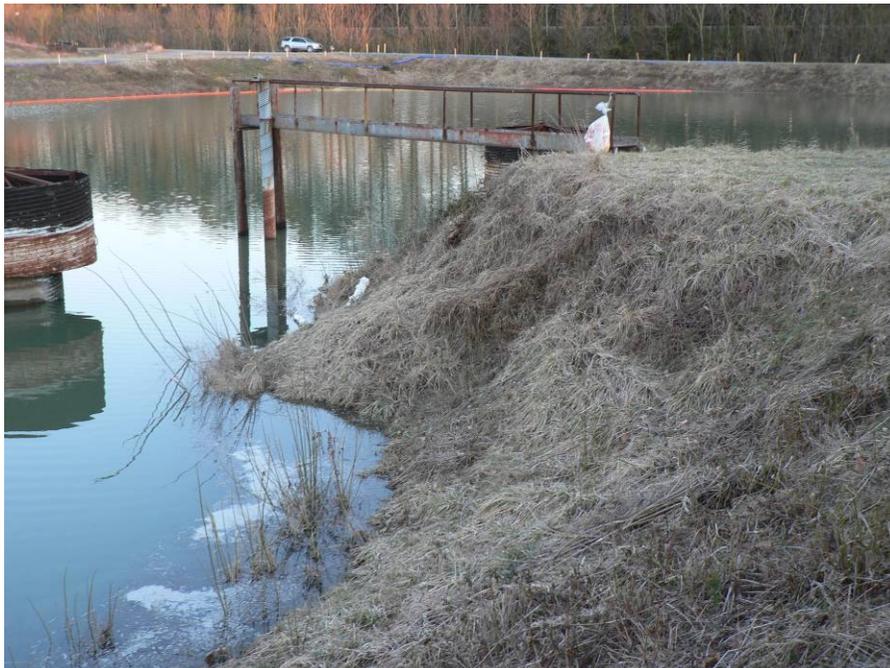
Drawing Mark P-W-4 Slump in interior bank of dike near spillways of sediment pond.

- Repair erosion and sloughed areas where noted on interior slopes of ponds. Any slope steeper than 3H:1V should be lined with rip-rap to help reduce future erosion.
- Continue to monitor areas of past seeps and wet areas for change of conditions.
- Locate the two 36 inch concrete pipes that could not be field verified.
- Monitor concrete spillway risers and joints and repair as needed. This spillway may ultimately be modified or replaced, pending Stantec-TVA assessment.

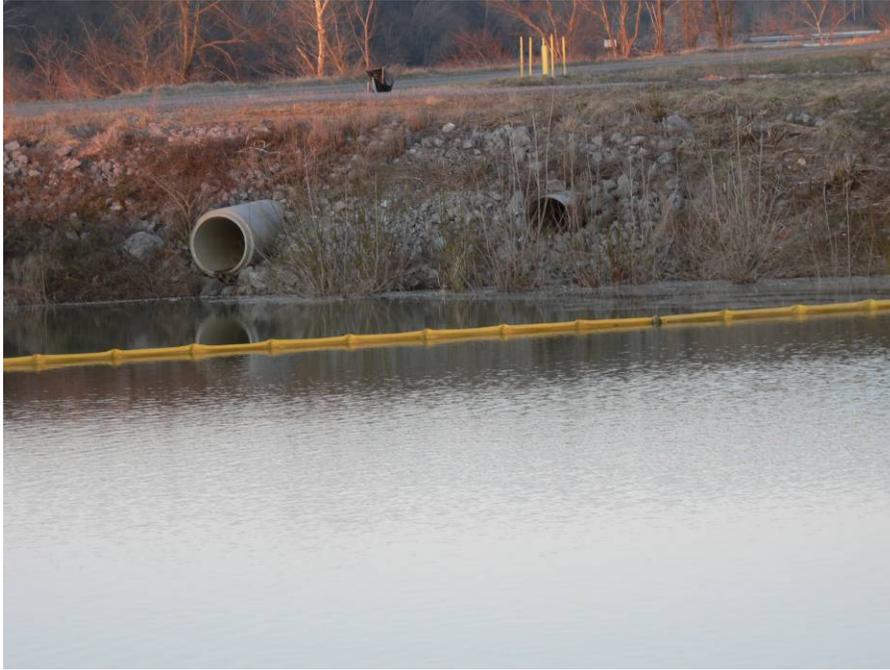
Drawing Mark P-W-5

Inlet pipes from drainage from dry stack area.

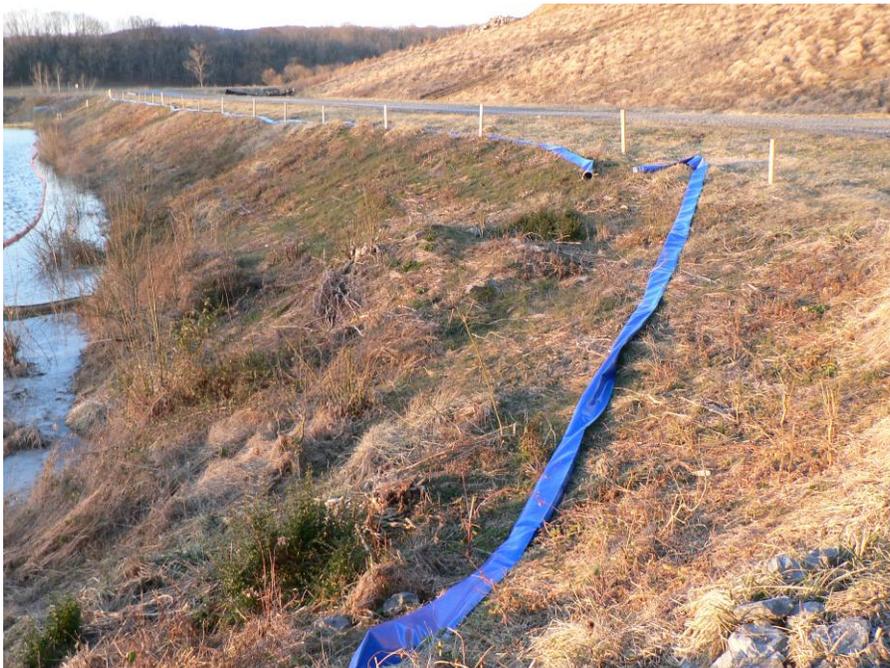
Drawing Mark P-W-6

Irregular terrain and possible slump at southeast corner.

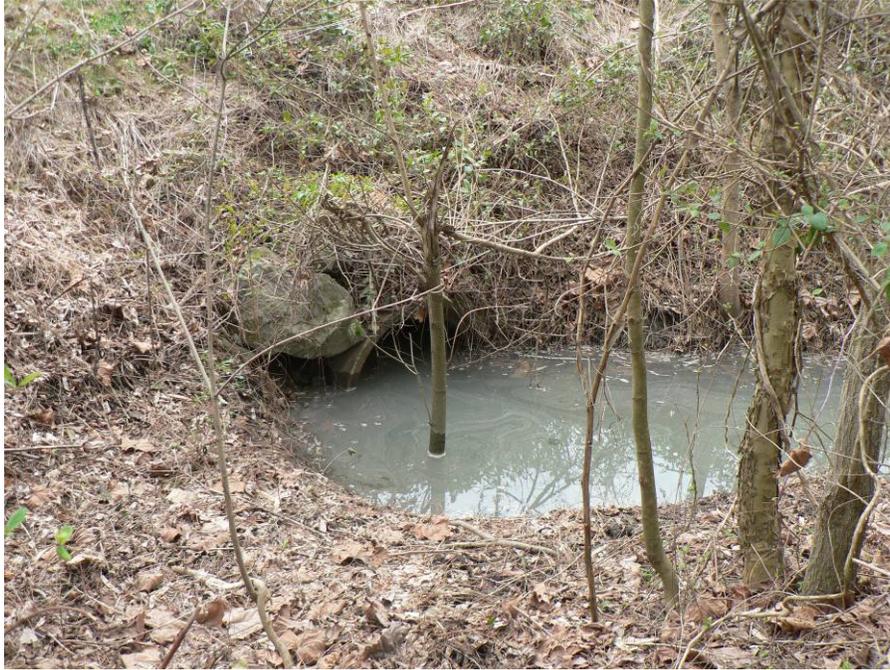
Drawing Mark P-W-7

36 inch Concrete drainage pipe near road.  
(Only 1 of 3 pipes located during field  
assessment).

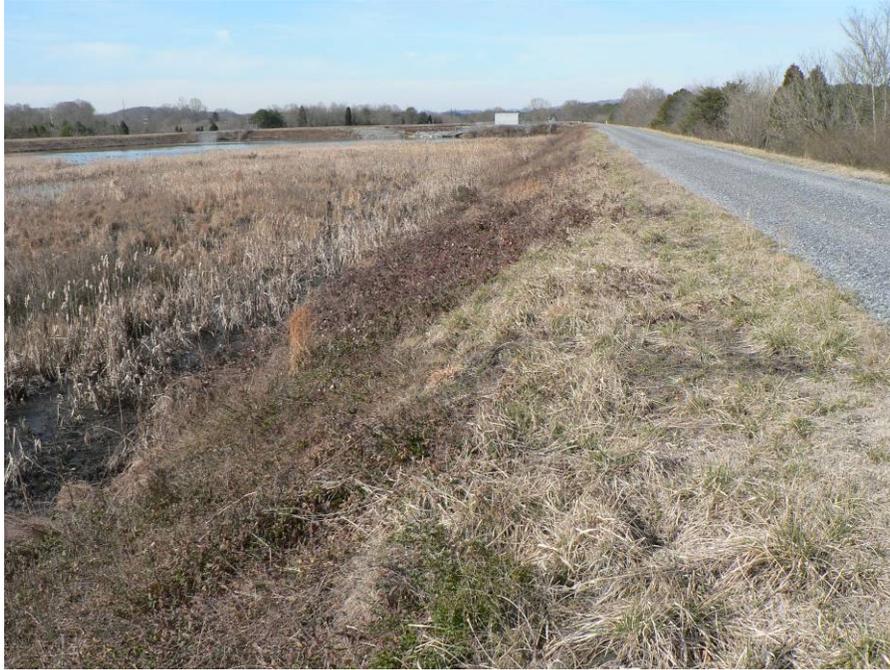
Drawing Mark BAD-2-1

Irregular slopes along interior slope of north dike of ash pond.

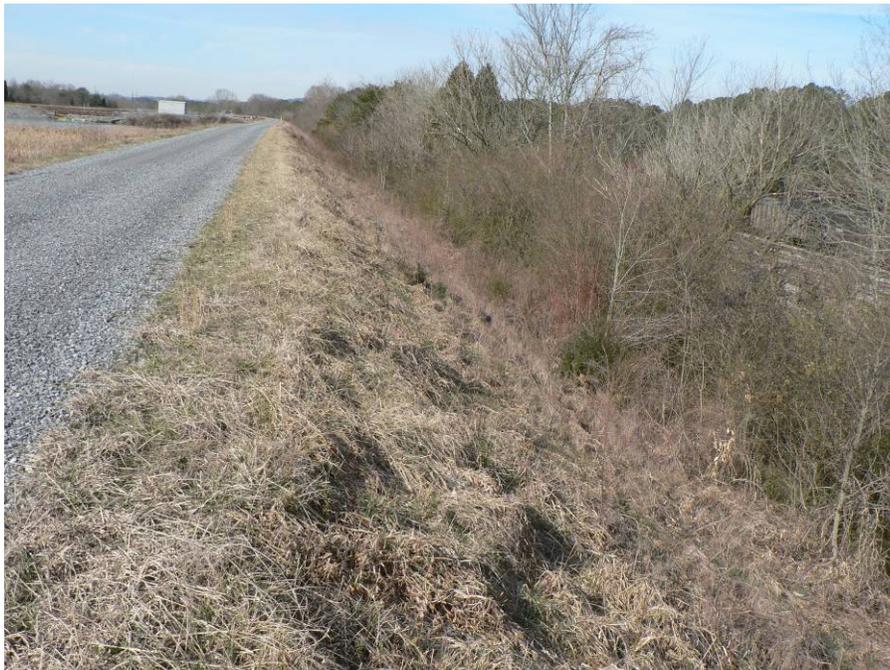
Drawing Mark BAD-2-2

- Steep exterior slopes were noted on the north side of the disposal area. These slopes are steeper than 2H:1V.
- Trees and heavy growth were observed on the north side exterior slopes.

Irregular steep exterior slopes of dike on north side of ash pond with trees and brush.

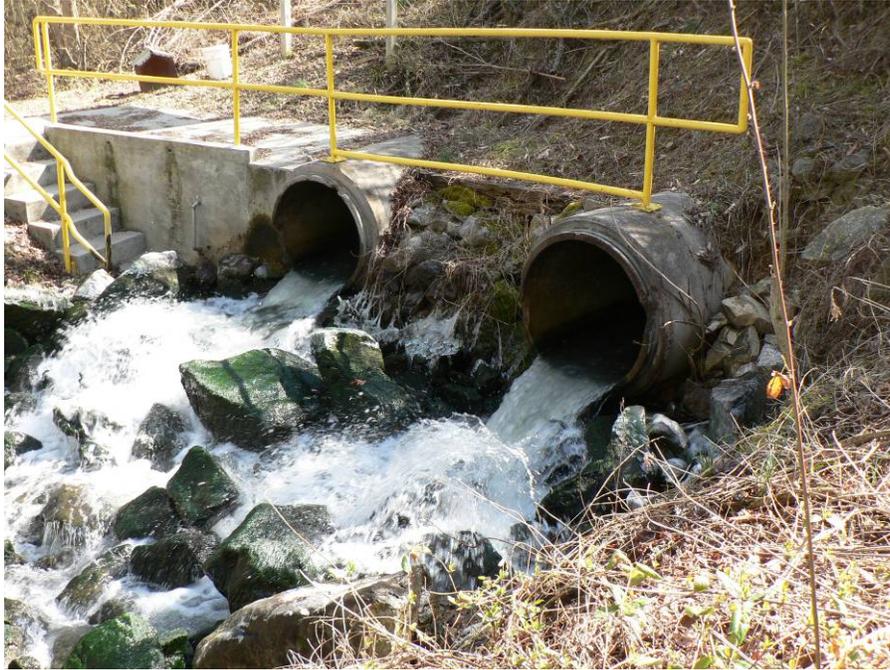
Drawing Mark BAD-2-3

Outlet pipes from riser structures of Bottom Ash Disposal Area 2.

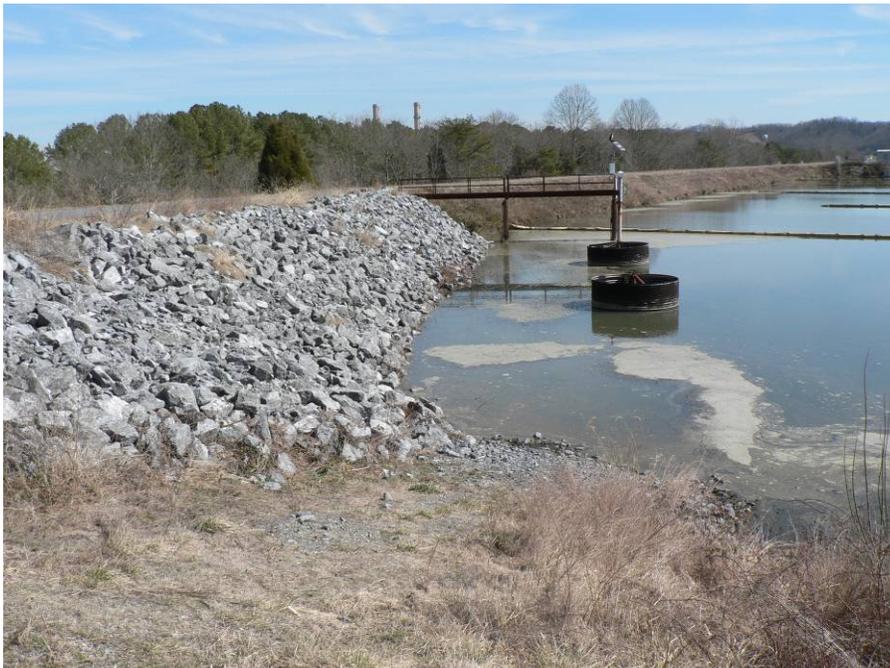
Drawing Mark BAD-2-4

Outlet riser structure in Stilling Pond.

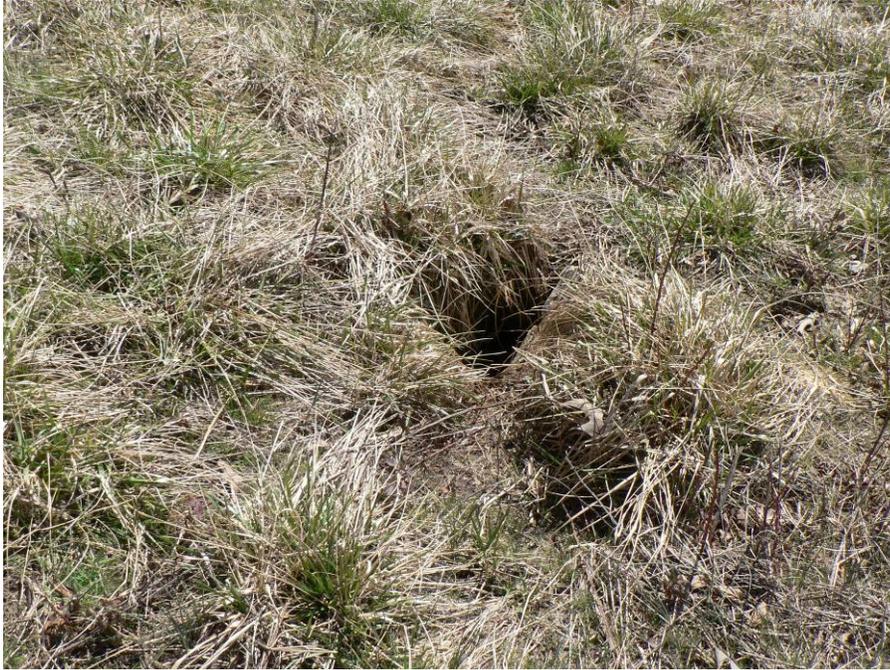
Drawing Mark BAD-2-5

- Numerous animal burrows were observed in the south exterior slope.
- Tire ruts with wetness in the depressions are observed along south exterior bench.

Animal burrows observed in south exterior slope.

- Repair animal burrows where noted.
- Repair erosion and sloughed areas where noted on interior slopes of ponds. Line interior pond slopes with rip-rap to help reduce future erosion.
- Monitor north exterior slope of Bottom Ash Disposal Area 2 for fallen trees. Remove fallen trees and repair areas by compacting earthfill and seeding over disturbed earth.
- Repair erosion areas of internal ash dike in Bottom Ash Disposal Area 2 and provide vegetative cover and/or rip rap protection along the east side of the dike along the ash channel.
- Continue mowing program on slopes but avoid leaving deep ruts from mowing on side slopes. Mow and remove brush from interior slopes of the Bottom Ash Pond and Stilling Pond.
- Continue to monitor noted seeps and wet areas for change of conditions.

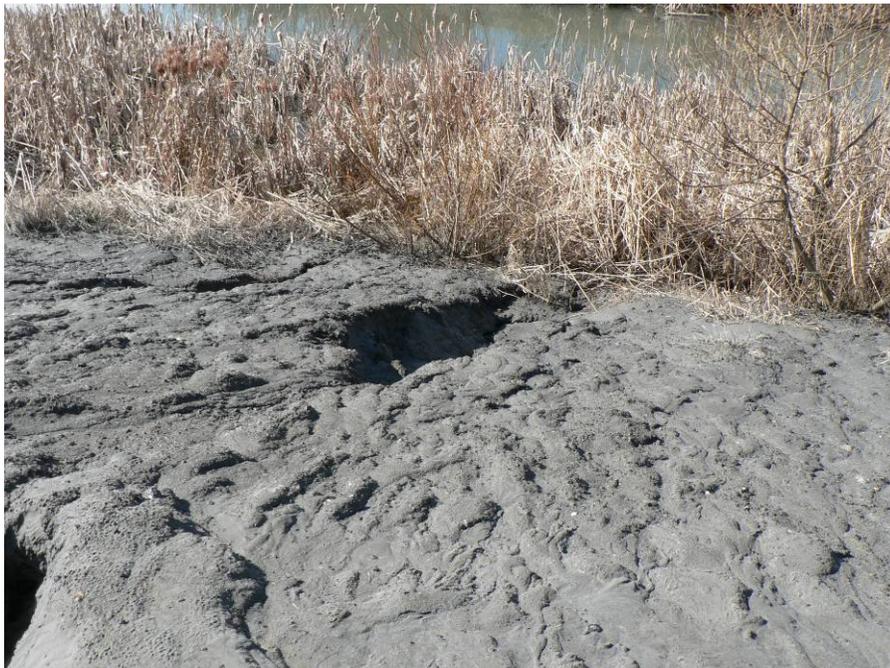
Drawing Mark BAD-2-6

Erosion on interior dike at dredge storage area and pond.

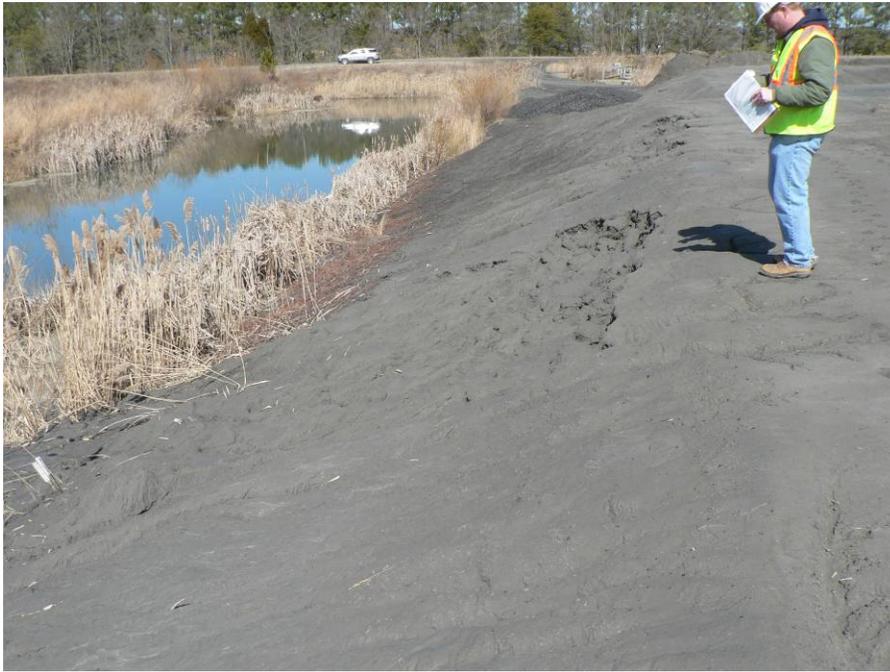
Drawing Mark BAD-2-7

Slump and erosion on interior dike of ash pond and dredged storage area.

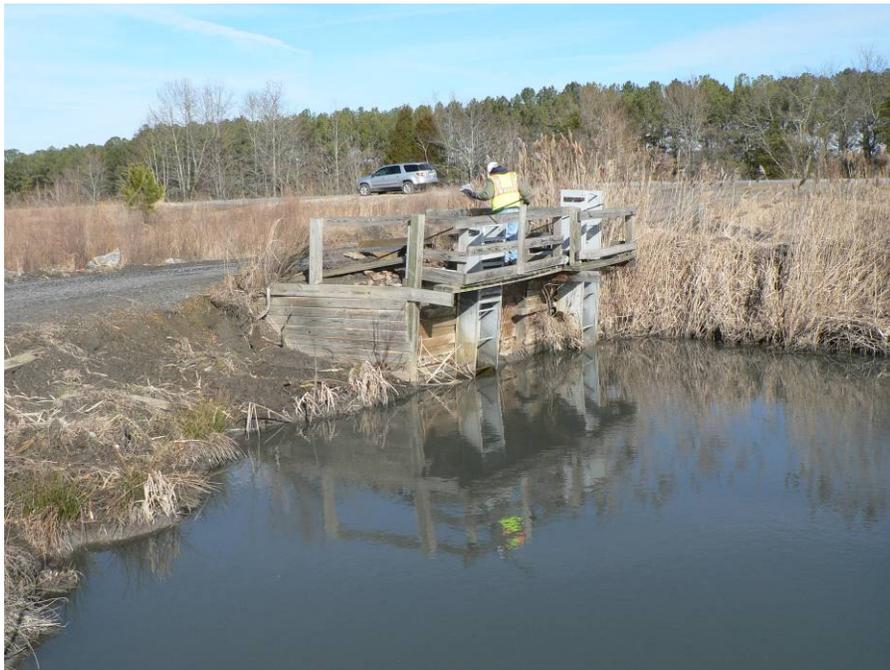
Drawing Mark BAD-2-8

Riser structure between Bottom Ash Channel and Bottom Ash Pond.

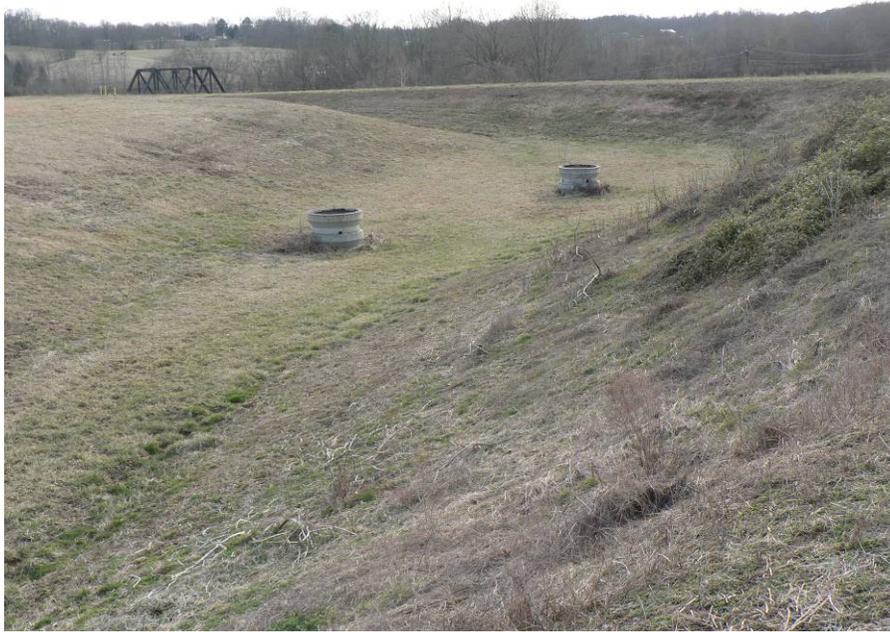
Drawing Mark AD-J-1

Risers within drainage basin at northwest corner of Ash Disposal Area J.

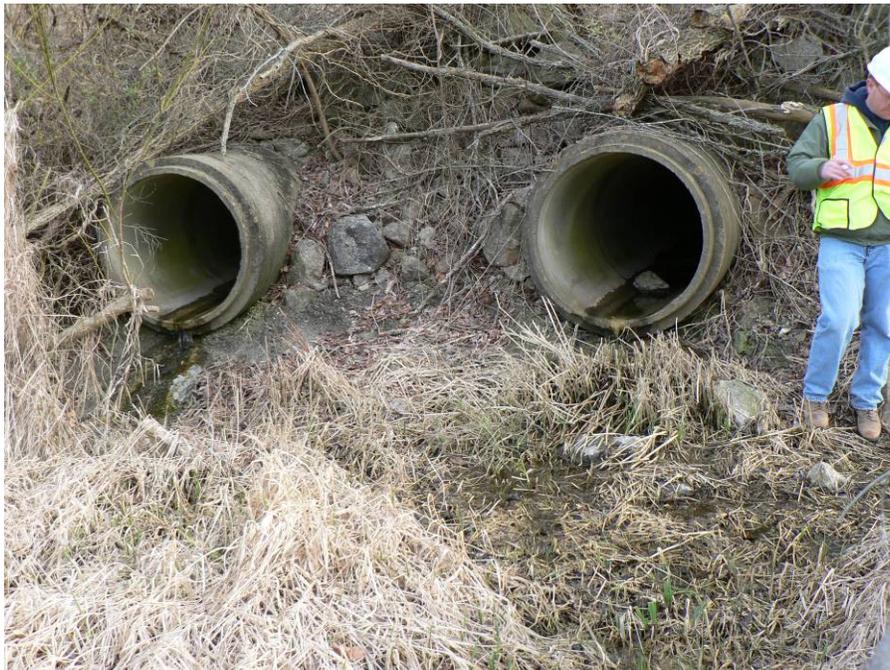
Drawing Mark AD-J-2

Outlet pipes on northwest corner of Ash Disposal Area J with vegetation and irregular topography at its outlet. Note drainage from pipes.

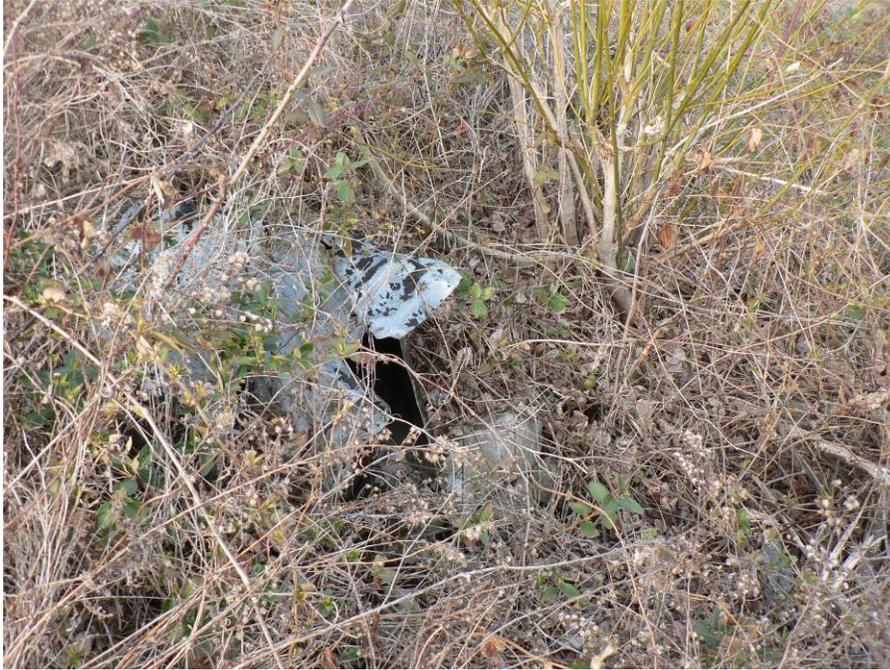
- Drainage pipes are spaced around the disposal area to take runoff from the drainage ditch and discharge it away from the area into the river and drainage channels. Seven of these pipes were observed and majority of pipes had siltation and deterioration of the pipes on upstream and downstream end.

Drawing Mark AD-J-3 Damaged outlet pipe covered by vegetation (typical problem).

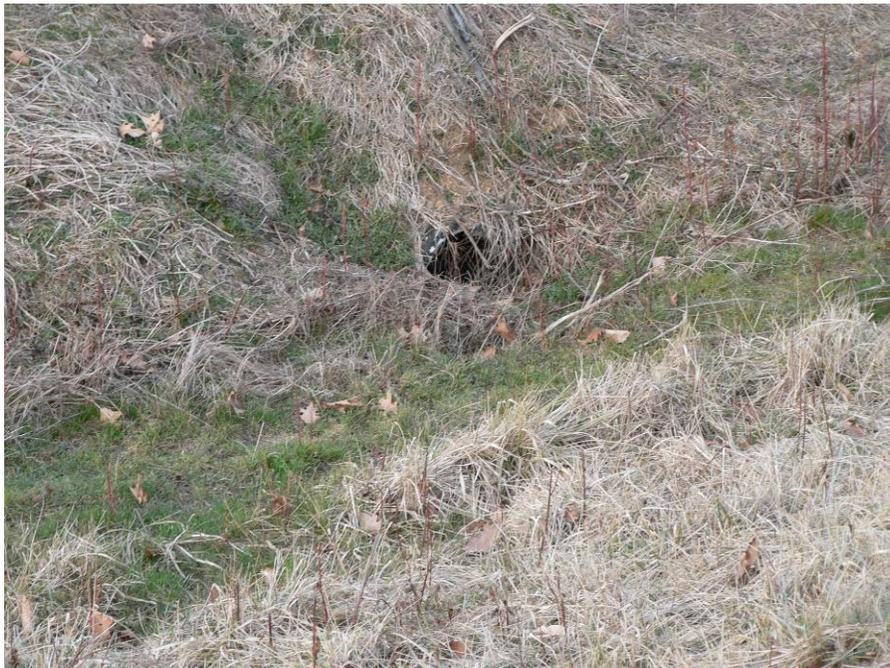
Drawing Mark AD-J-4 Silted inlet pipe within drainage channel (typical problem).

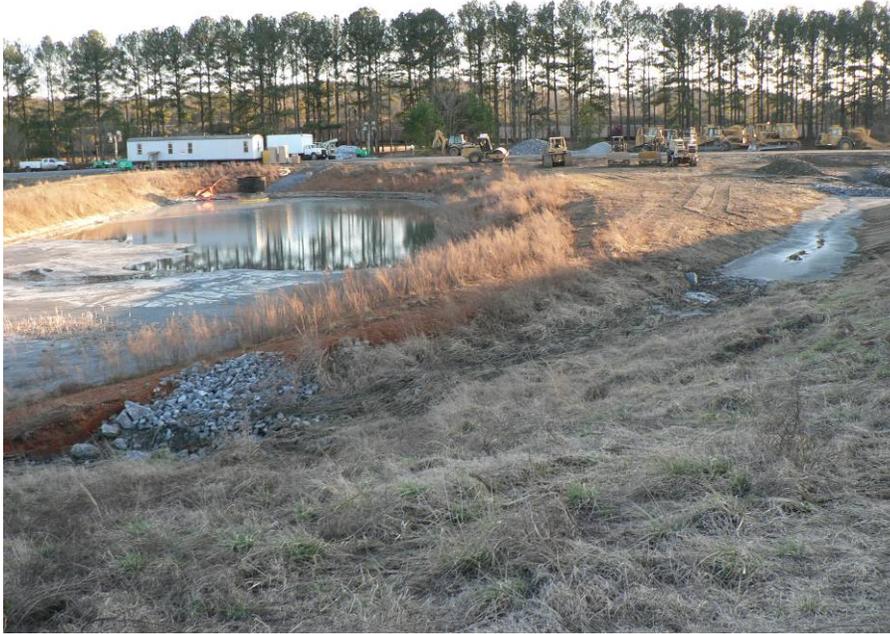
Drawing Mark P-E-1

Western end of sediment pond with inlet end of diversion channel shown.

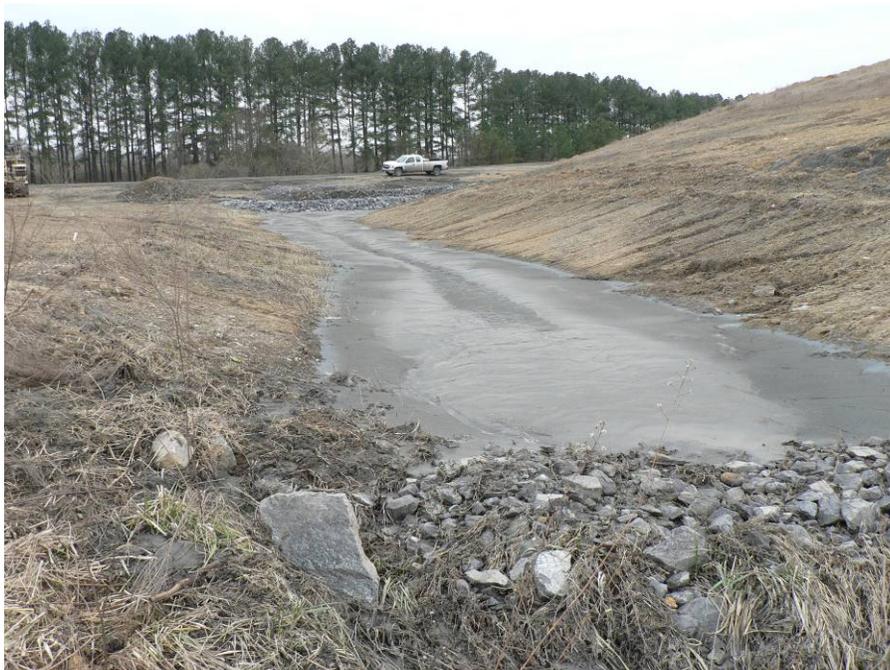
Drawing Mark P-E-2

Inlet drainage channel to sediment pond showing check dams and ash buildup.
