## TVA Disposal Facility Assessment Phase 1 Plant Summary John Sevier Fossil Plant (JSF)

**TVA Disposal Facility Assessment  
Phase 1 Coal Combustion Product Disposal  
Facility Summary  
John Sevier Fossil Plant (JSF)  
Dry Fly Ash Disposal Area (DFADA)**

Field Assessment Dates: January 16, 2009 and February 23, 2009

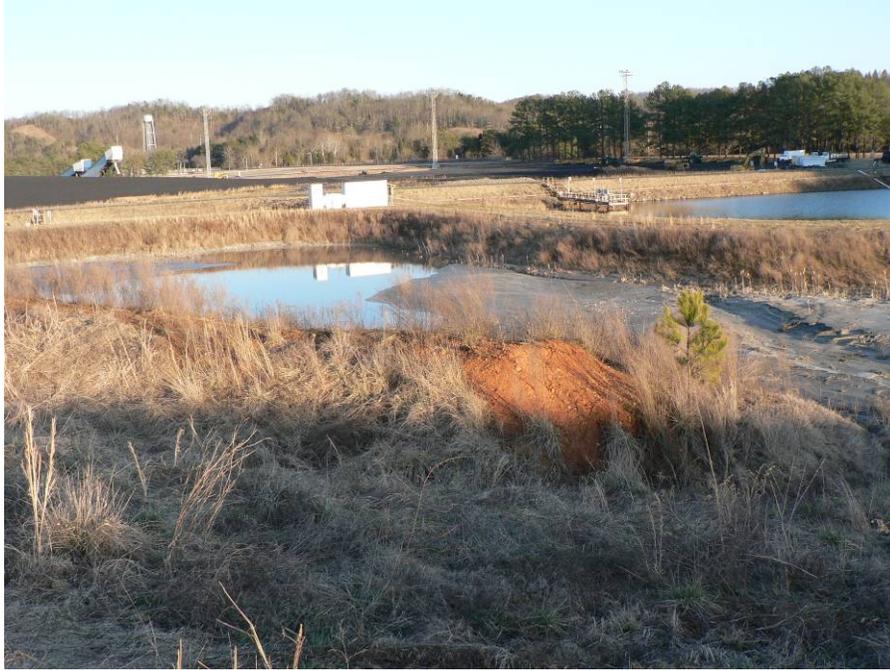
Drawing Mark P-E-3 Northern end of sediment pond.

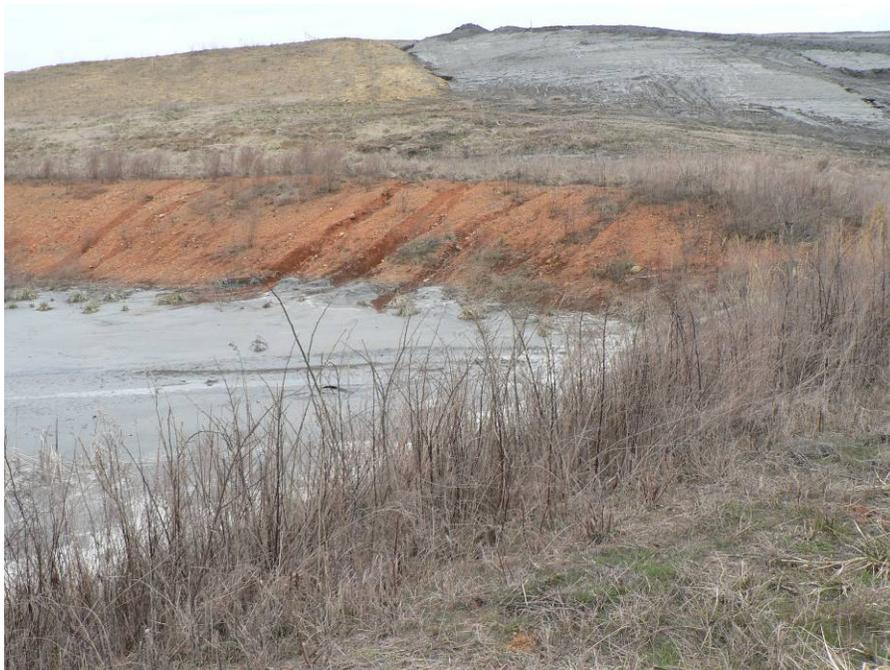
Erosion: Erosion gullies were observed in the north slope (see observations).

Drawing Mark P-E-4 Areas of erosion on north bank of sediment pond.

- Repair erosion and sloughed areas where noted on interior slopes of ponds. Any slope steeper than 3H:1V should be lined with rip-rap to help reduce future erosion.
- Clear drainage channels of excess deposited ash and remove excess ash from sediment pond to improve capacity.
- Establish vegetative growth on the north and west interior banks to reduce erosion.
- Monitor concrete spillway risers and joints and repair as needed. This spillway may ultimately be modified or replaced, pending Stantec-TVA assessment.

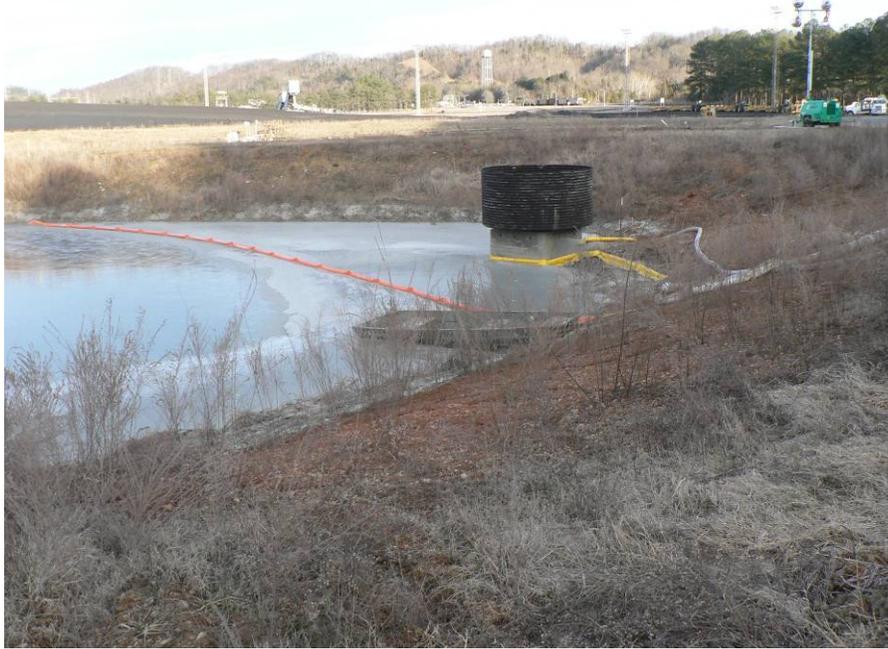
Drawing Mark P-E-5

Outlet riser on southern portion of sediment pond.
