TVA Disposal Facility Assessment Phase 1 Plant Summary Johnsonville Fossil Plant (JOF)

TVA Disposal Facility Assessment Phase 1b Byproduct Disposal Facility Summary Johnsonville Fossil Plant (JOF)

**TVA Disposal Facility Assessment
Phase 1 Coal Combustion Product Disposal
Facility Summary
Johnsonville Fossil Plant (JOF)
Active Ash Disposal Areas 2 & 3 (AADA 2&3)**

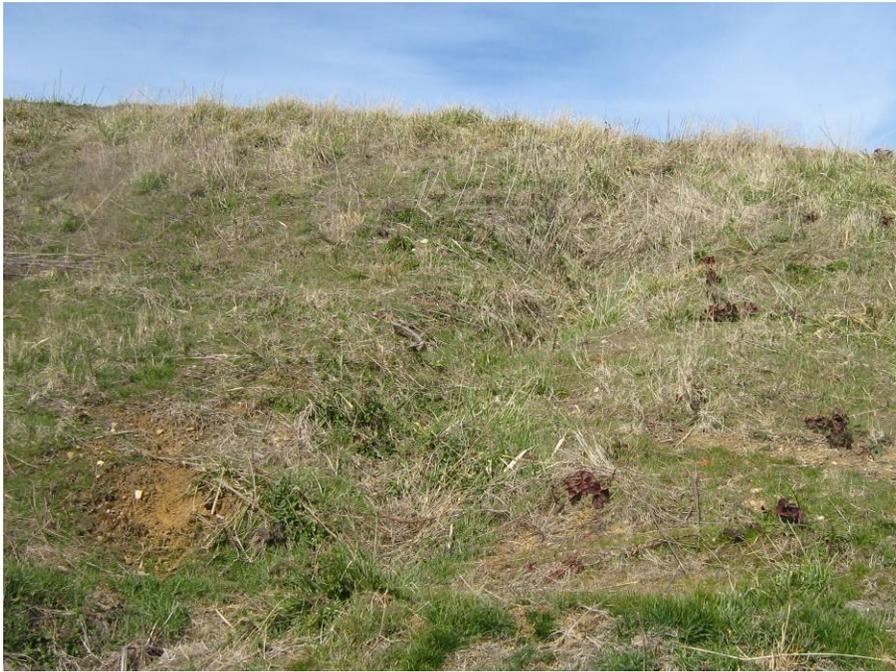
Drawing Mark AP-2&3-1 Erosion rill along exterior perimeter dike slope (Typ.).

- Cut and maintain heavy, tall phragmites growth on interior slopes of ponds to allow better observation.
- The plant should continue best management practice of repairing areas of erosion, animal burrows, depressions, etc. and covering and seeding exposed areas within the Active Ash Disposal Areas 2 & 3. The areas should continue to be monitored and repairs made as conditions warrant.

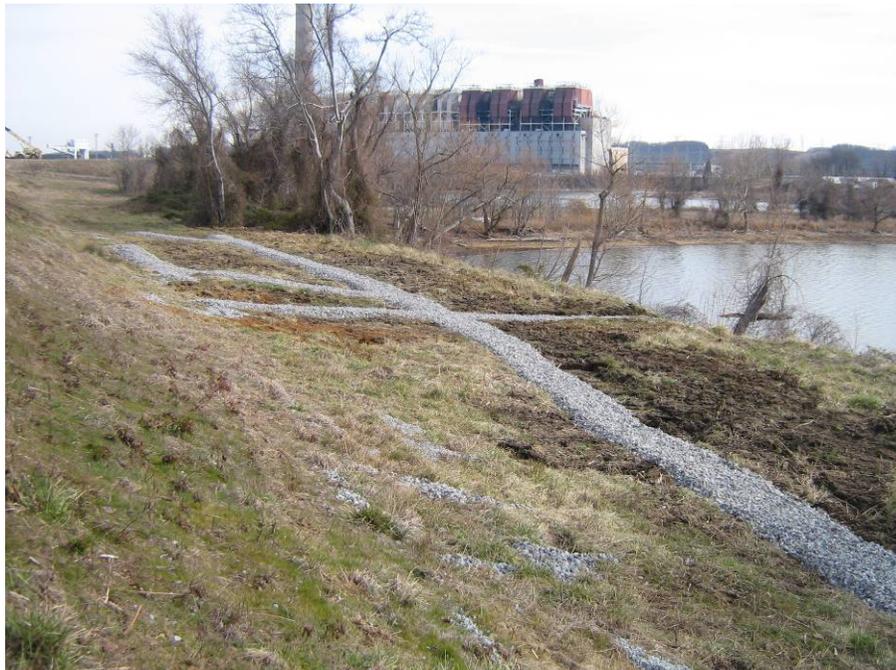
Drawing Mark AP-2&3-2 Seepage collection system on southeast perimeter dike.

- The seepage observed along the toe of the perimeter dike at the east side of Ash Disposal Area 2 & 3 should continue to be monitored. A seepage monitoring point should be installed similar to the collection system installed on the toe of the southeast dike.

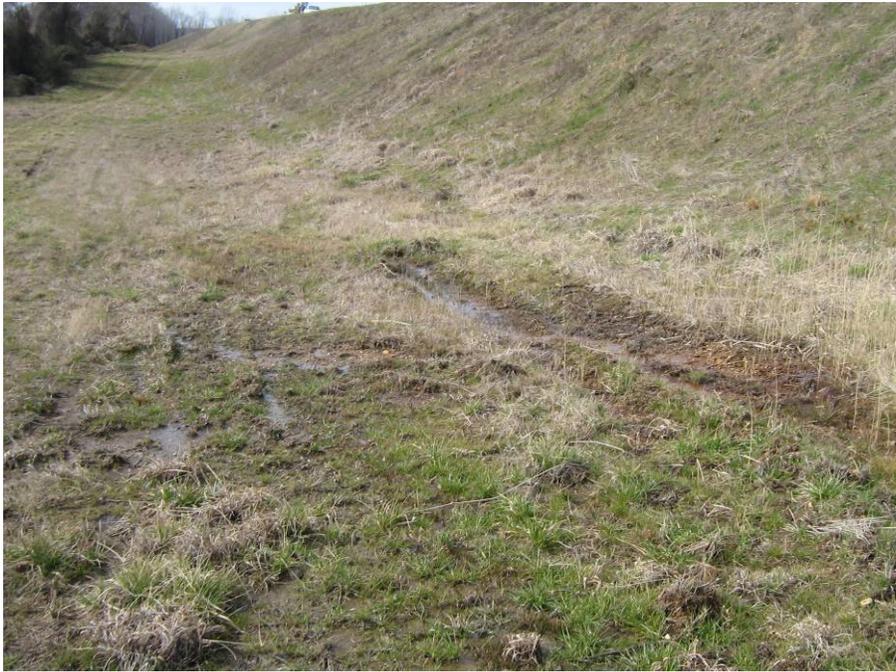
Drawing Mark AP-2&3-3 Standing water/seepage along southeast perimeter dike toe.

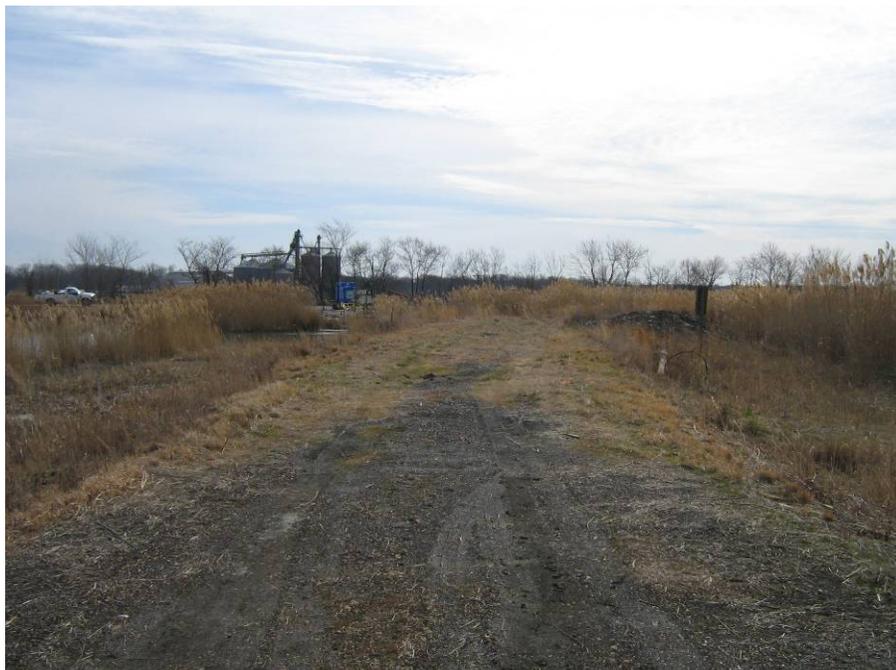
Drawing Mark AP-2&3-4 Heavy growth and phragmites along interior divider dike (Typ.).

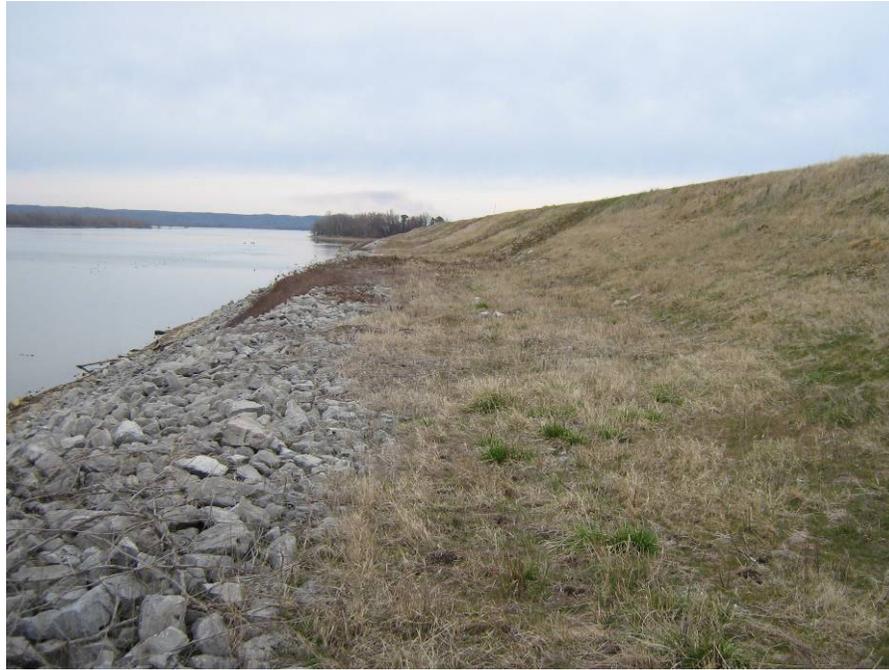
Drawing Mark AP-2&3-5 Bench and lower rip rap slope along northwest perimeter dike.

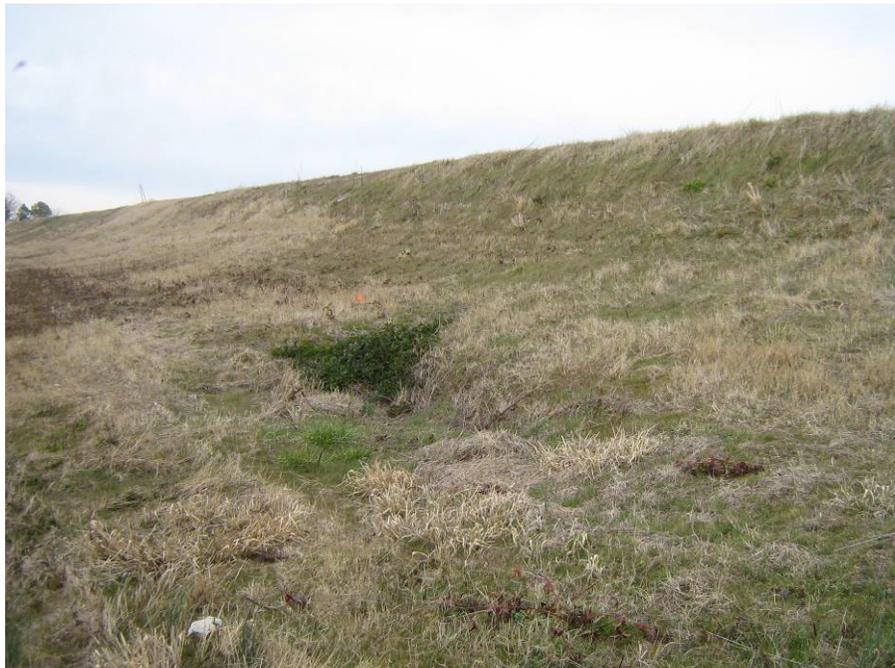
- Animal burrows were noted along the perimeter dike faces in several areas. The animal burrows are abundant and have been reported for several years.
- Shallow depressions were observed in several areas on the perimeter dike outer slope along the west side. These depressions have been observed for several years and could be attributed to tree removal.

Drawing Mark AP-2&3-6 Depression along exterior slope at northwest dike (Typ.).

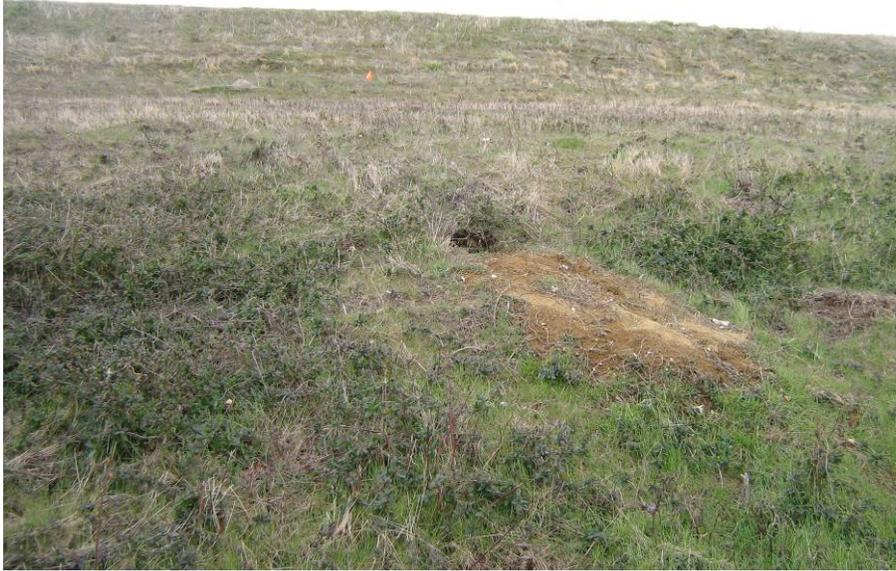
Drawing Mark AP-2&3-7 Animal burrow (Typ.).

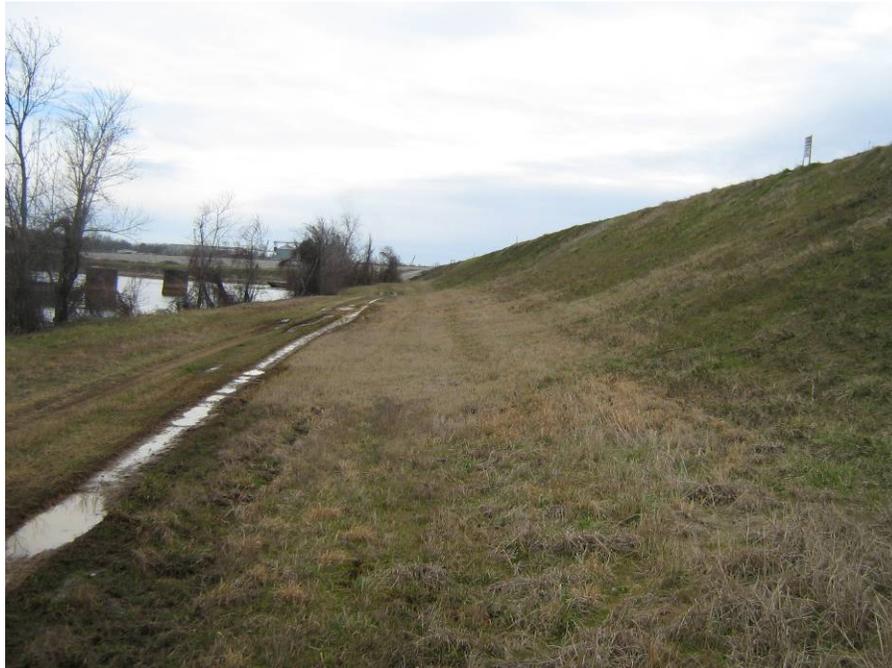
- Some rutting was observed along the toe of the east perimeter dike. The rutting was previously reported in annual inspections and is likely due to traffic within the seepage areas in this area.

Drawing Mark AP-2&3-8 Standing water/seepage and rutting along toe of northeast dike (Typ.).

- The seepage observed along the toe of the perimeter dike at the northeast side of Ash Disposal Area 2 should continue to be monitored. A seepage monitoring point consisting of a collection system and weir box or similar structure should be installed.

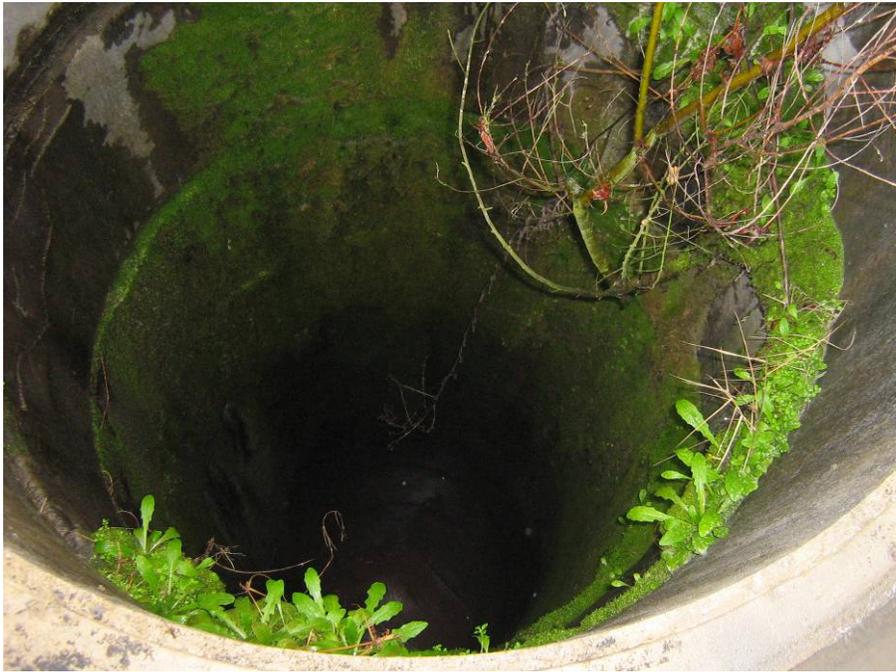
Drawing Mark AP-2&3-9 Southeast weir taken out of service (Typ.).

- It is recommended that the abandoned weir structures within Active Ash Disposal Areas 2 & 3 be evaluated and a plan prepared to properly close these structures.

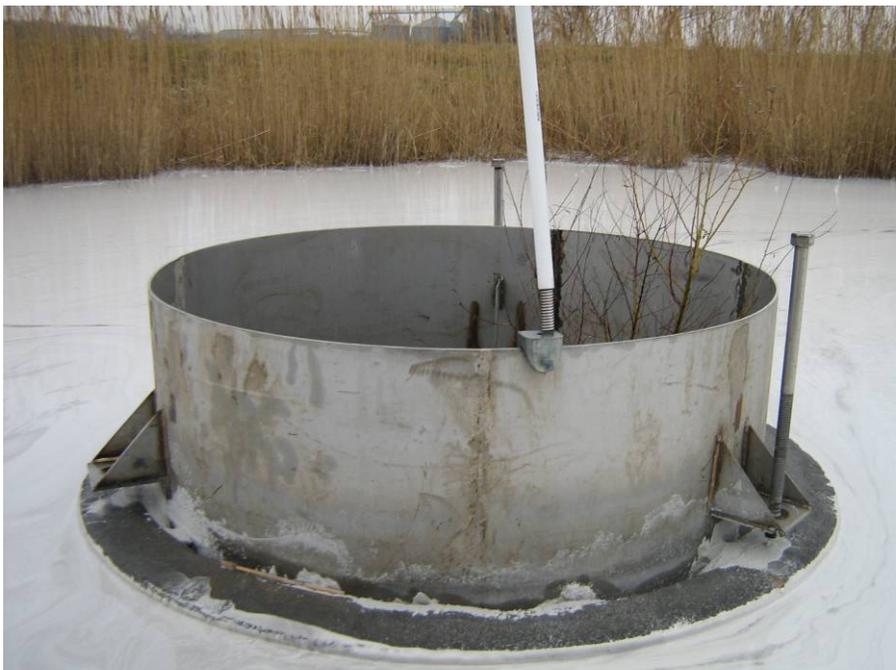
Drawing Mark AP-2&3-10 Raised weir at southeast set of spillways (Typ.).

- A plan is currently being prepared to lower the pool in Active Ash Disposal Areas 2 & 3 to allow for installation of a new spillway structure. Routine repairs and monitoring of the spillway systems should be continued until replacement is complete. Once the new spillway is in place, a plan should be prepared for proper closure of the old RCP stacked riser spillways.

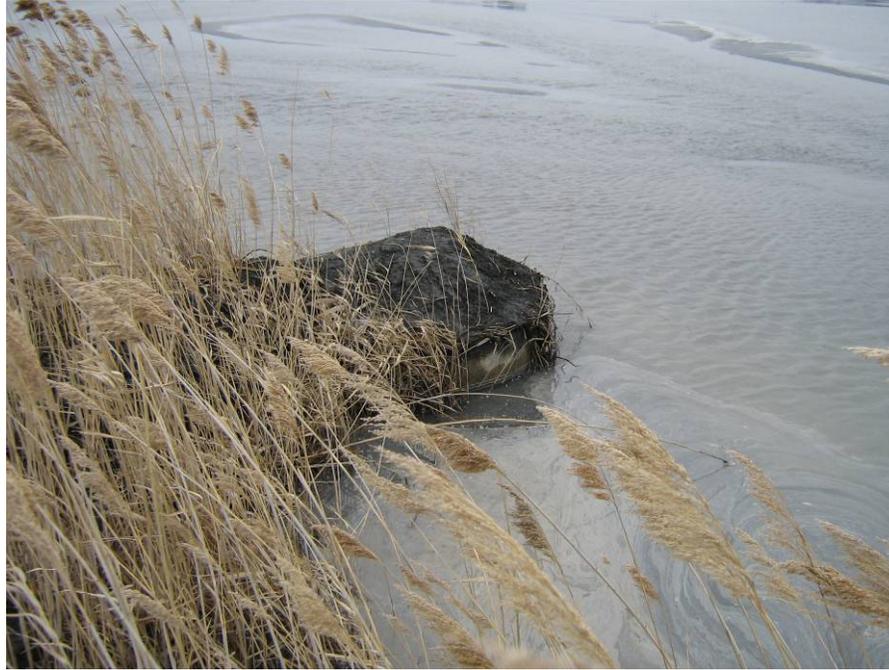
Drawing Mark AP-2&3-11 Abandoned weir along northwest set of spillways (Typ.).

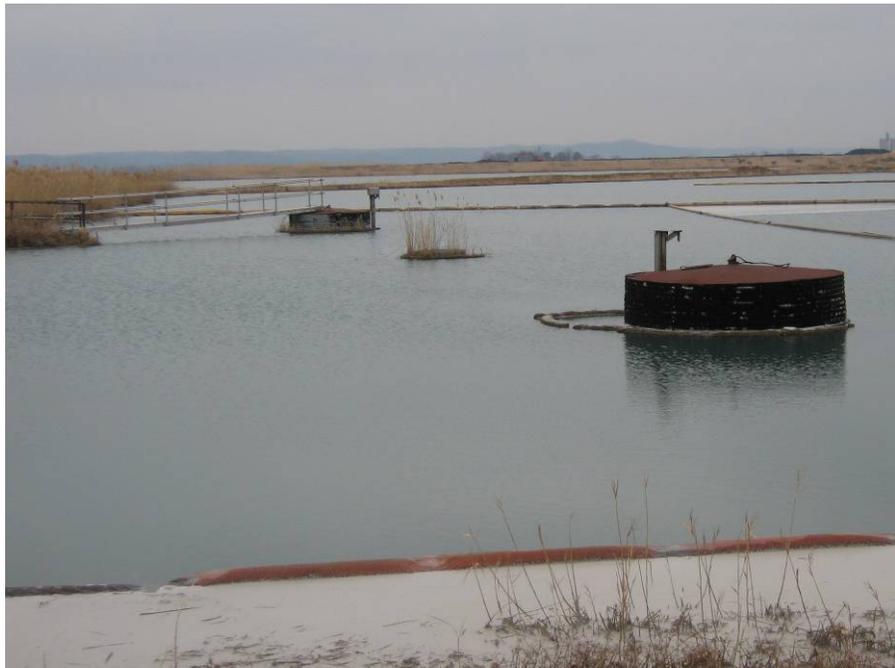
Drawing Mark AP-2&3-12 Active spillways along southwest side of pond.

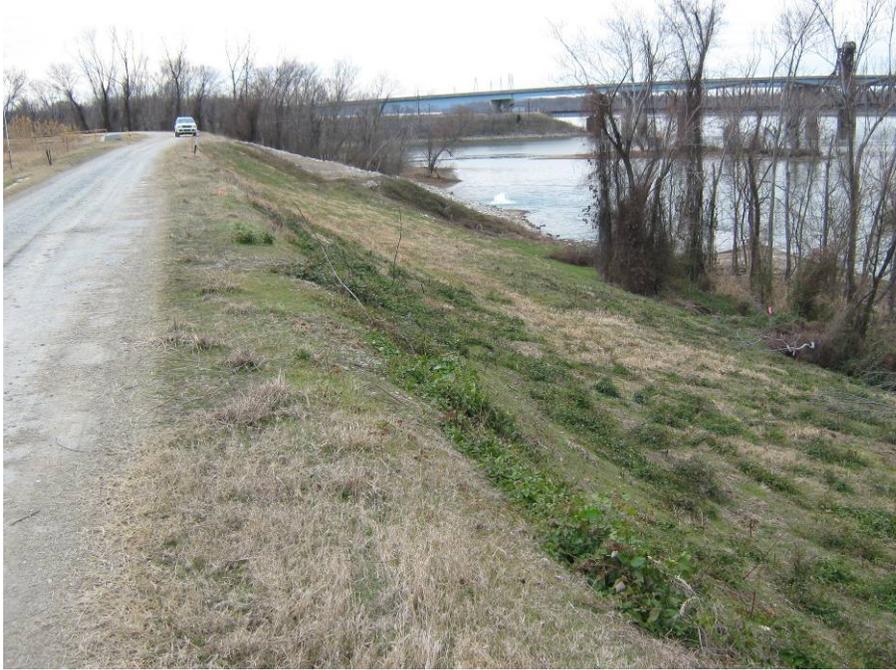
- Trees are located along the toe of the perimeter dike slopes along the southwest and southeast portions of the pond. The trees are beginning to infringe upon the toe in these areas. In addition, briars are beginning to re-establish along the toe and outer slopes of the pond in these areas.
- Previous inspection reports appear adequate, but there is a trend of not all maintenance recommendations being executed.

Drawing Mark AP-2&3-13 Trees along toe of southwest dike (Typ.), note surging discharge pipe.

- Remove trees from noted locations at Ash Disposal Areas 2 & 3 and repair slopes as needed following tree removal. To minimize damage to the toe and slopes, rip rap should be placed along the slopes once tree removal is complete to protect against wave action.

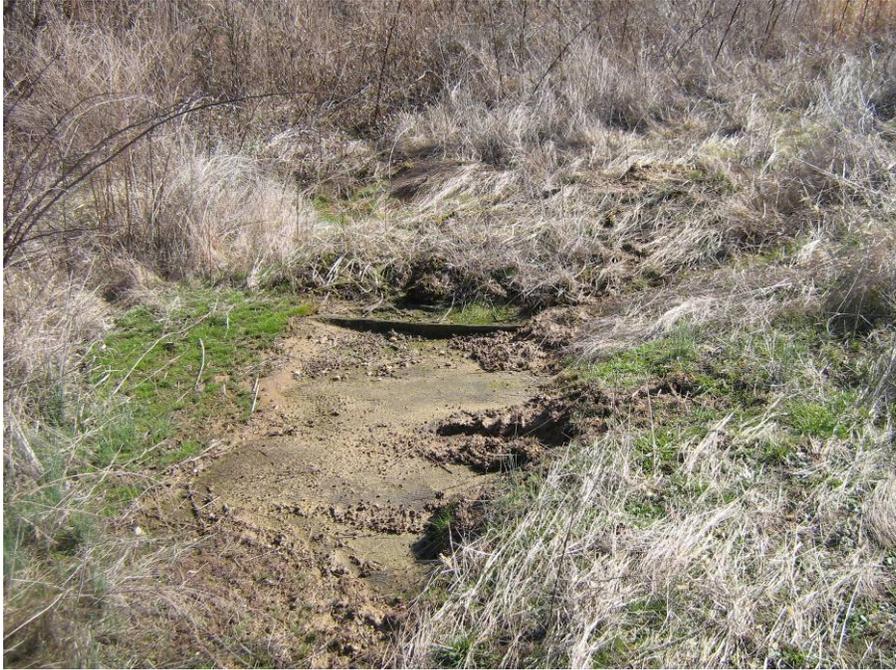
Drawing Mark CDA-4-1 Erosion exposing liner along toe of eastern stack area.

- Refer to the current Annual Inspection Report for repair locations and instructions for the disposal area. The plant should continue best management practice to mow and maintain the exterior slopes and top of the disposal area to allow for better assessment of the facility. This includes cutting and maintaining vegetation, tree removal, repairs of erosion areas, etc.
- Continue annual inspection program and execute recommendations.

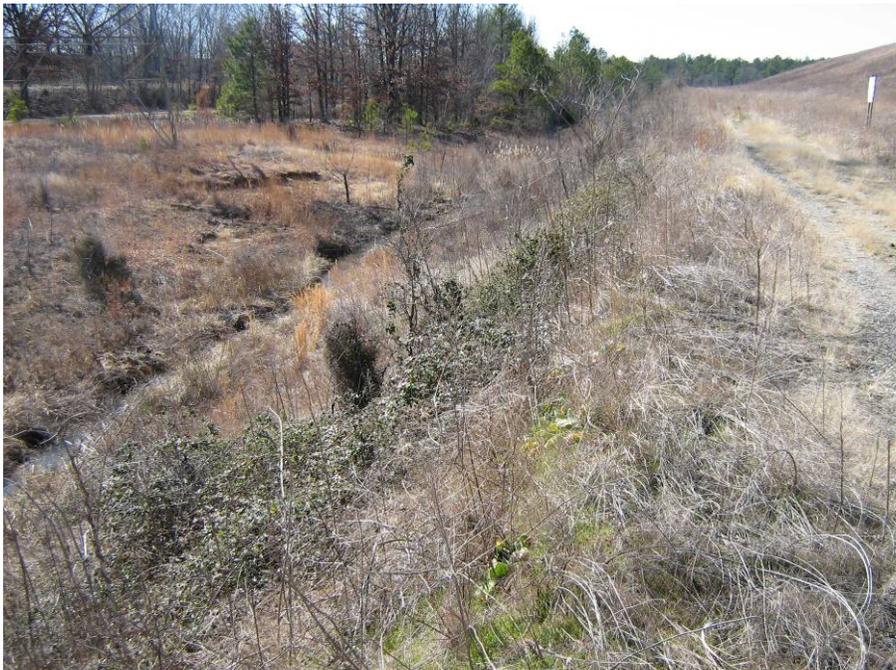
Drawing Mark CDA-4-2 Steep slopes and heavy growth along original starter dike slope (Typ.).

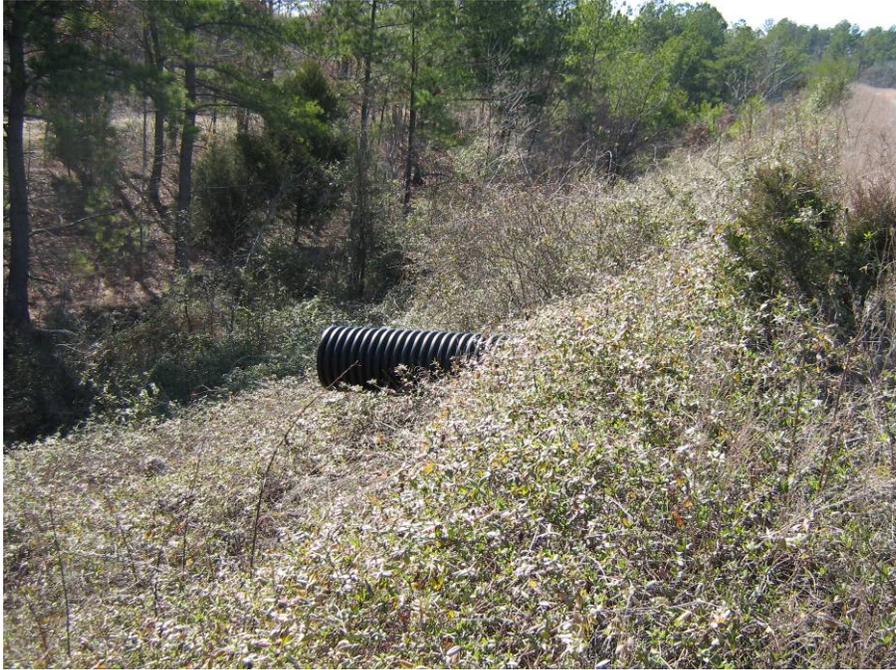
Drawing Mark CDA-4-3 Outlet for drainage area along southern portion of disposal area (Typ.).

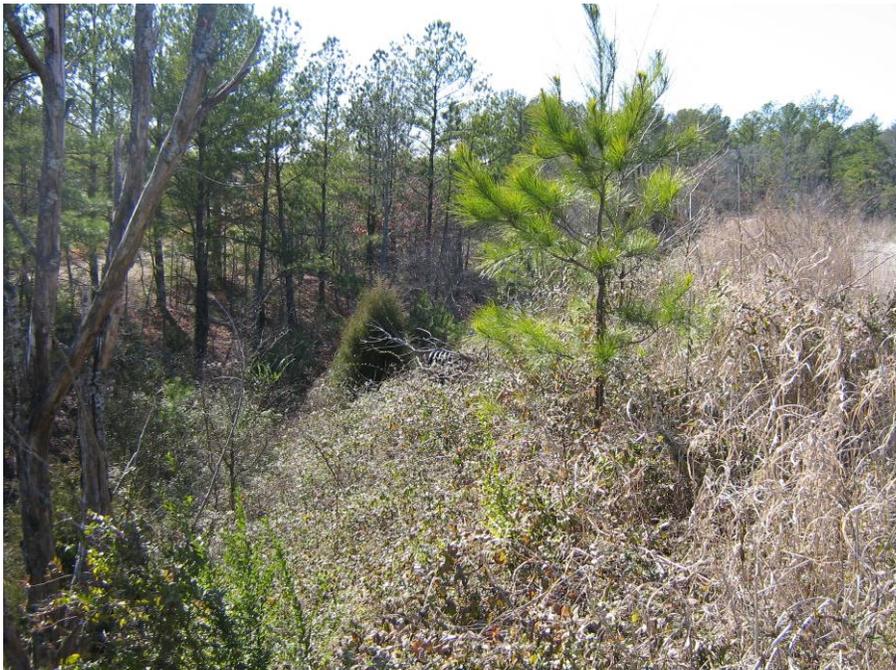
- In addition to the trees observed along the original starter dike, some small trees were observed along various portions of the disposal area.

Drawing Mark CDA-4-4 Trees and heavy growth along original starter dike slope (Typ.).

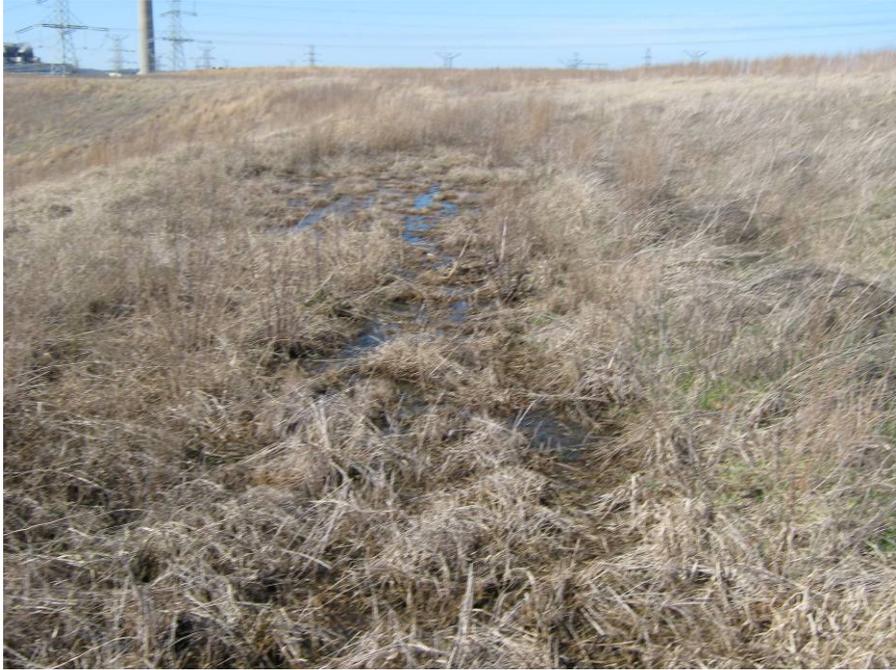
Standing Water in Ditches or on Benches: Standing water was observed within some of the drainage ditches throughout the disposal area and along portions of the benches within the eastern stack area.

Drawing Mark CDA-4-5 Standing water along bench of eastern stack area (Typ.).

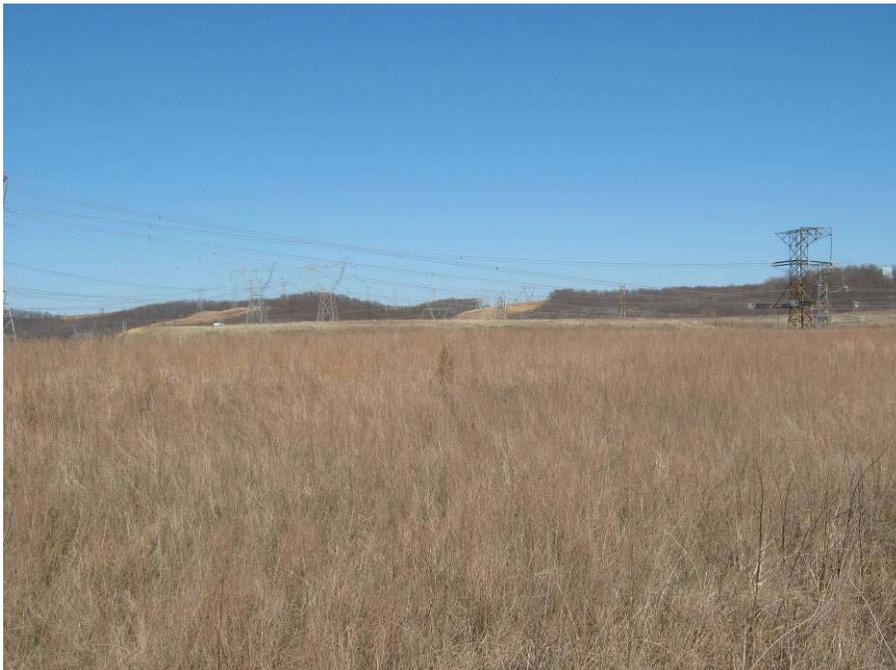
Drawing Mark CDA-4-6 Heavy vegetation along top of disposal area (Typ.).

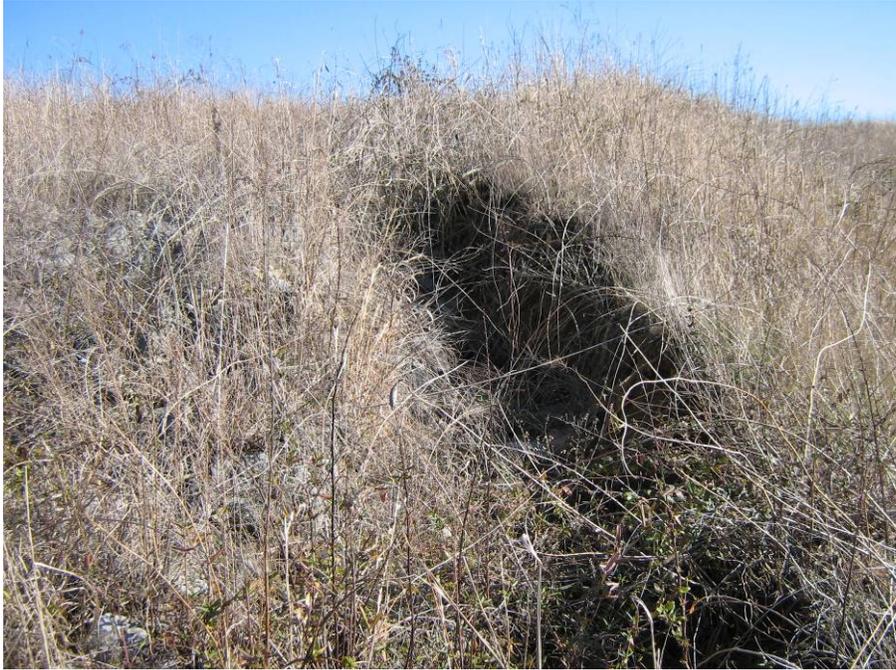
Erosion: Erosion areas including washouts and rills were noted at various areas along selected drainage ditches.

Drawing Mark CDA-4-7 Erosion rill along southwest side of disposal area (Typ.).

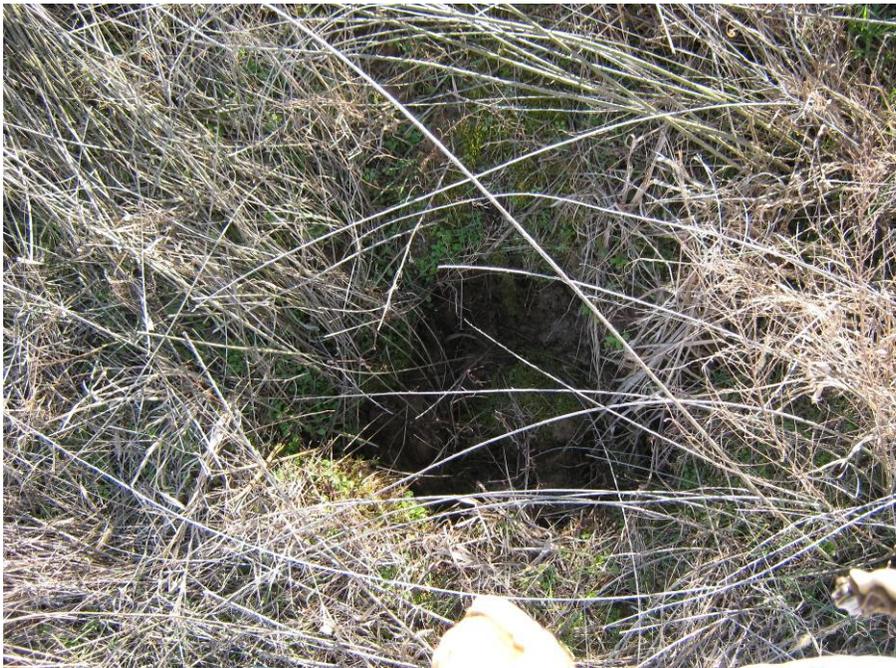
Drawing Mark CDA-4-8 Washout along northwest stack area slope (Typ.).

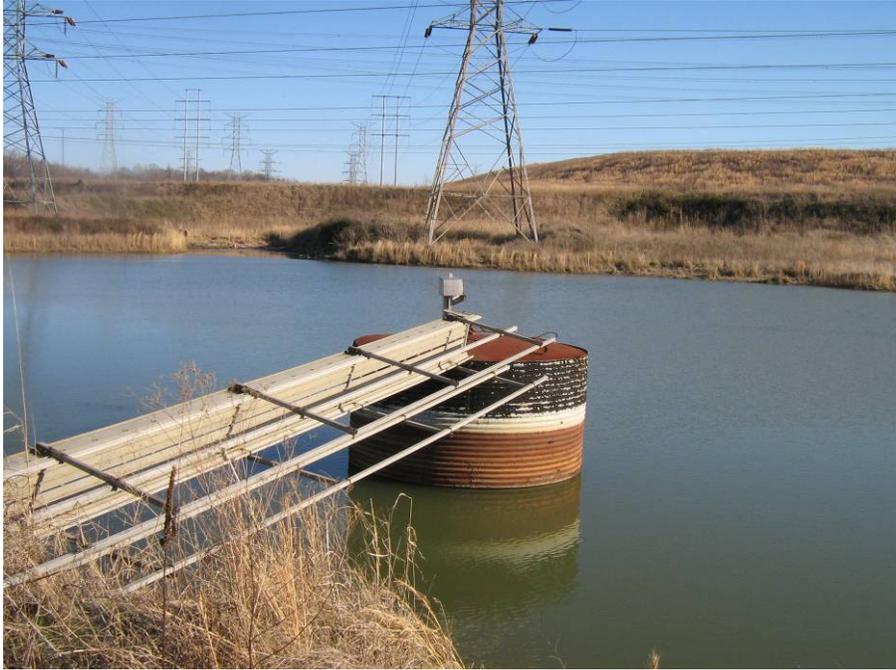
Drawing Mark CDA-4-9 Spillway in Stilling Pond "D"

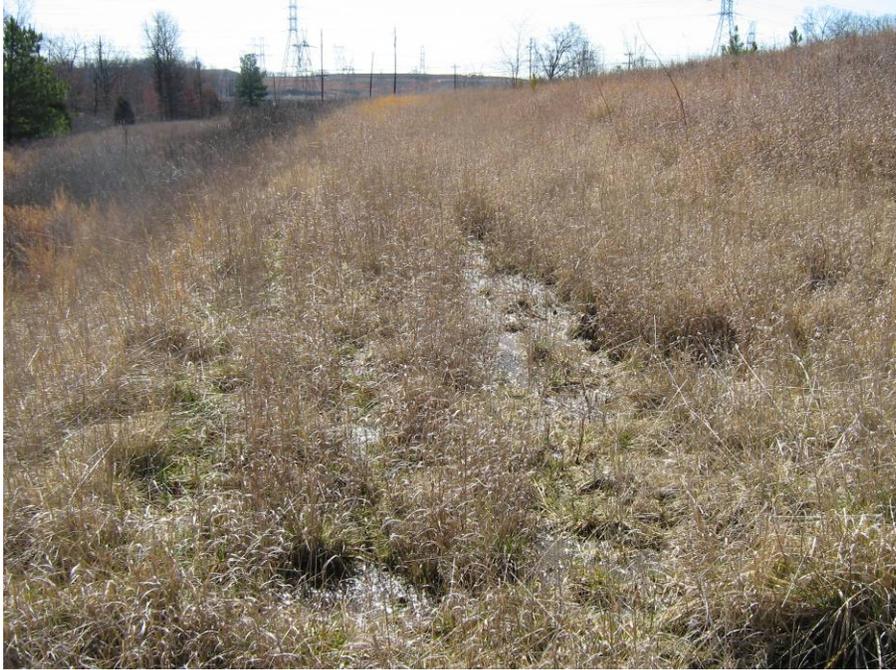
Seepage:	Seepage was observed along the crest of the original starter dike around the entire perimeter of the cell. Heavy stands of phragmites are present throughout the crest of the starter dike due to the wet, soft ground conditions. This seepage has been reported for several years and originally started in the north portion of the cell. The seepage has continued to extend farther around the cell for years and appears to have completely surrounded the cell at this point.
Benches:	Crest of original starter dike appears as a bench below the Phase 2 dike above.
Foundations, Drains, Relief Wells, Instrumentation:	No provisions for drainage/seepage control, or instrumentation were observed
Animal Burrows:	None observed.
Slope:	Measured: 2.5H:1V for starter dike and 3H:1V or flatter for upper Phase 2 dike at Section 1 Design: 3.0H:1V for starter dike and 4H:1V for Phase 2 dike (from drawing 10W218-5).

Drawing Mark CDA-5-1 Seepage along crest of starter dike (Typ.).

- The seepage observed around the Ash Dredge Pond East of Gas Turbines Area 5 should continue to be monitored. A seepage collection system should also be planned and installed to collect the seepage to outlets that can be easily monitored and to prevent further saturation of the starter dike until such time that the evapotranspiration actions are established and functioning.

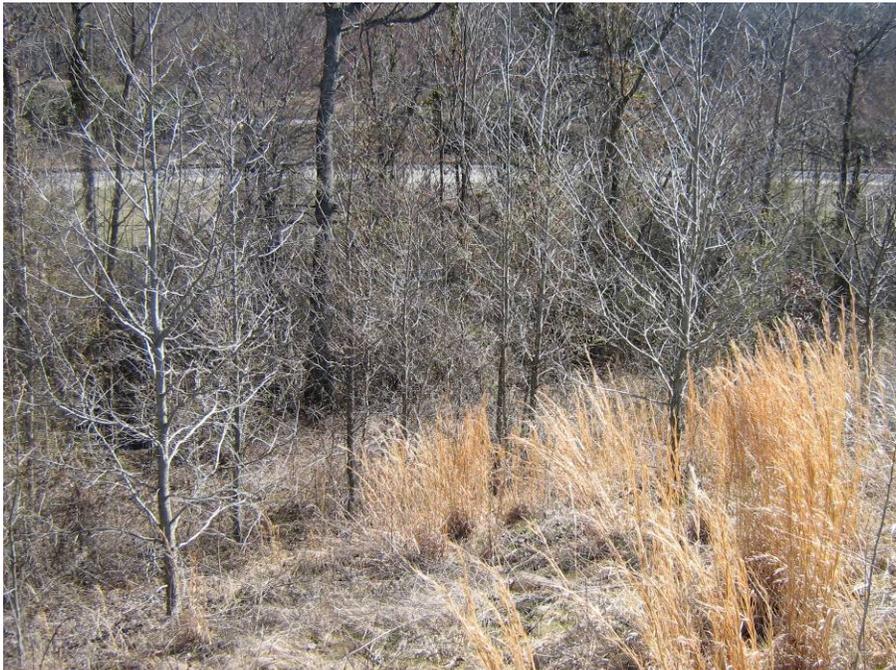
Drawing Mark CDA-5-2 Trees along exterior starter dike slope in north end of cell.

- It is recommended that trees be removed from exterior starter dike slopes. Slopes should be repaired as needed following tree removal.
- The plant should continue best management practice to mow and maintain the exterior slopes of the closed cell to allow for better assessment of the facility. This includes cutting and maintaining heavy/tall phragmites growth within seepage areas around the cell to allow better assessments, repairing erosion areas, and monitoring animal paths and repairing erosion if it occurs.

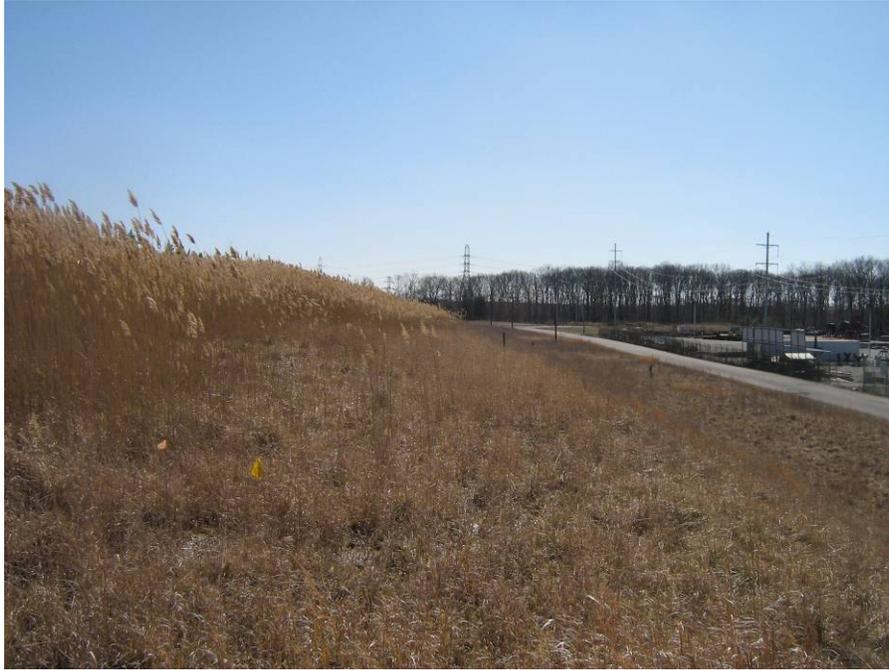
Drawing Mark CDA-5-3 Heavy phragmite growth along seepage area at crest of starter dike (Typ.).

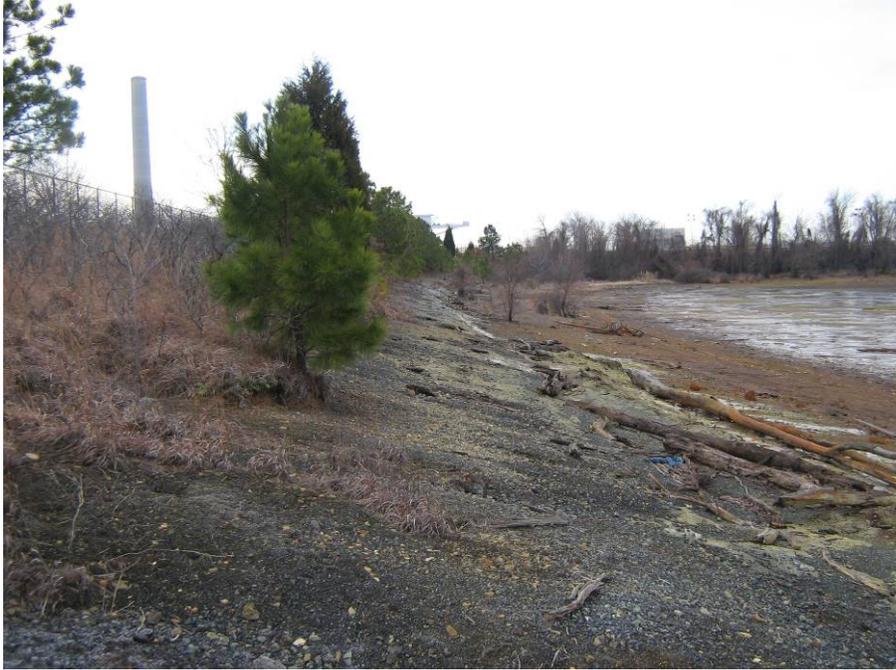
- Some trees were observed along various portions of the outer dike slopes along the west side of Pond A. Some erosion is also present along the clay cover with exposed ash present in some areas along the banks of Kentucky Lake.
- Seepage has been reported along the west banks of Pond A for several years. The seepage was also observed during the assessments by Stantec personnel. Continued monitoring of these seepage areas will be required.

Drawing Mark CDA-1-1 Erosion, trees, exposed ash along west dike of Area A (Typ.).

- It is recommended that trees be removed from the outer slopes along the west side of Area A. Slopes should be repaired as needed following tree removal. Areas of erosion and exposed ash should also be repaired and new clay cover installed. To minimize damage to the toe and slopes, rip rap should be placed along the slopes once repairs are complete to protect against wave action. The dike should continue to be monitored and repaired as conditions warrant.
- The seepage observed along the toe of the west dike at the North Abandoned Ash Disposal Area 1 (Area A) should continue to be monitored.
- The plant should continue best management practice to mow and maintain the closed cell until such time that management of the facility is assumed by Dupont.
- Continue annual inspection program and execute recommendations.

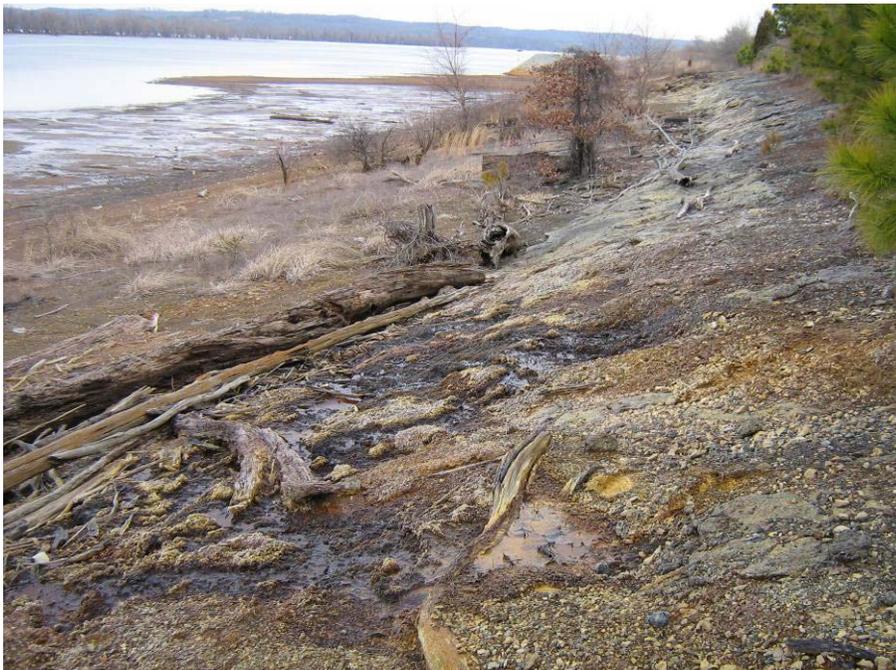
Seepage: Seepage was observed along the toe of the west dike in several areas. This seepage has been reported for several years and appears unchanged from previous inspections.

Drawing Mark CDA-1-2 Seepage along toe of west dike of Area A.

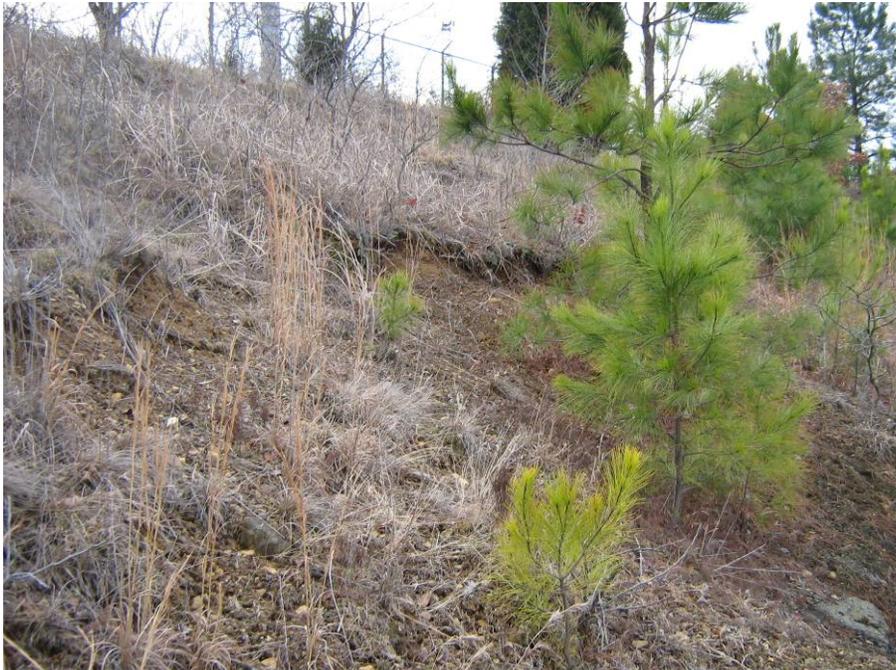
Instabilities: Some erosion and shallow sloughing were observed in various areas along the exterior slope.

Drawing Mark CDA-1-3 Erosion, shallow scarps along west dike of Area A (Typ.).

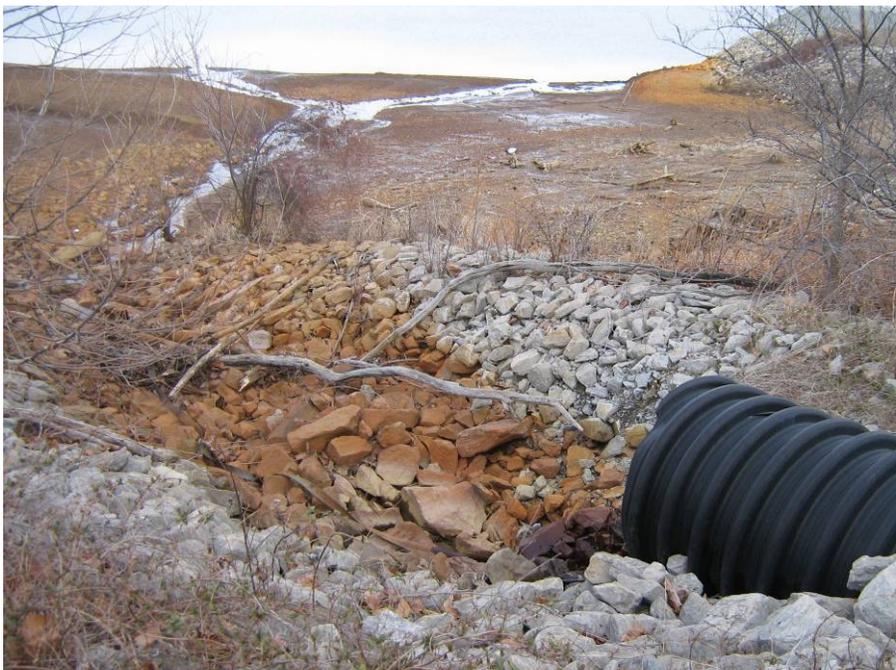
Number:	One (1) outlet pipe observed to drain interior runoff ditch, total number unknown.
Size, Type and Material:	36 inch Corrugated HDPE
Headwall:	None observed.
Joint Separations:	None reported
Mis-Alignment:	None reported.
Closed/Abandoned Conduits:	None reported.

Drawing Mark CDA-1-4 Ditch outlet pipe adjacent to Dupont property.

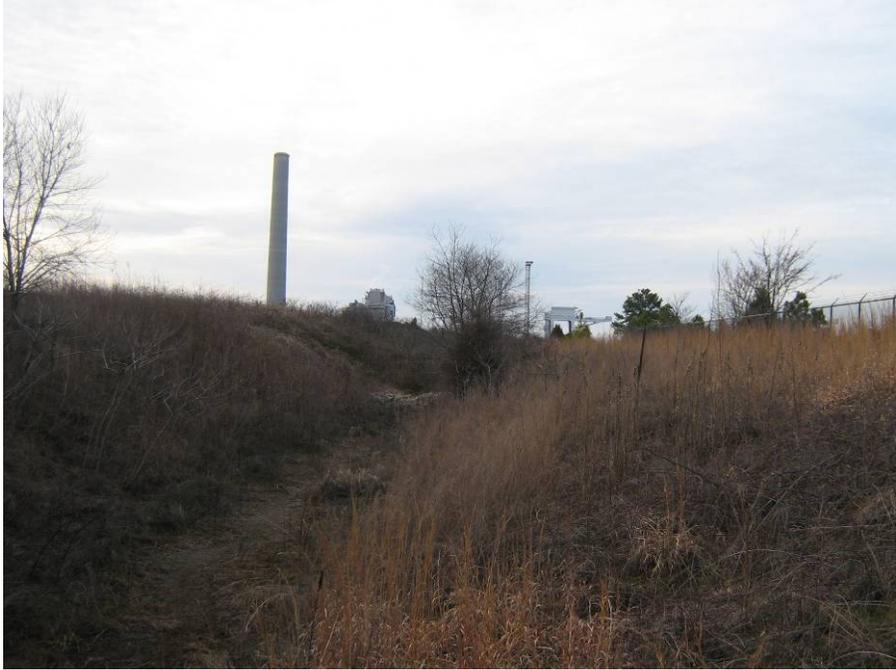
Vegetation:	Ditch slopes along interior of Area A heavily vegetated.
Trees:	Trees present along interior ditch slopes.
Wave Wash Protection:	None observed.
Erosion:	Some erosion observed along interior ditch slopes.
Instabilities:	None observed.
Animal Burrows:	None observed.
Freeboard:	Measured: Cell currently closed. Design: Not available.
Encroachments:	None observed.
Slope:	Measured: None measured. Design: Ditch excavated to elevation 370 with 2.5H:1V slope (from drawing 10H443)

Drawing Mark CDA-1-5 Heavy vegetation along interior ditch side slopes (Typ.).

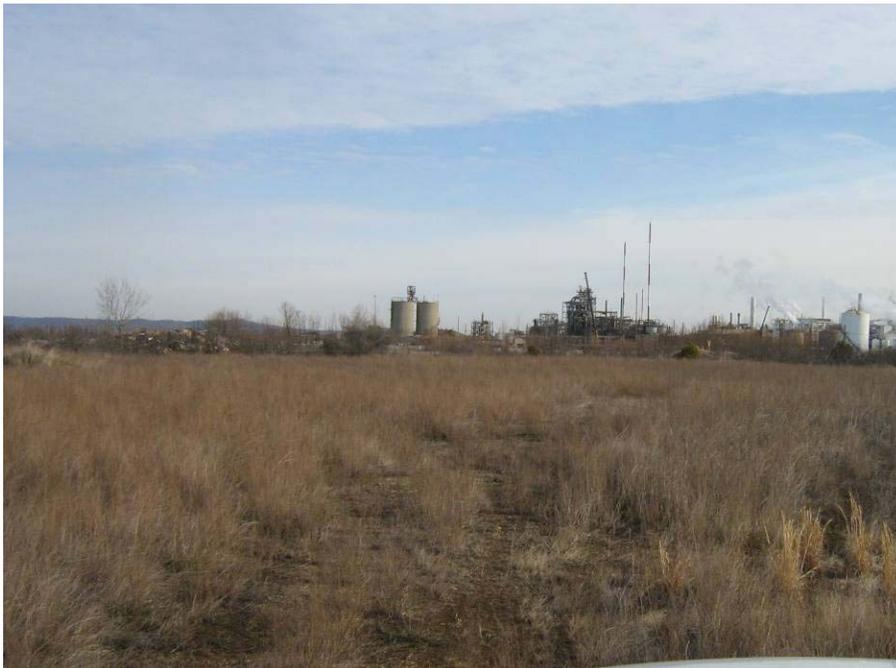
Bare Spots/Rutting: Some bare spots observed along top of closed cell.

Drawing Mark CDA-1-6 Areas of erosion and lack of vegetation along top of closed Area A (Typ.).

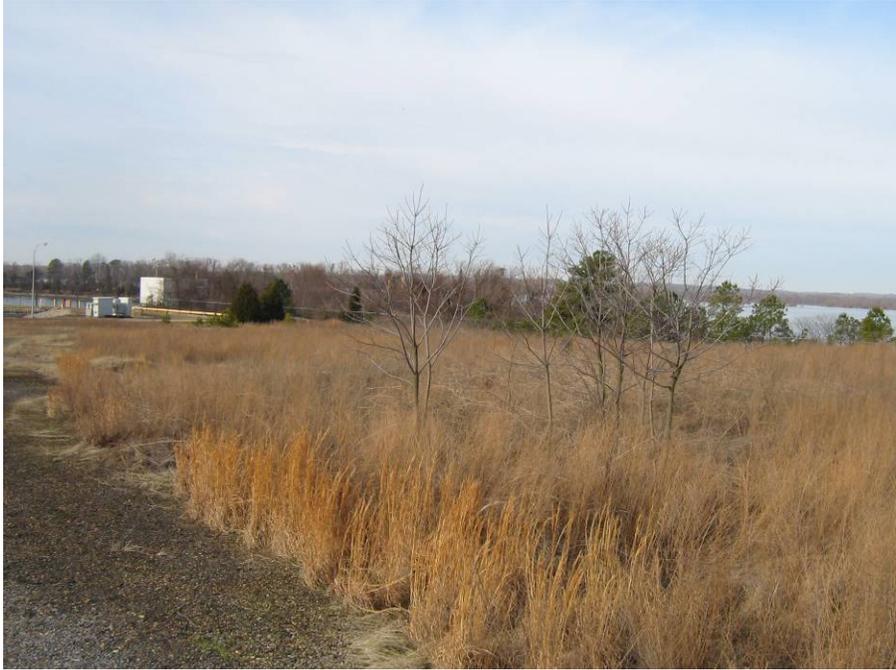
Drawing Mark CDA-1-7 Heavy vegetation and some trees along top of closed Area A (Typ.).
